Accident
on 25 December 2003
at Cotonou Cadjèhoun
aerodrome (Benin)
to the Boeing 727-223
registered 3X-GDO
operated by UTA
(Union des Transports Africains)

REPORT TRANSLATION
3x-o031225a

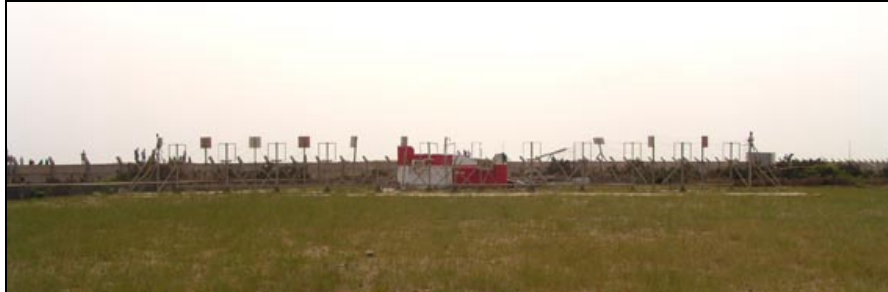
Zone 1

The airplane damaged the localizer antennas, which were about a hundred and fifteen meters from the end of the runway, then destroyed the reinforced concrete building housing the electronic equipment bays.

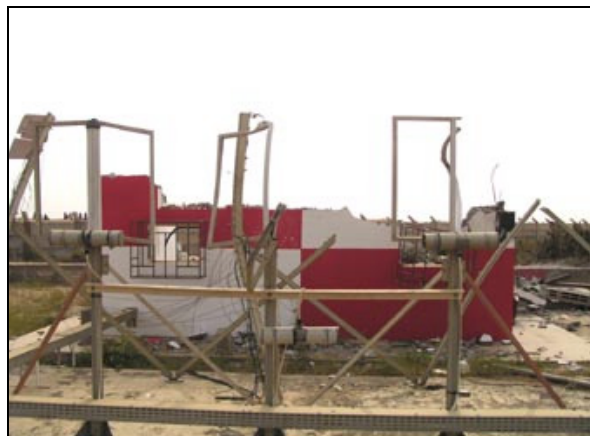
The photo below shows the north wall of the building with a black mark on the right side caused by the right inner tire. This mark was one meter twenty from the ground.

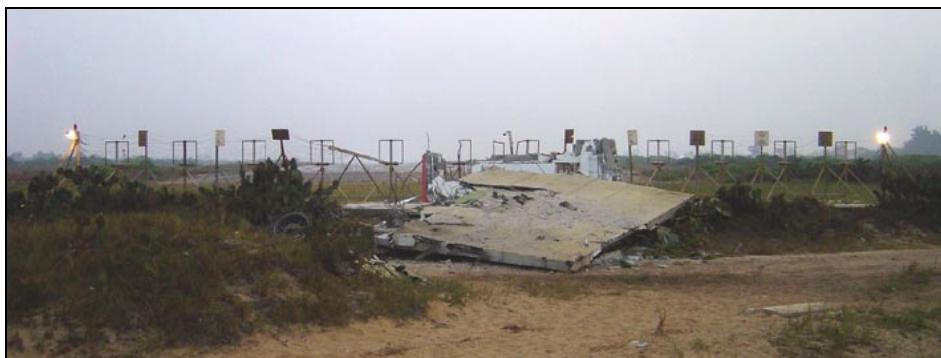
The roof of the building was torn off. It rotated 45° to the left and was thrown nine meters to the south.

Damage on the right was noted that was caused by the right main landing gear, on the central part marks were left by the lower part of the fuselage and on the left side there was damage caused by the left main landing gear.

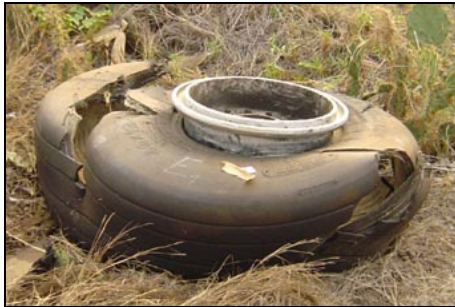
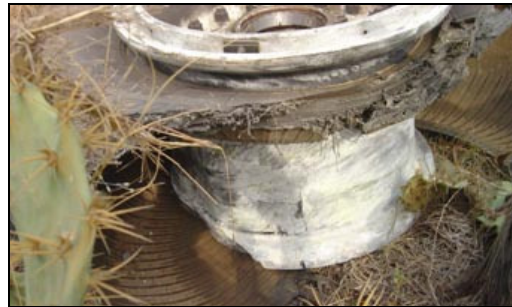
A part of the airplane's tail and some steps from the retractable ventral stairs were also found among the debris inside the building. The right main landing gear and its outer right wheel were found fifteen and eighteen meters southwest of the building respectively. The rims showed marks of the wheels' collision with the building.

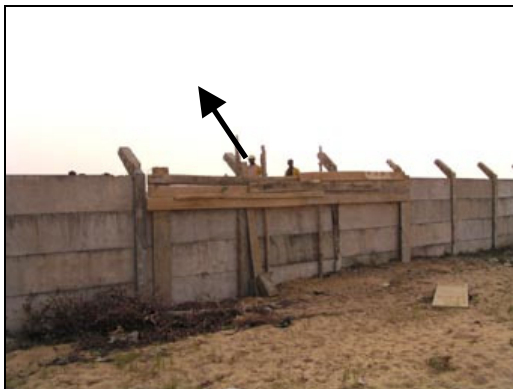
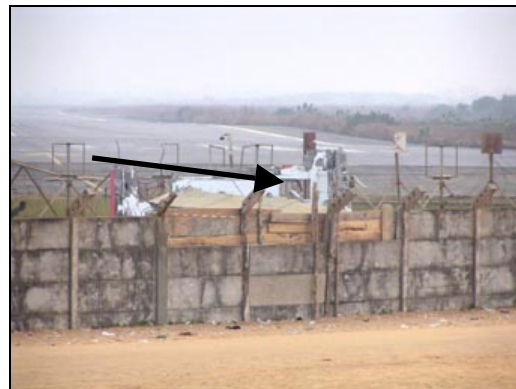
Zone 2

A part of the aerodrome boundary wall located on the runway extended centerline, at a distance of thirty-five meters from the localizer building, was damaged.

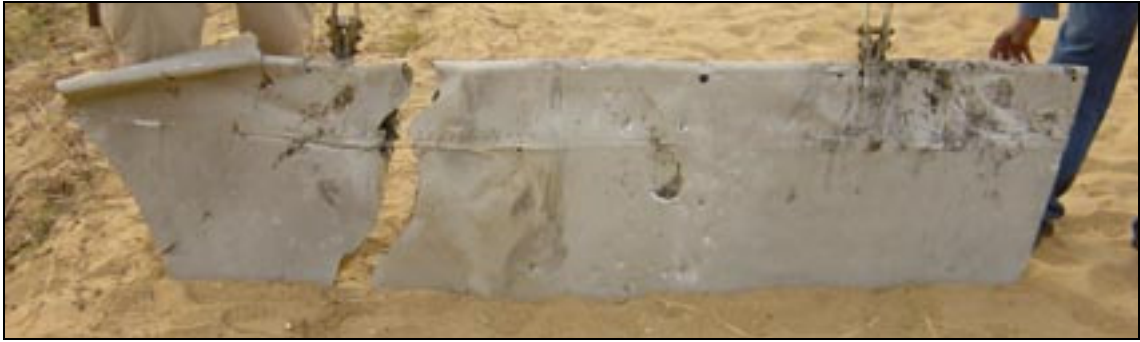
Zone 3

Six meters to the west of the previously-mentioned parts, two parts of the right flap were found. Tire marks were found on the underside along with a circular-shaped puncture about two centimeters deep.

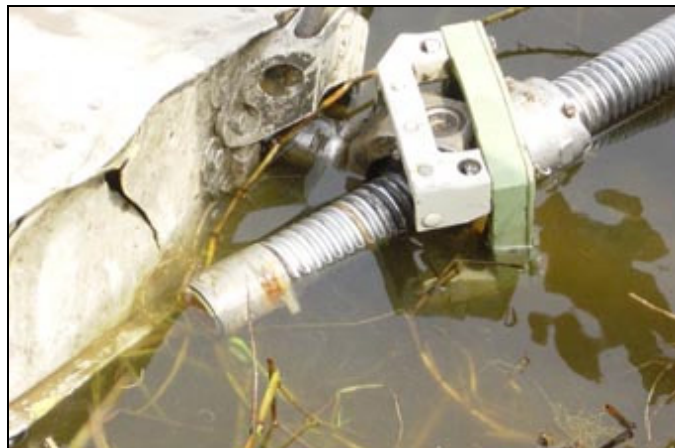
Beyond, near the opposite bank but in the water, a part of the right inner flap ②, with its screwjack and, a few meters away, a piece of the right wing with a part of the outer right aileron ③ were found.

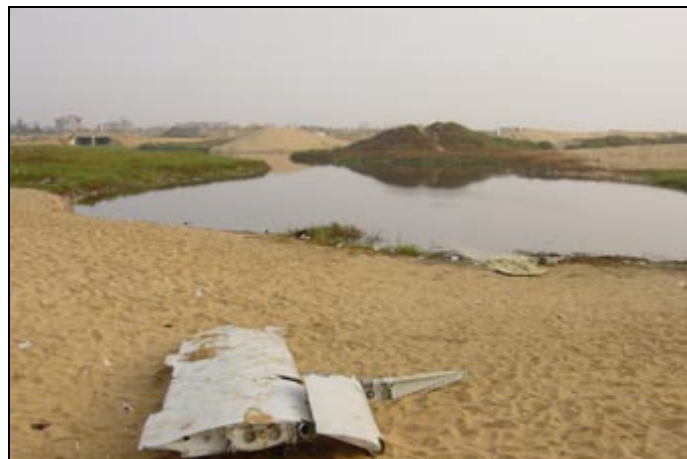
On the left bank of the canal, a part of the skin of the right wing ④ was found, then, five meters away, another part of the right wing with a leading edge slat ⑤.

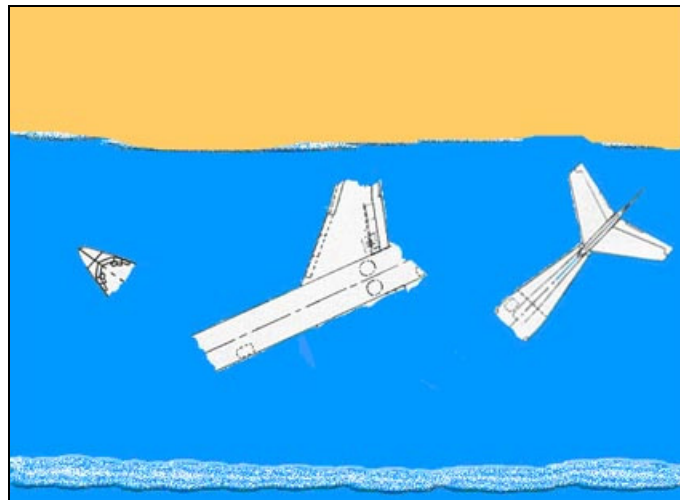
The main part of the airplane had turned over and only the lower part of the fuselage and the underside of the left wing were visible. Both of the outer engines had separated from the tail.

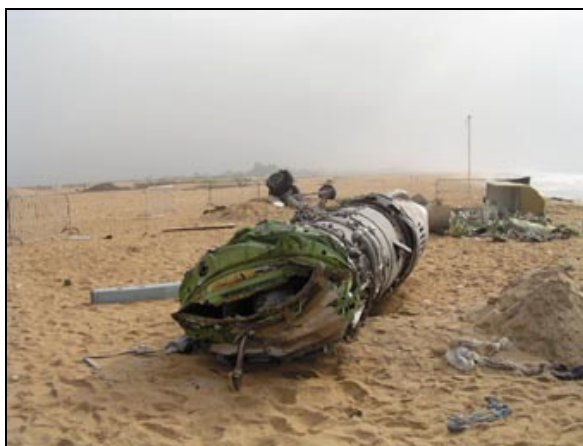
Right engine

The majority of engine 3 was intact. The thrust reverser was still attached to the engine, in the retracted position. No damage due to a fire or an uncontained burst was noted.

The nose cowl was crushed and twisted. The visible fan blades were intact, with the exception of a blade that had marks from an impact with a hard object on its leading edge. The visible main stage blades were severely damaged. One of them had broken off just above its base and the others were generally broken off about halfway up and bore impact marks on their leading edges.

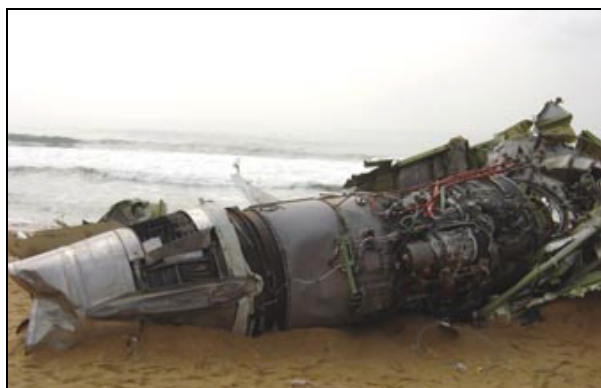
Central engine

The visible parts of engine 2 showed no signs of damage due to a fire or an uncontained burst. The nose cowl was missing. The thrust reverser, in the retracted position, and the exhaust section were intact. The last stage low pressure turbine blades were intact, which indicated that the turbine assembly was intact. The nose dome was slightly dented and pushed in. The compressor blades were not all visible due to the damage to the air intake channel, and the visible main stage blades were relatively lightly damaged.

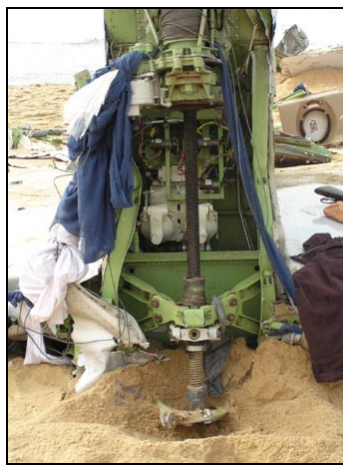
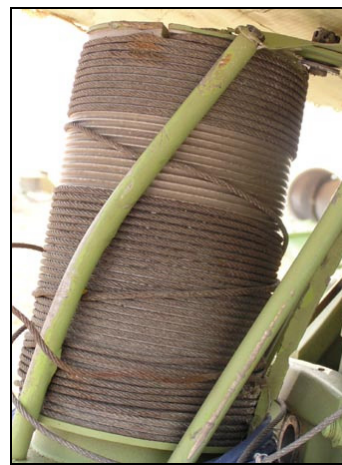
Tail

During recovery operations, the tail broke in two, the rudder and the central engine in one part and the stabilizer and the elevator in the other. The stabilizer jackscrew was intact; its drive cables were broken.

The position of the jackscrew did not make it possible to validate the position of the stabilizer, the cause and the sequence of the cable ruptures being undetermined.

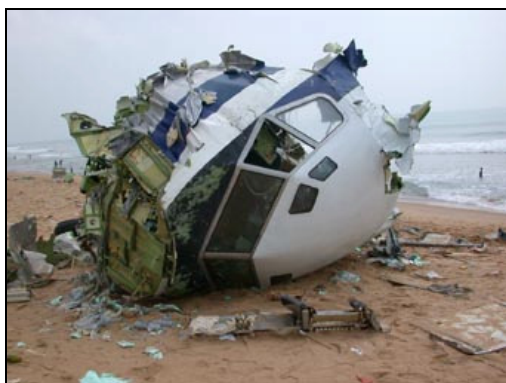
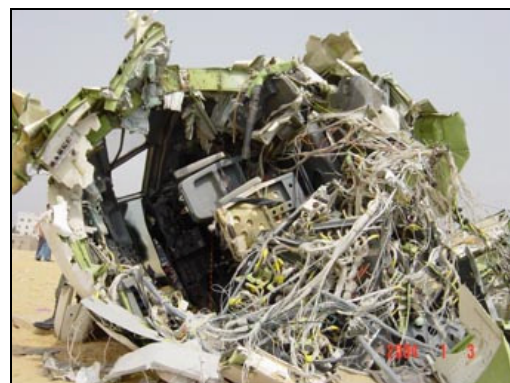
Cockpit

The cockpit was not very damaged, except for the Flight engineer's panel and a large part of the equipment. There was a strong compression mark on the floor and the skin of the partition and the outer right side of the fuselage. The nose gear had been ripped off.
