CAA PAPER 98002

**FRICITION CHARACTERISTICS
OF HELIDECKS ON OFFSHORE
FIXED-MANNED INSTALLATIONS**

I Beaty, Cranfield University

REPORT PREPARED BY COLLEGE OF AERONAUTICS
FLIGHT SYSTEMS AND MEASUREMENT LABORATORIES,
AIRCRAFT GROUND OPERATIONS GROUP
AND PUBLISHED BY
CIVIL AVIATION AUTHORITY, LONDON, MARCH 1998

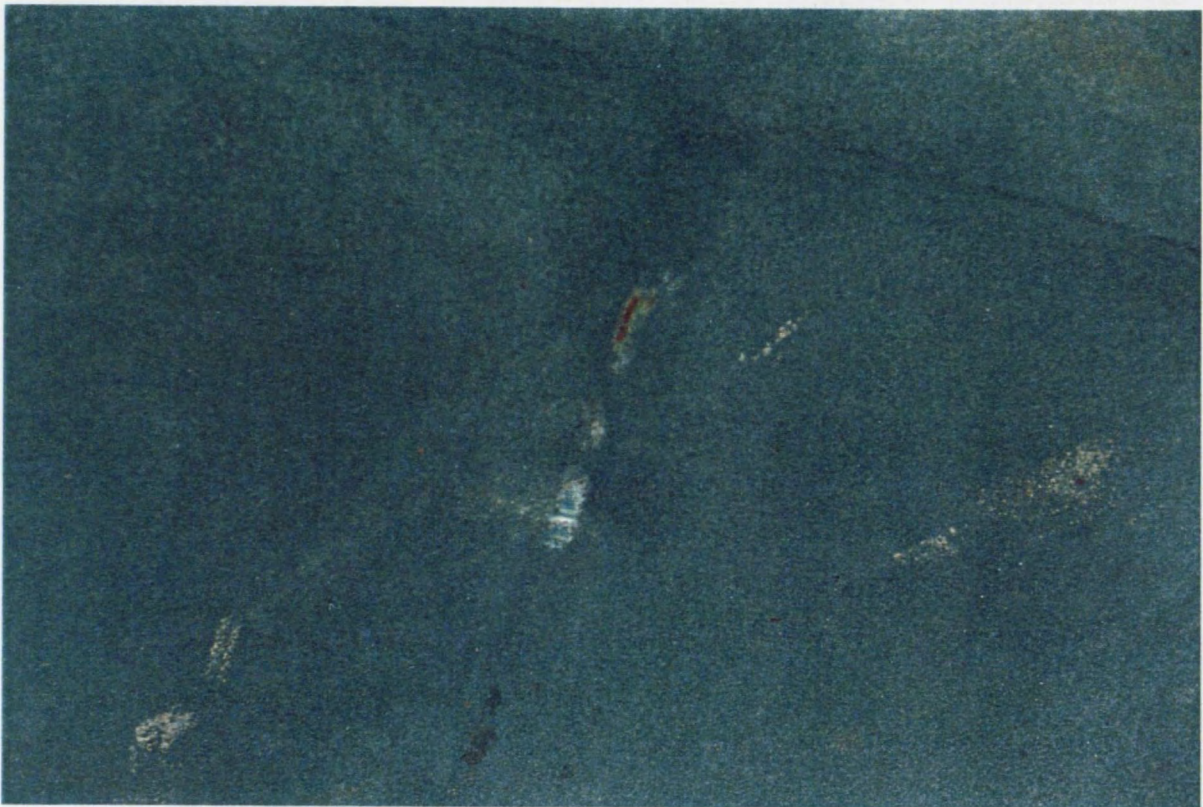
Figure 4 Damage to Weld Seam by Helicopter Skids

- 2.3.3 Since the installation of the new surface some damage has been caused by helicopters fitted with skid-type undercarriages (Figure 4). The damage consisted of worn patches on the tops of the deck weld seams which had permitted corrosion to occur, together with areas where the friction material had been badly scuffed. This was caused by high pressure contact with the skids of the in-field shuttle helicopter, which sits on the helideck with the engine running and rotor blades turning for considerable periods of time while personnel and freight are being loaded and unloaded. The resulting vibration had worn the surface coating in scattered areas (all within the aiming circle).

2.8.4 There is more variability inside than outside the aiming circle which can be attributed to two factors; a) contamination from fuel and oil spillage which, although cleaned off regularly, still marks the surface; b) surface damage caused by helicopters with skids. The contamination can be kept under control by regular cleaning. The latter problem will soon be eliminated with the withdrawal of skid-fitted helicopters from North Sea operations.

2.9.3 The surface has stood up well to the regular impact of the skid fitted inter-platform shuttle helicopters. Scuff marks have been repaired by the resident helideck team.

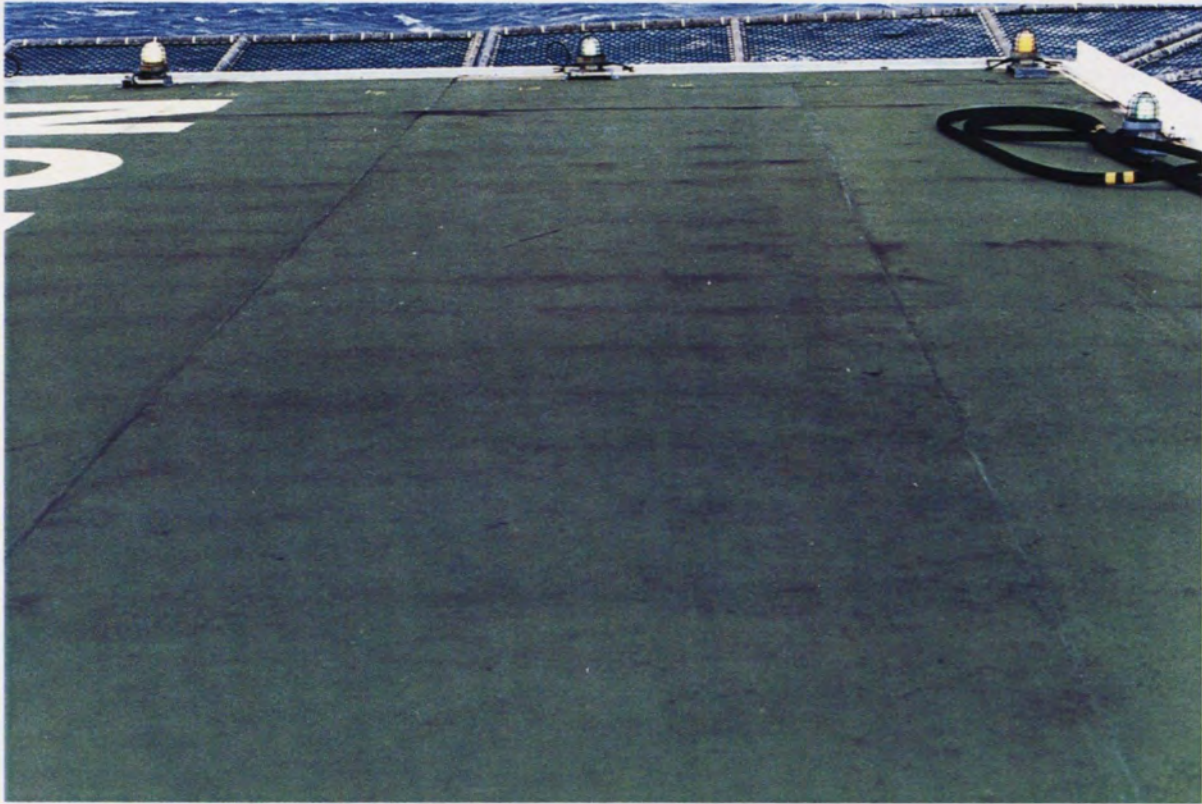
Figure 5 Pollution Deposits

- 2.3.4 In the early stages some dark staining of the deck occurred in the north-west corner (Figure 5) which was thought to be caused by pollution.
- 2.3.5 In the later stages the surface material attained a white 'bloom' (Figure 6) which was believed to be caused by the adverse weather conditions during the installation. In the summer of 1994 the deck was overlaid with a thin layer of polyurethane resin which succeeded in restoring the original green colour of the surface at the cost of a short-term slight reduction in the friction value, (Figure7).

2.7.2 The October 1994⁶ trial was an additional test necessitated by work carried out on the surface to rectify staining and colour fading problems which occurred after the surface had been exposed to the elements for some time (Figure 5 & Figure 6). To correct these problems, the surface was coated with an additional thin layer of polyurethane resin, which the tests showed had the effect of reducing the average available friction from 1.02 (February 1994) to 0.97, still well above the 0.70 requirement for 1 year operation without a net.

2.9.4 Initial dark staining of the deck, thought to be caused by pollution, has worn off and not reappeared. A white bloom, thought to be caused by moisture ingress during the initial installation, was overlaid and successfully eliminated with a thin layer of polyurethane resin.

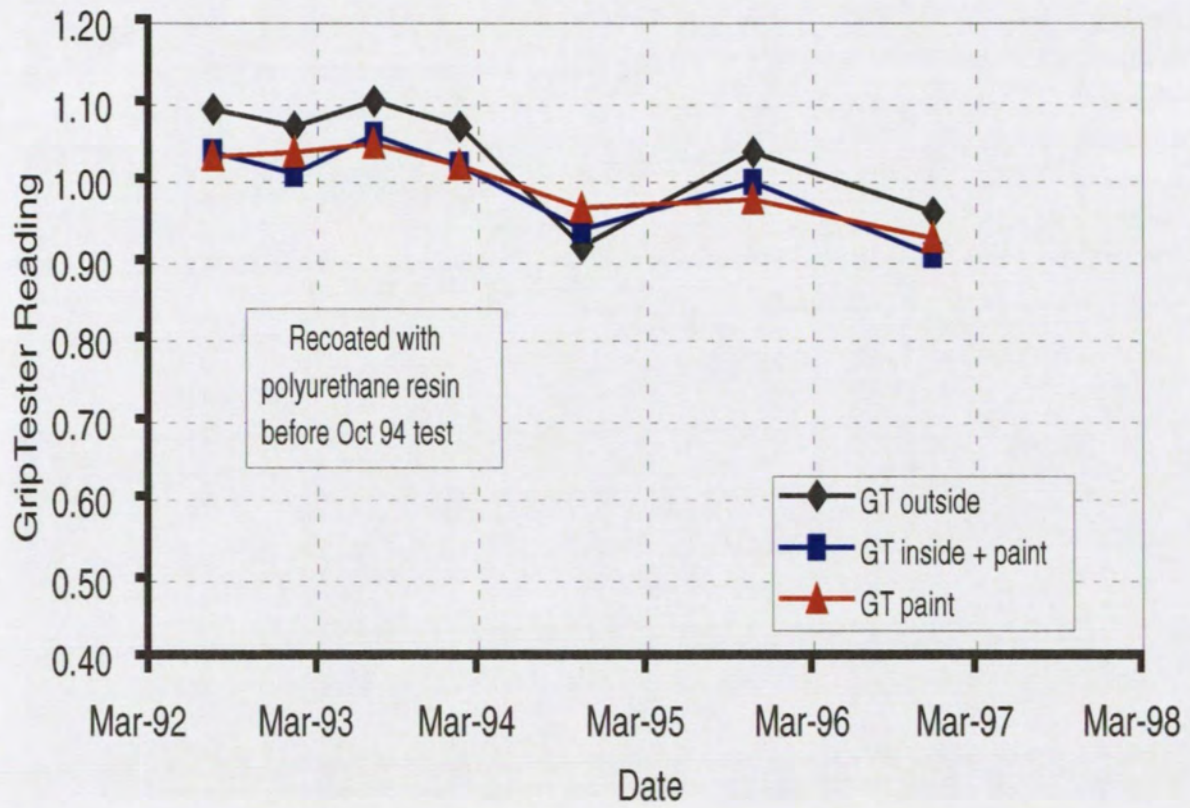
Figure 7 North Cormorant Friction History

2.8.3 The friction values on this helideck have remained high throughout its life to date, but the overall trend in friction readings is downward (Figure 7). Extended trendlines in Figure 8 will cross the 0.7 μ level at the end of 2005. It should be noted that the test in October 1994 was the only one performed on a wet deck.
