Tail strike during take-off

Boeing 737-800, registration PH-HZB,
Rotterdam Airport, January 12th 2003

The Hague, November 2006, project number 2003004

DUTCH SAFETY BOARD

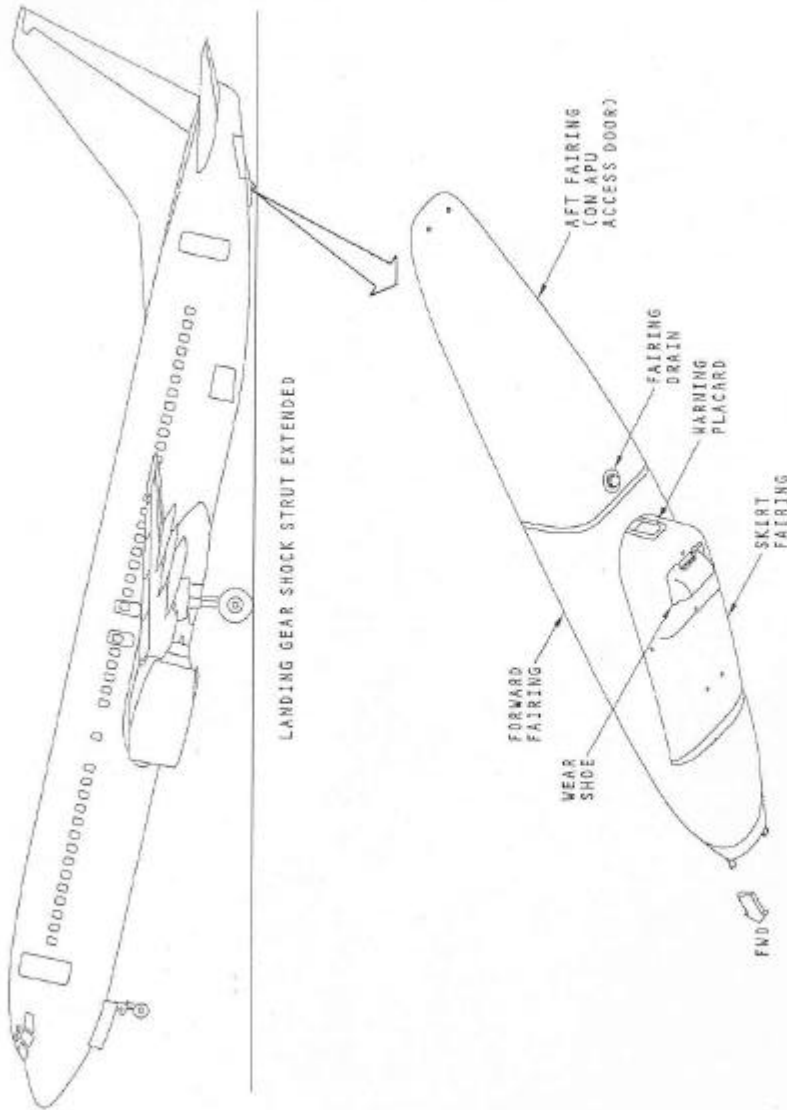
TAIL SKID - GENERAL DESCRIPTION

The wear shoe of the aircraft was found at the beginning of runway 24. The four bolts of the wear shoe were detached from it. See appendix B for the position of the wear shoe on the tail skid of the Boeing 737-800.

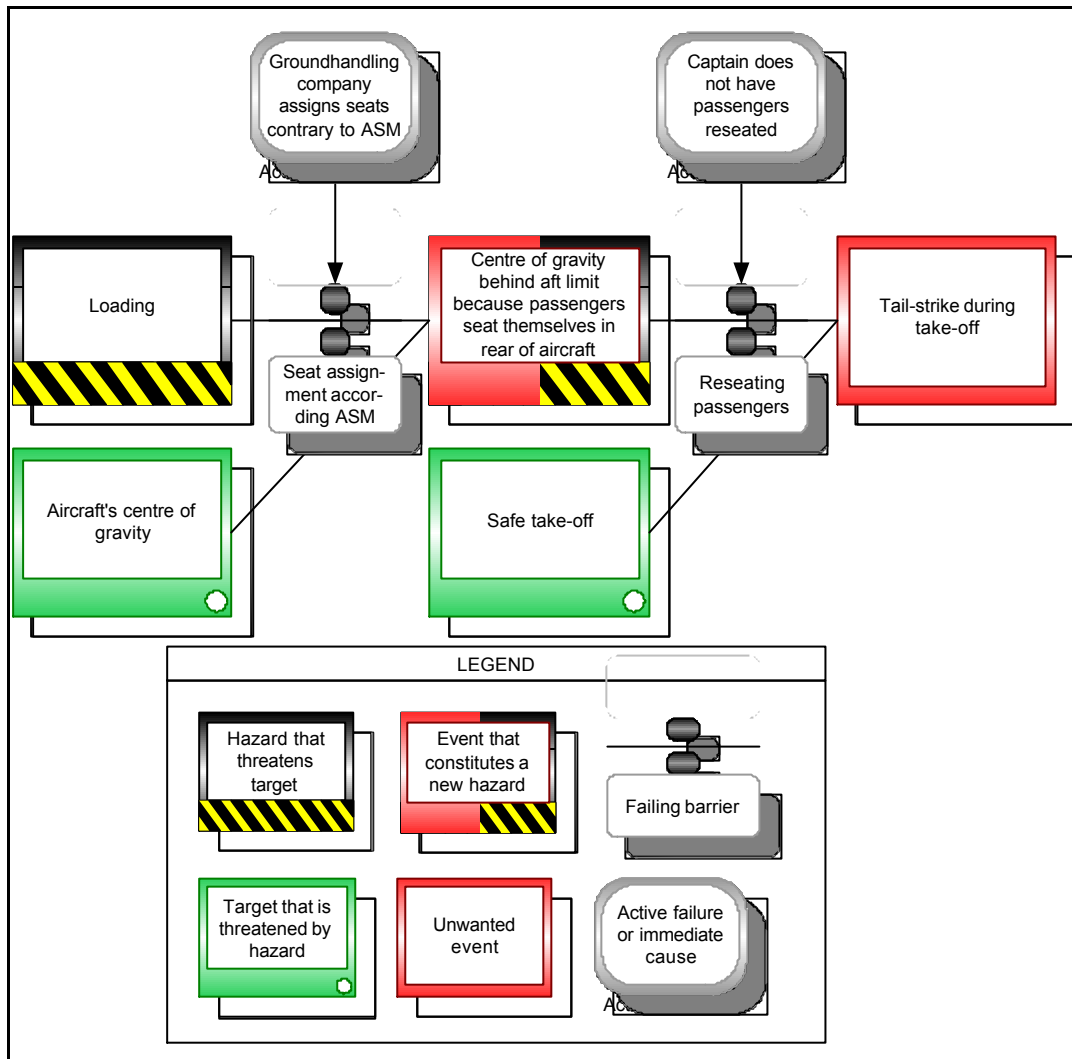
Figure 1: Simplified diagram of the Tripod analysis of the "Tail strike" of the Boeing 737-800 during take-off at Rotterdam airport on January 12th 2003

- Aviapartner did not assign the seats to the passengers in accordance with the passenger distribution table in ASM. As a result, passengers seated themselves in the rear of the cabin;
- Consequently, the aircraft's centre of gravity was situated behind the applicable aft limit. This deviation was not rectified by reseating the passengers;
- Because of this, the aircraft pitched nose-up just after take-off thrust had been selected. Subsequently, this movement stopped when the aft fuselage and the tailskid assembly contacted the runway (i.e., tail strike during take-off).

For both barriers, the present report describes how and why these "controls" failed. In this respect, and in agreement with Tripod Beta, the report distinguishes between preconditions and latent failures at the organisational level. To uphold the readability of the diagram the preconditions and latent failures are not included in figure 1, but are presented separately in table 11.
