**CAP 661**

**Mandatory Permit Directives**

**For Aircraft Operating on a Permit to Fly**

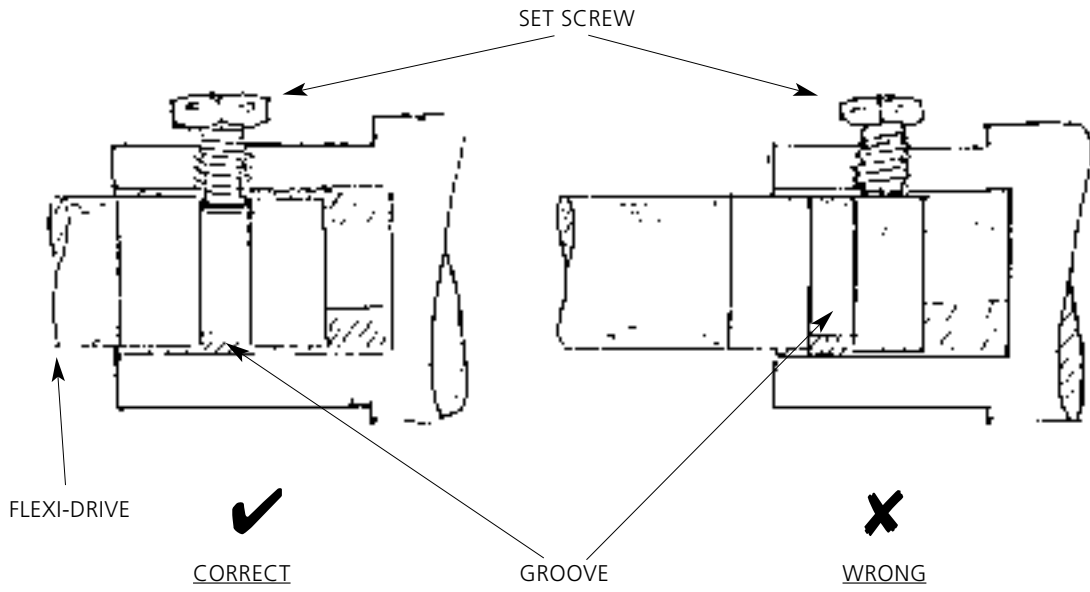
Figure 1

- (a) Remove the set screw, having first noted the amount of aluminium end ferrule projecting from the end socket. This should correspond with the distance of the centre line of the tapped hole normally occupied by the set screw from the face of the socket. If these dimensions do not correspond, the flexible drive shaft is incorrectly fitted, as it is possible to clamp the drive shaft ferrule at positions away from the groove in such a way that the drive is held by friction instead of positively located by the set screw in the groove. (See Figure 1).

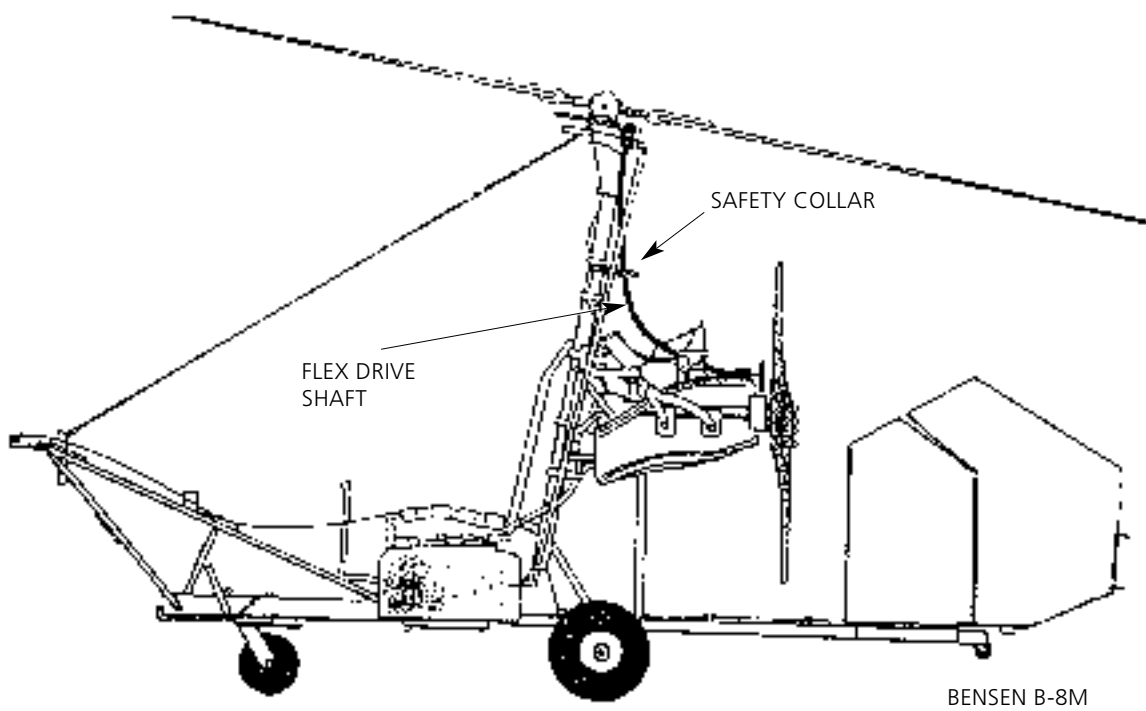
Figure 4 Pre-Rotator Drive Safety Strap

- 2 Check that the flexible drive shaft is correctly restrained in position on the aircraft by a safety collar mounted on the rotor pylon positioned approximately 10" below the rotor head cluster plates. (See Figure 3). This safety collar is a loose fit around the shaft which must be able to move freely up and down as the flying controls are moved. (See Figure 4).

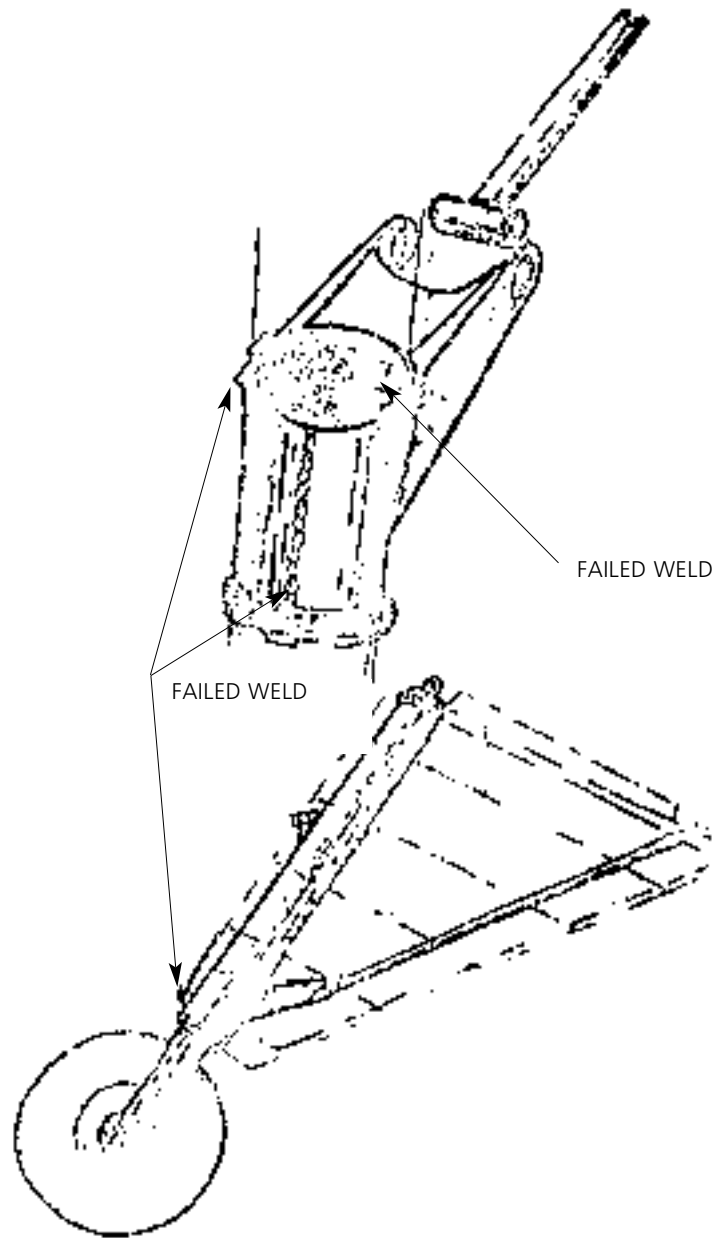
Reason: While taxiing back from a normal landing the pilot found the aircraft difficult to steer and vibration developed. The aircraft swung violently to the left and the left-hand wing struck the ground. Examination revealed that the welded joints on the radius rod sleeve of the left-hand landing gear had failed. The radius rod had then separated from the oleo leg which had folded forward.

Compliance: At the next opportunity and thereafter following any heavy landing and at each Permit to Fly renewal inspect the landing gear welds for cracking. (See Figure 1 overleaf).

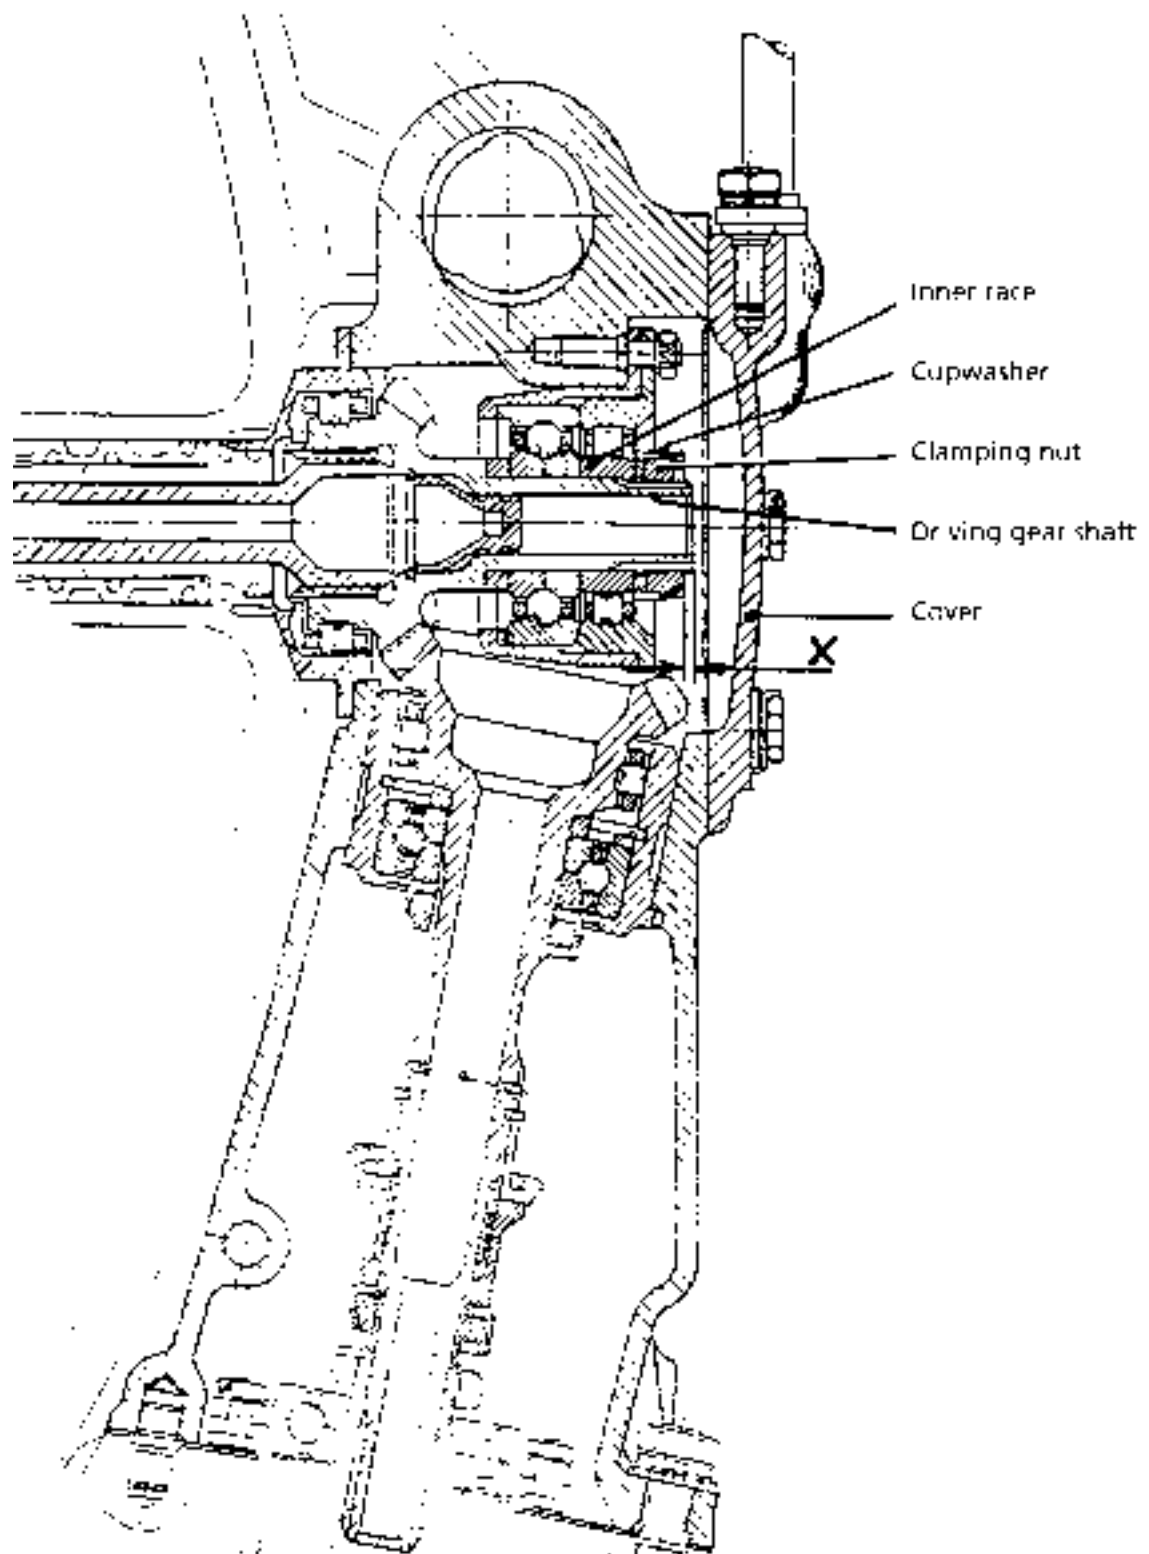
Figure 1  
Avon Mk. 203 & Mk. 207  
Right hand auxiliary gearbox drive

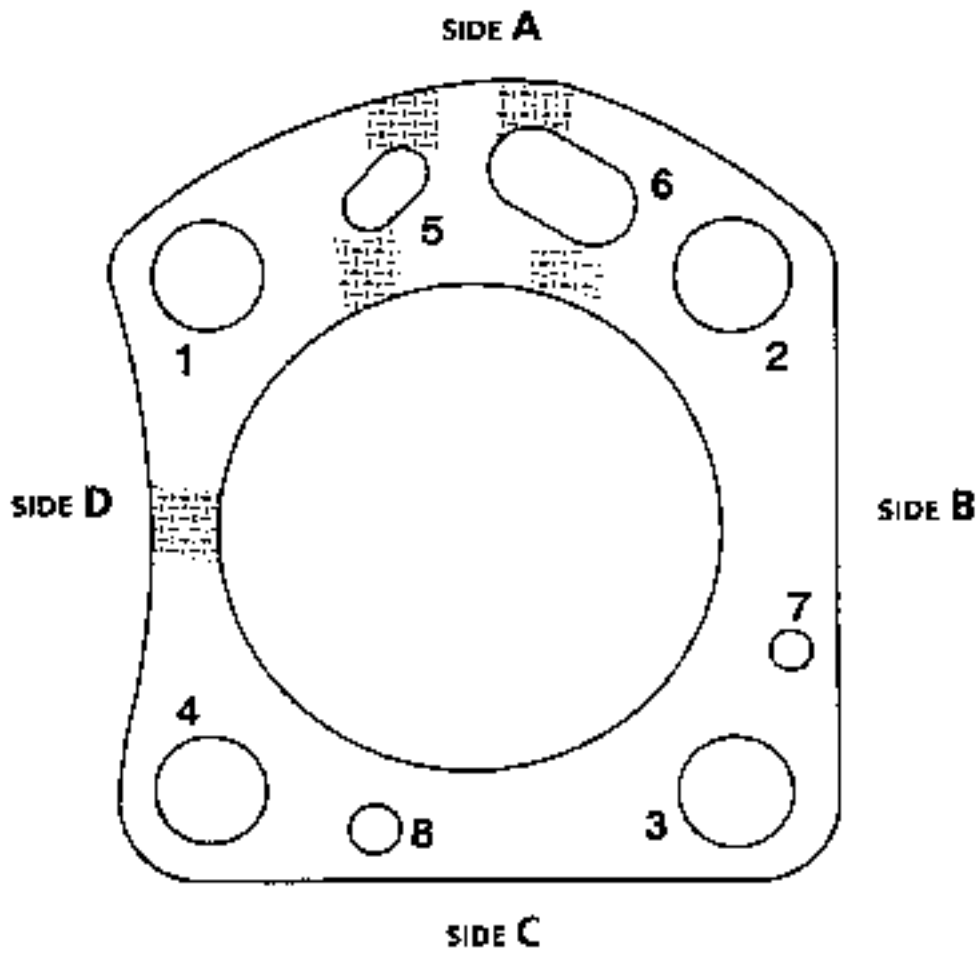
**Figure 1 Plan view of Augmentor and By-Pass Valve Joint Washer**

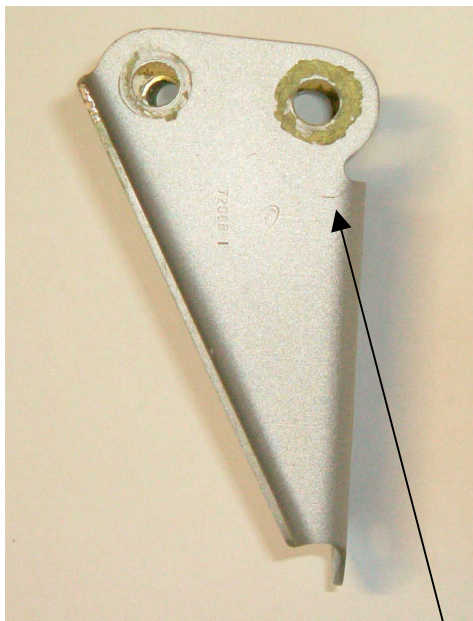
**Reason:** Cracks have been found in the engine mounting brackets of three Hurricane aircraft. A pair of brackets is installed on each side of the engine mount. The photographs below show the location of the cracks.

Location of  
cracks

A 72086 bracket showing the location of  
cracking

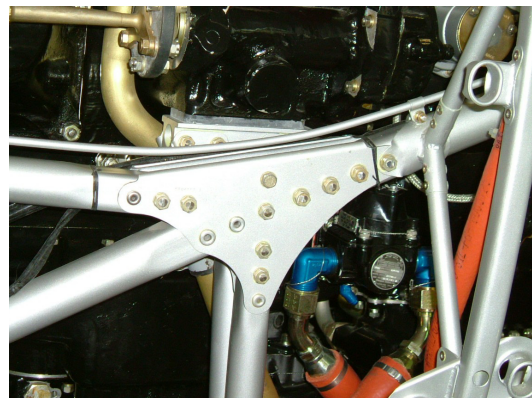
View of port rear engine mount in a partly assembled  
MK 2B

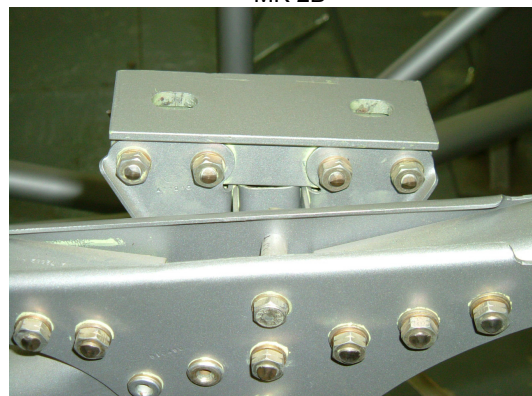
A port rear engine mount in a partly assembled  
aircraft showing the area of inspection on the  
outboard side of the brackets.

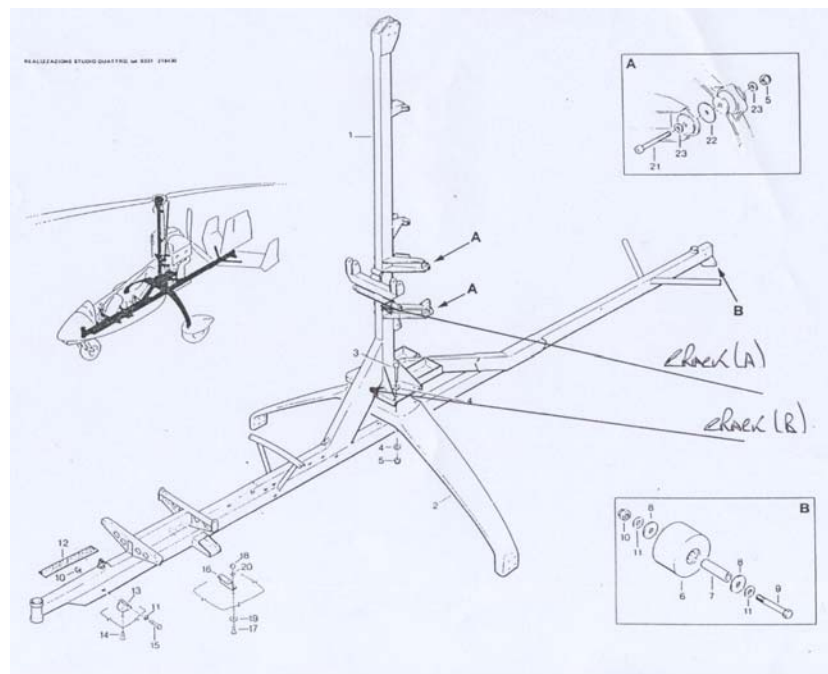
Figure 1. General Arrangement of VPM M16 Fuselage Structure showing areas where cracks have been seen.

If cracks are found then the aircraft must not be flown and a full report submitted to the Light Aircraft Association. The manufacturers have indicated that a factory repair may be available on an airframe-by-airframe basis; advice should be sought from the UK agent (details overleaf).

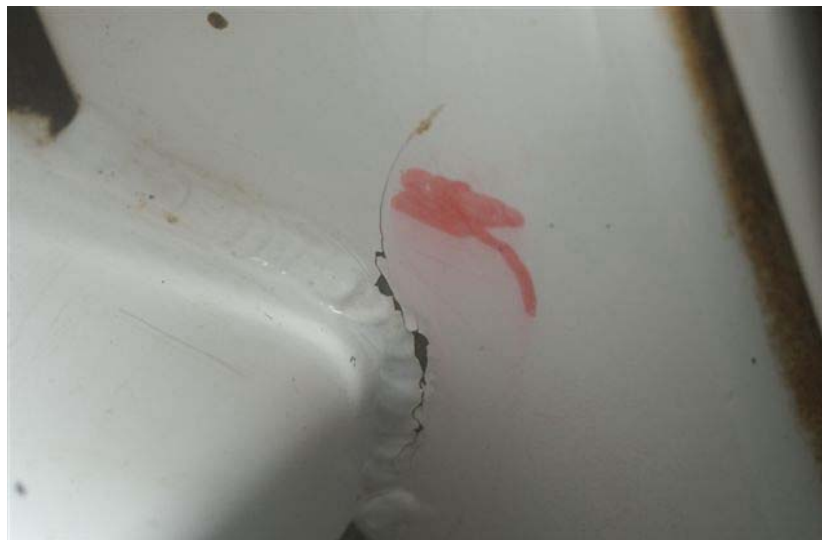
Figure 2. An example of a crack emanating from a welded connection. (Photo. R. Savage)

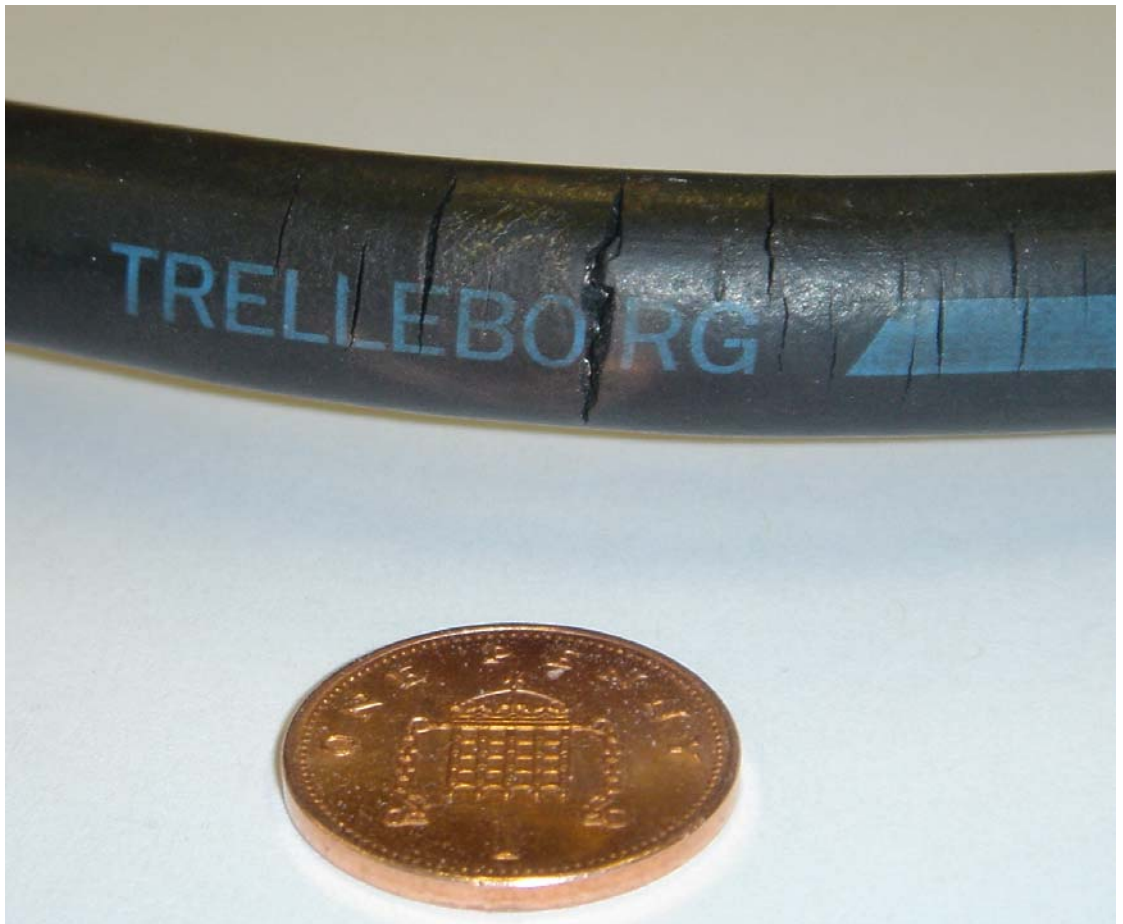
The CAA has been made aware of a number of occurrences of cracking of this hose type, which has occurred within 6 months from new. In some instances, the hose has cracked through to the inner core resulting in significant fluid leakage, which could result in fuel or oil exhaustion, or an aircraft fire.

<b>Compliance:</b>	<p>a) Within 28 days of the effective date of this MPD, visually inspect all Trelleborg Hydro K flexible hoses for signs of cracking. If any cracks are found, before further flight, replace the affected hose(s) with new parts or an alternative approved hose.</p> <p>b) If no cracks are found under a) inspect the hoses for cracks at intervals of 30 flight hours or every month, whichever is the shorter. If cracks are found during any of these inspections, the hoses are to be replaced with new parts or an alternative approved hose.</p> <p>Note:</p> <p>1. For Rotorsport UK Ltd. MT03 and MTO Sport gyroplanes, Service Bulletin number 012, Modification MC112 introduces an alternative hose type. Further details of this modification can be obtained from:</p> <p style="padding-left: 40px;">Rotorsport UK Ltd. Poplar Farm Prolley Moor Wentnor Bishops Castle SY9 5EJ Telephone and fax number: 01588 650769 Email: <a href="mailto:rotorsport_uk@yahoo.co.uk">rotorsport_uk@yahoo.co.uk</a></p> <p>2. For other aircraft types, please contact the type approval holder, the BMAA or LAA as appropriate for details of approved modifications.</p>
