ADELT review report

CAP 1144

January 2014

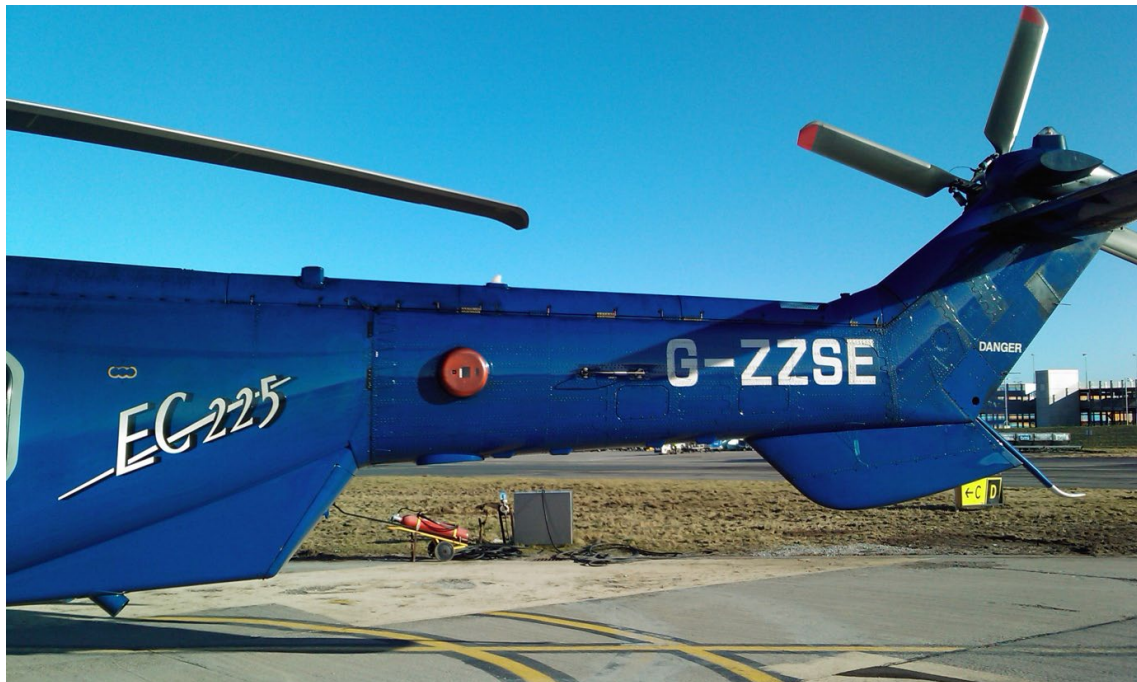
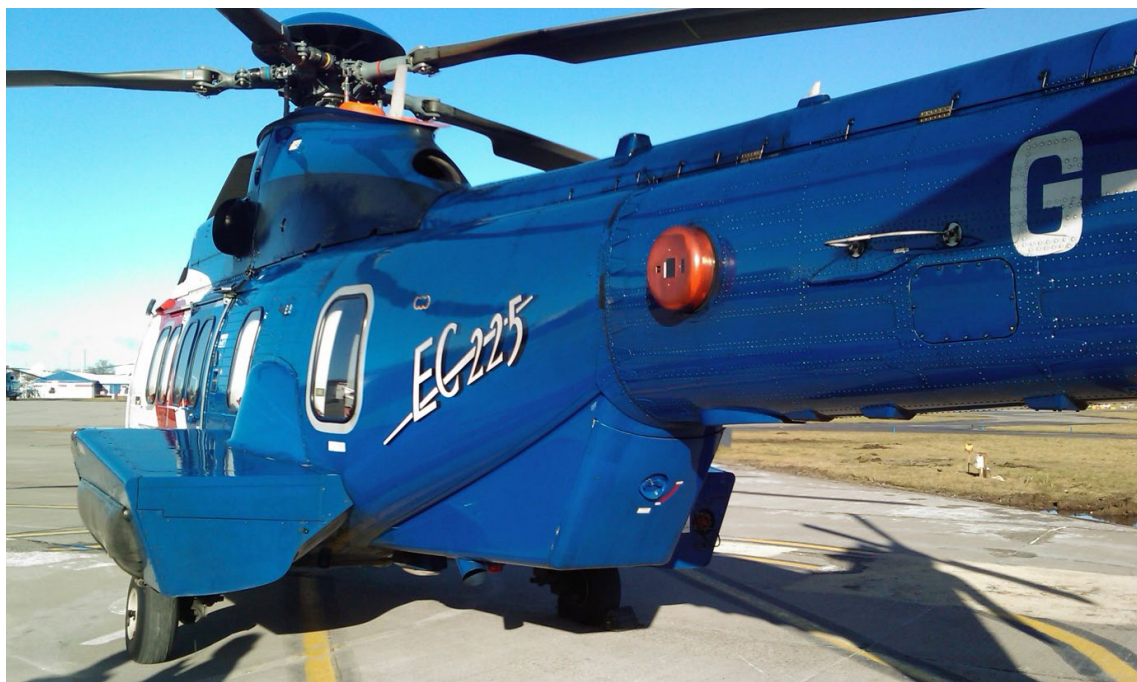
The analysis of the accident data used for this review also considered whether there was any link between controlled ditching and the incidence of tail boom separation. The data indicates that a controlled ditching is slightly less likely to result in a separation of the tail boom, but when this is viewed against the overall dataset, it does not change any of the recommendations of this report. As a crash can result in loss of the tail boom it is still preferable, where possible, to locate an ADELTA forward of the transport joint.

Figures 1 and 2 show an ADELTA installation that is aft of the transport joint and more susceptible to the effects of a tail boom separation, e.g. damage to or breaking of wiring.

Recommendation 1a – It is recommended that EASA develop guidance material to assist designers of future ADELts/CPIs and aircraft ADELt/CPI installations to demonstrate compliance with CS XX:1301, 1309, 1529 and 1581. This guidance material should address the issues associated with determination of the appropriate location of an ADELt/CPI with respect to the transport joint and the main rotors to maximise the likelihood of deployment and transmission.

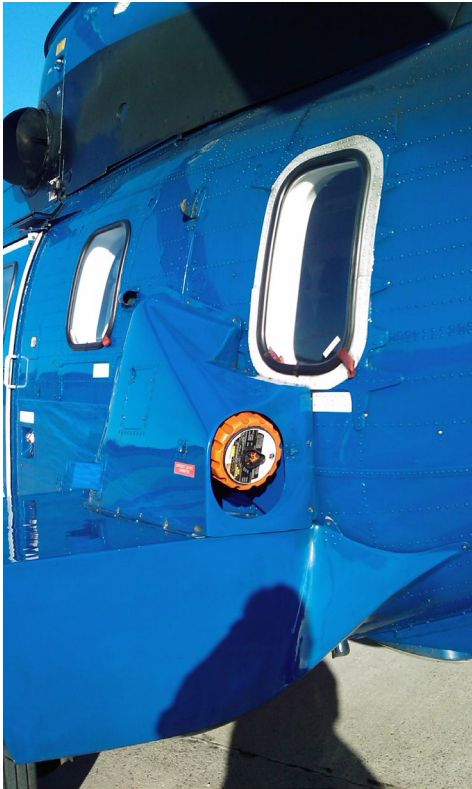
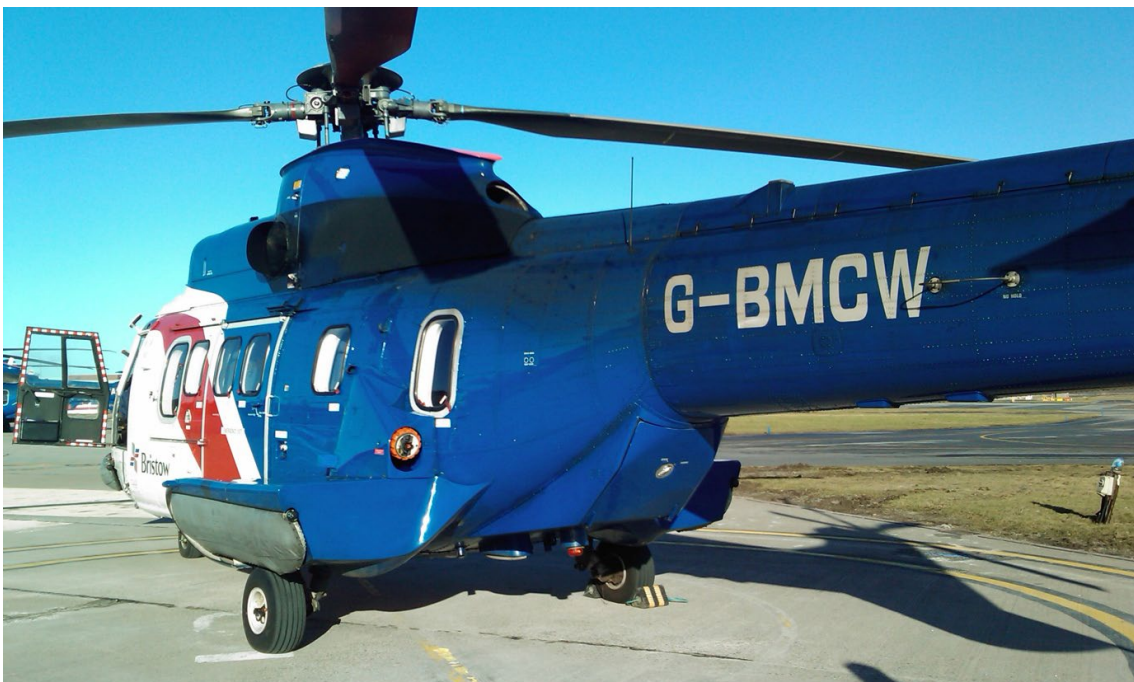
Figures 3 and 4 show an ADELTA installation that is forward of the transport joint and, as such, is less likely to be damaged or lost in the event of a tail boom separation.
