Civil Aviation Authority
SAFETY NOTICE
Number: SN-2021/013

Issued: 10 June 2021

**Undercarriage Leg Support Bracket
Avions Max Holst MH.1521 “Broussard” (All Marks)**

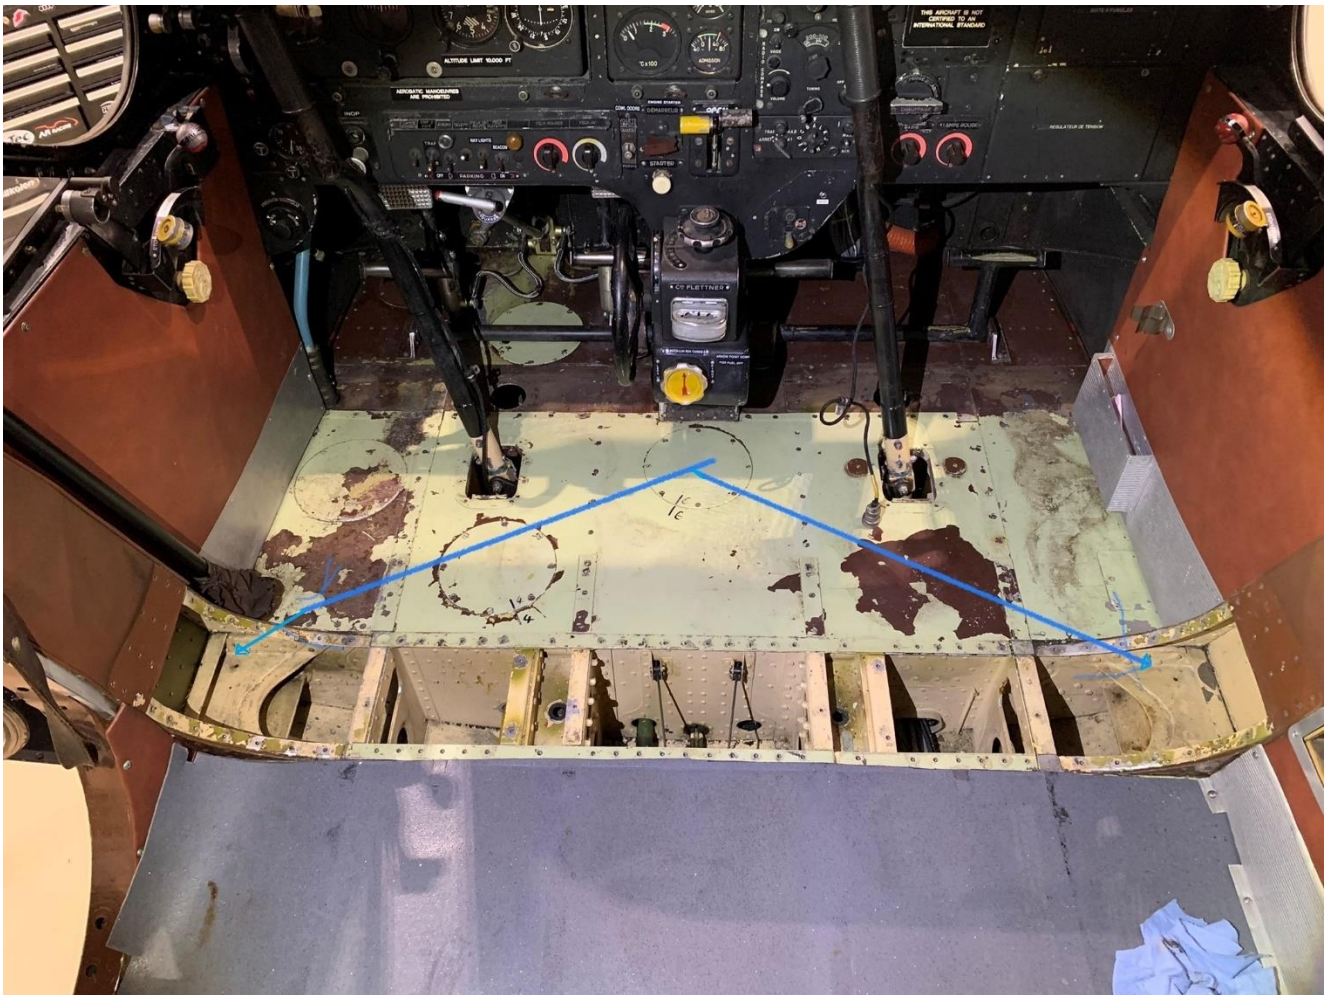
MH.1521 port and starboard undercarriage support letterbox brackets. Undercarriages removed

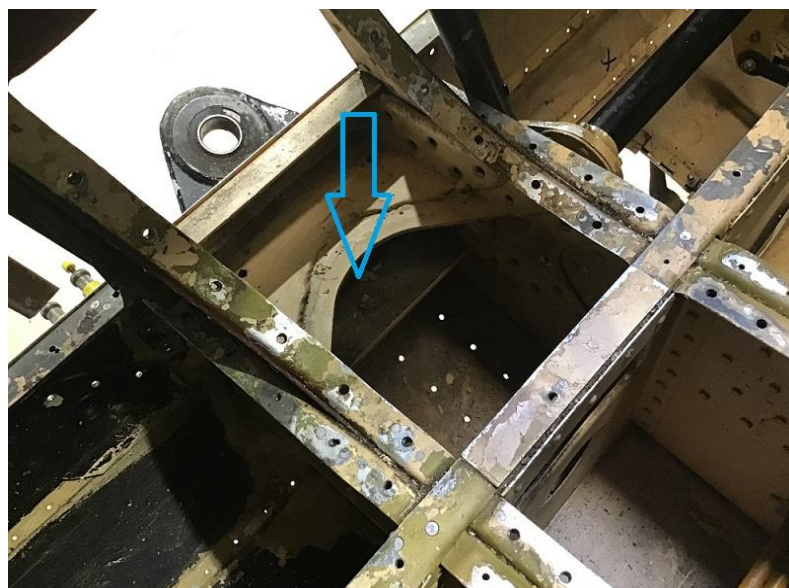
MH.1521 port undercarriage support letterbox bracket. Floor panels and leg removed for access

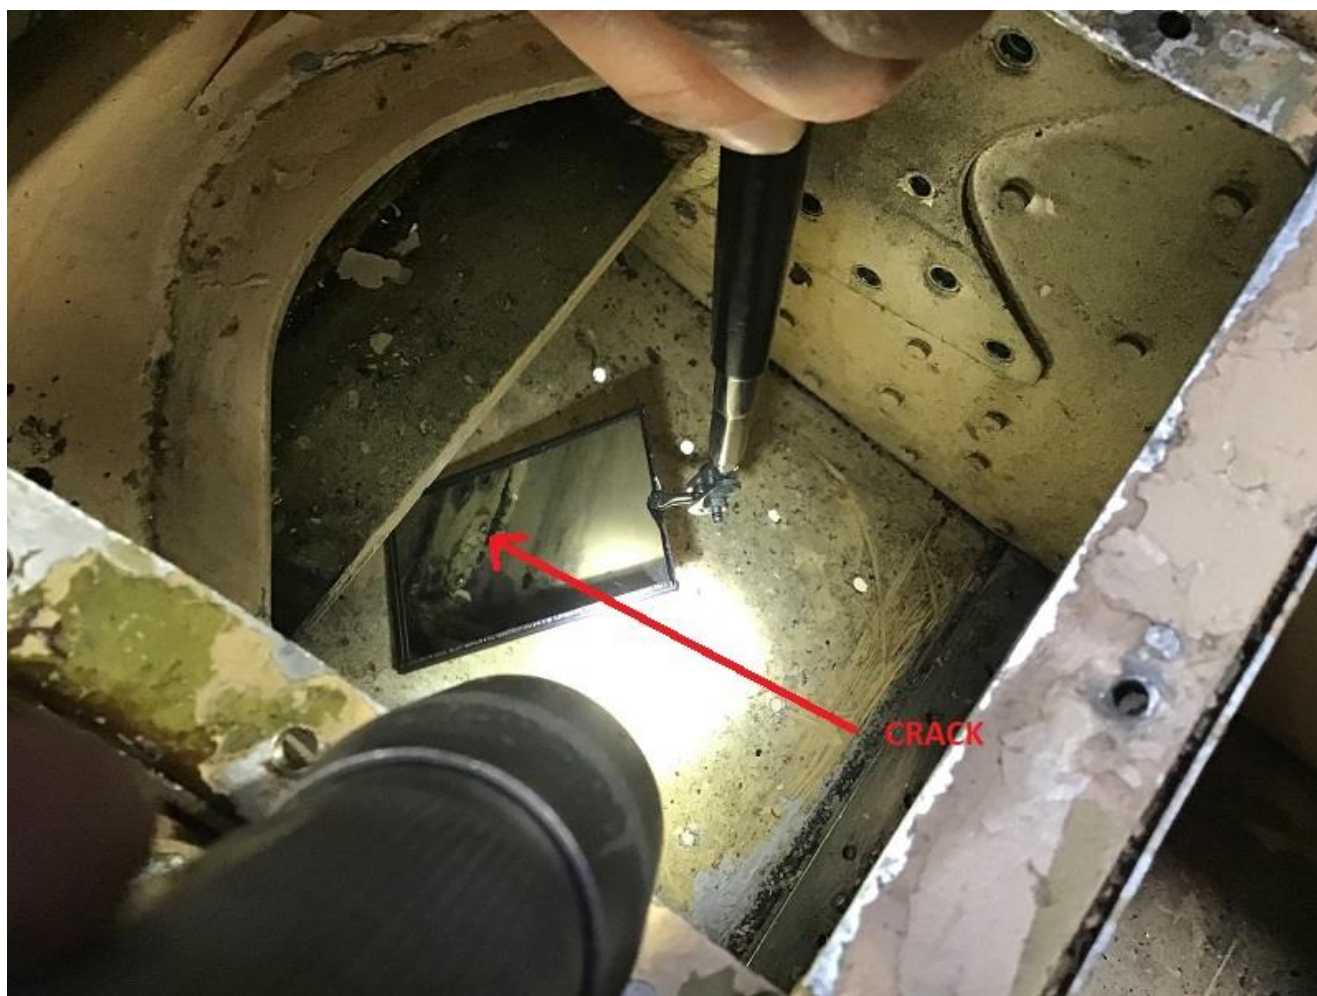
- 1.2 During aircraft scheduled annual maintenance on an MH.1521, seats and forward cockpit floor were removed to gain access to service inspection items such as control cables, pulleys and undercarriage legs. While inspecting the aircraft undercarriage components under the floor, longitudinal cracks were found initially on the left-hand side (see [Appendix 1 photos](#)) and then subsequently in the starboard leg outboard lower support bracket (letter box bracket). The crack was observed on the bottom forward shelf of the bracket. The crack was approximately 1 inch long, visible by eye while using an inspection mirror to observe the general condition of the area below the undercarriage leg. The engineers who found the crack were alerted to its presence initially on the left-hand side, due to a deformation or skin ripple forward of the letterbox fitting. Reference [Appendix 1](#).

MH.1521 left hand (port) undercarriage support letterbox bracket. Leg removed, crack shown on lower shelf

- 4) If, upon inspection, cracks or damage are found to the bracket, the faulty unit should be removed for repair or replacement.
 - 5) If access is too difficult with undercarriage legs fitted, jack and support the aircraft as necessary, and remove the undercarriage legs to facilitate inspections (see [Appendix 1](#)).

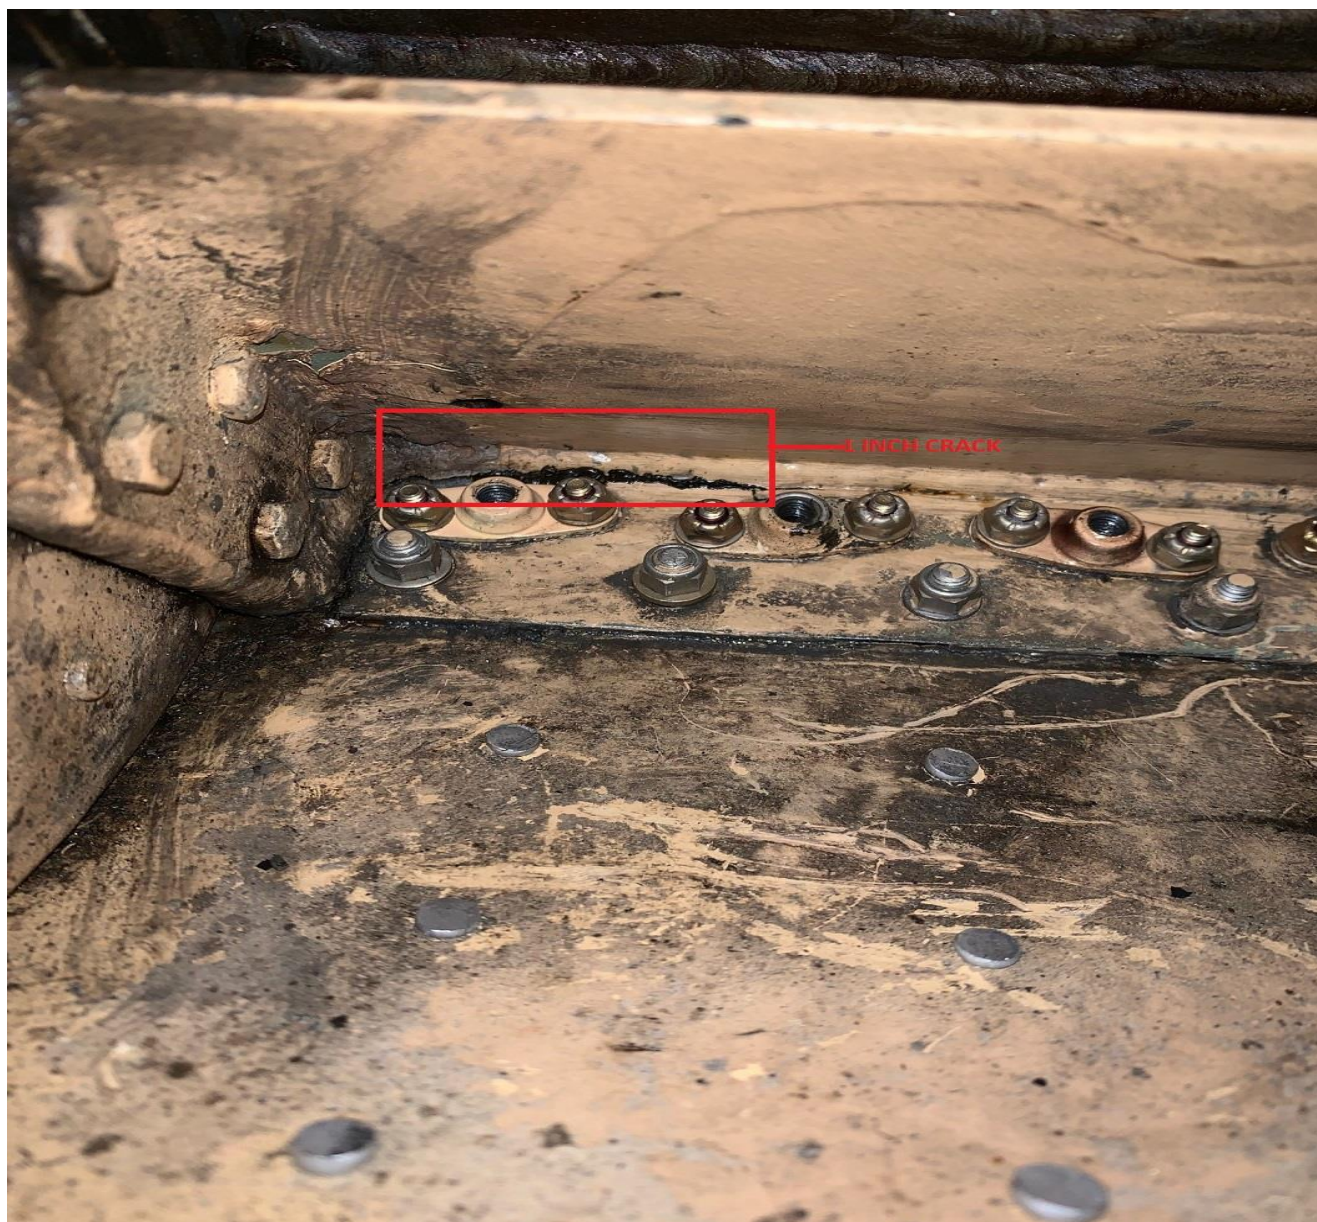
- 3) Check the letterbox bracket for signs of fatigue damage or cracking in the corners of the lower shelf of the bracket (see [Appendix 1](#)) checking for evidence of cracking around all the stud/nut attachment areas.

MH.1521 Left hand (port) undercarriage support letterbox bracket lower shelf. Crack is shown from underneath, photo taken whilst leg removed. Photo taken with a mobile phone

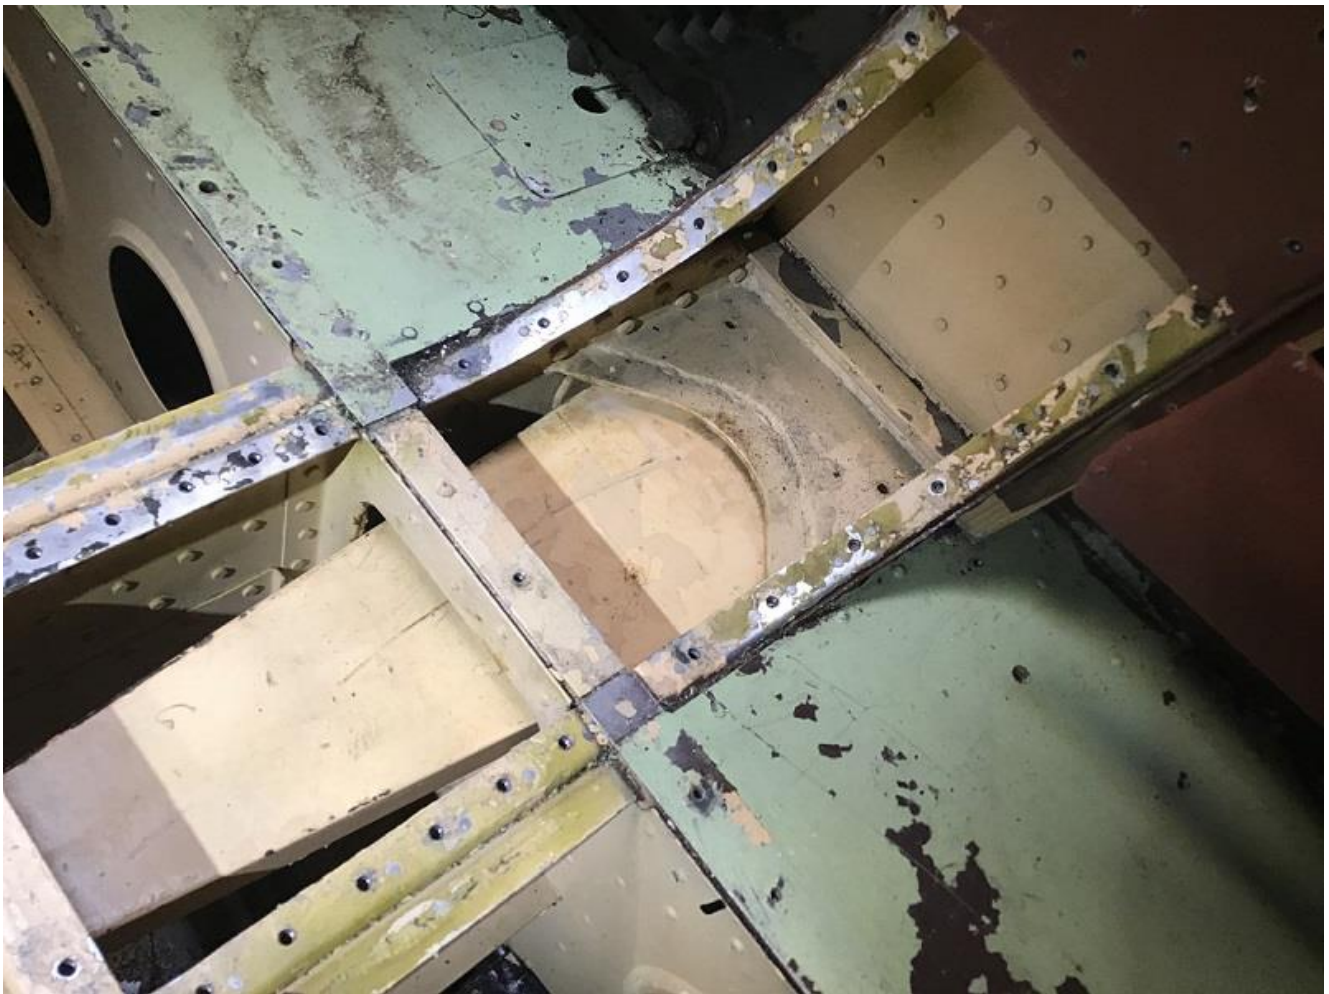
- 1.4 With the difficulty of access for inspection (see [Appendix 1](#)) and the equally difficult nature for general visibility of the bracket (the undercarriage leg while fitted, obscures easy access for inspection), cracks or damage could be missed or overlooked.

MH.1521 Starboard undercarriage support letterbox bracket. Undercarriage leg still fitted

- 2) Where access is possible, the use of an inspection mirror/borescope or magnifying glass and torch to pay particular attention to the underside of the lower shelf of the letterbox bracket (See [Appendix 1](#)) is advised. It is recommended that a flexible borescope is used in preference to an inspection mirror due to the difficulty in manipulating a mirror in this area, if the leg is installed.

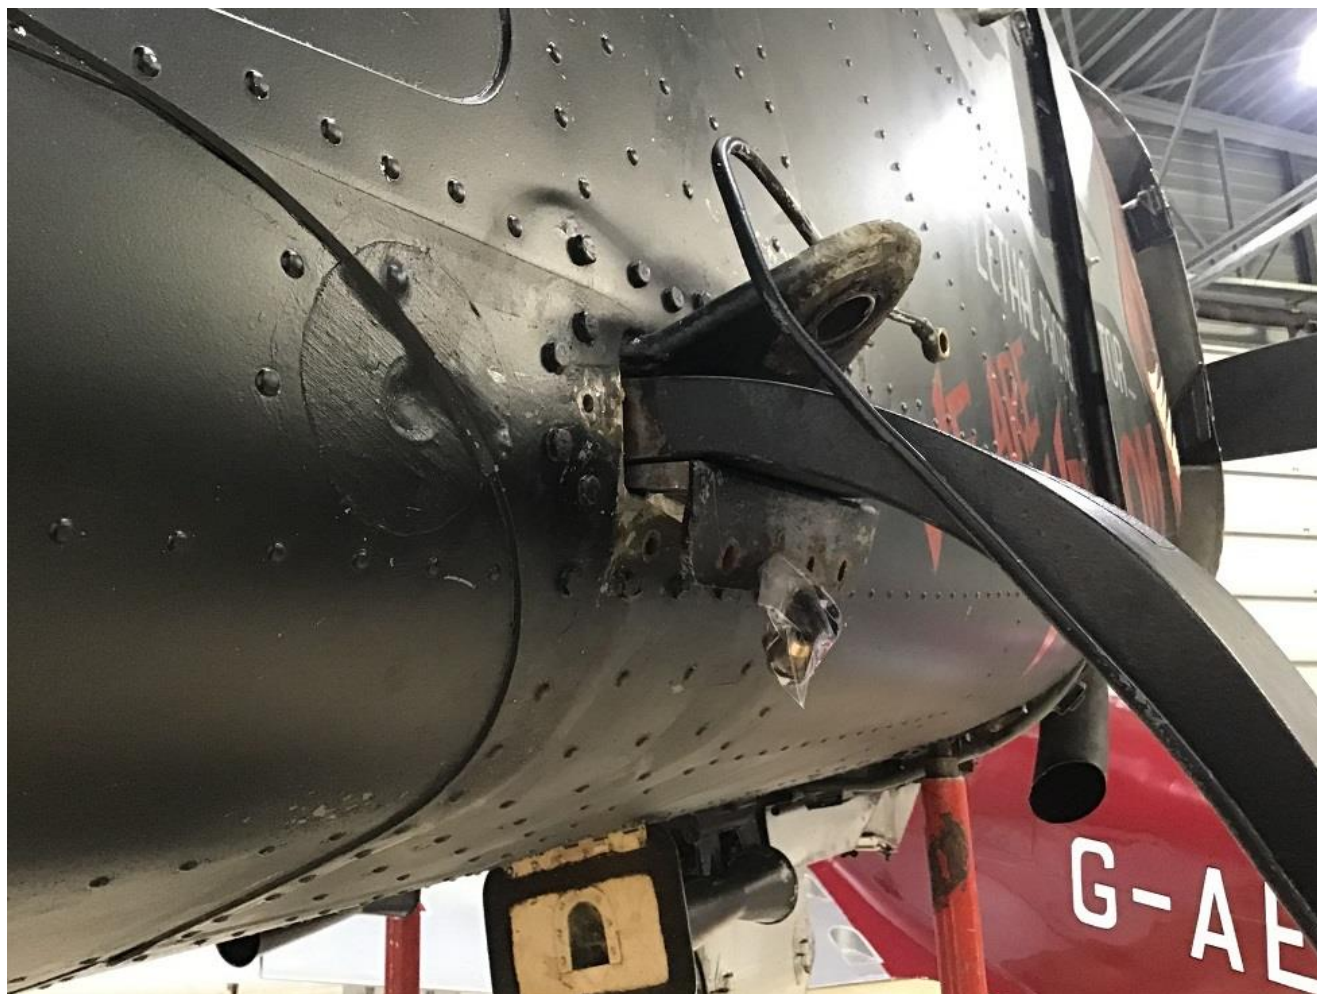
MH.1521 starboard undercarriage leg fitted through letterbox bracket
