Civil Aviation Authority
SAFETY NOTICE
Number: SN-2021/015

Issued: 8 July 2021

Engine Valve Springs
Rolls-Royce and Packard Merlin (All Marks)

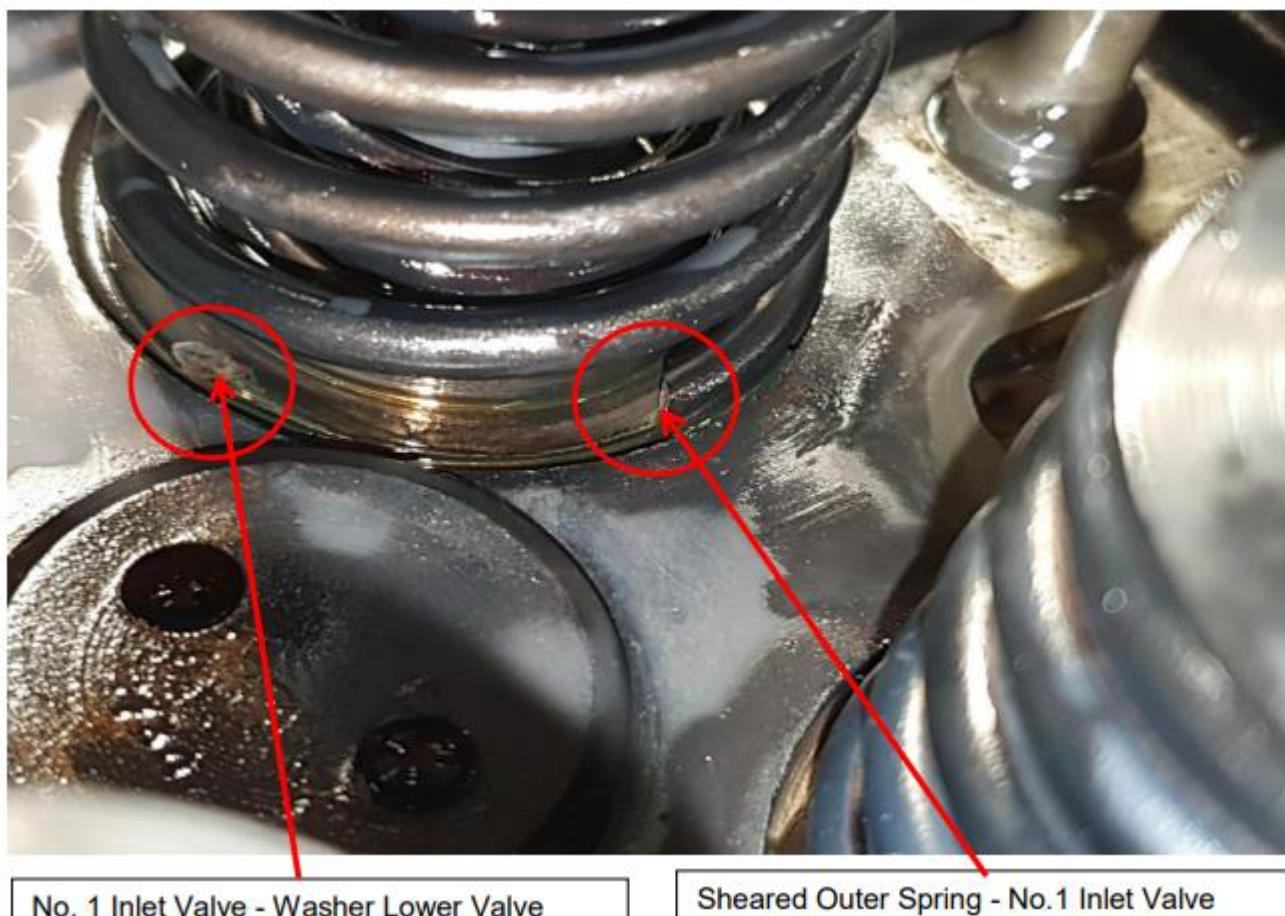
- 1.3 An examination and study of a recently found failed inlet valve spring and retaining collet determined that the likely cause was a spring and retaining collet failure due to a high cycle fatigue mechanism propagating from an area of corrosion pitting. The associated collet also subsequently failed due to a high-cycle fatigue mechanism propagating from a corrosion pit or gouge.

Figure 2: Failed Inlet Valve Outer Spring

- 4) If evidence of gouging, surface pitting or corrosion are found, it is recommended that the component and/or collet should be removed and replaced prior to further flight.

- 5) If any valve spring or retaining collets are found to be broken or incomplete, and the missing fragments or debris cannot be located, accounted for and removed, it is recommended that the engine is taken out of service for further examination.
