Civil Aviation Authority
SAFETY NOTICE
Number: SN-2021/016

Issued: 9 September 2021

Rudder Lower Pintle Pivot Pin
British Aircraft Corporation 167 Strikemaster and Jet Provost (All Marks)

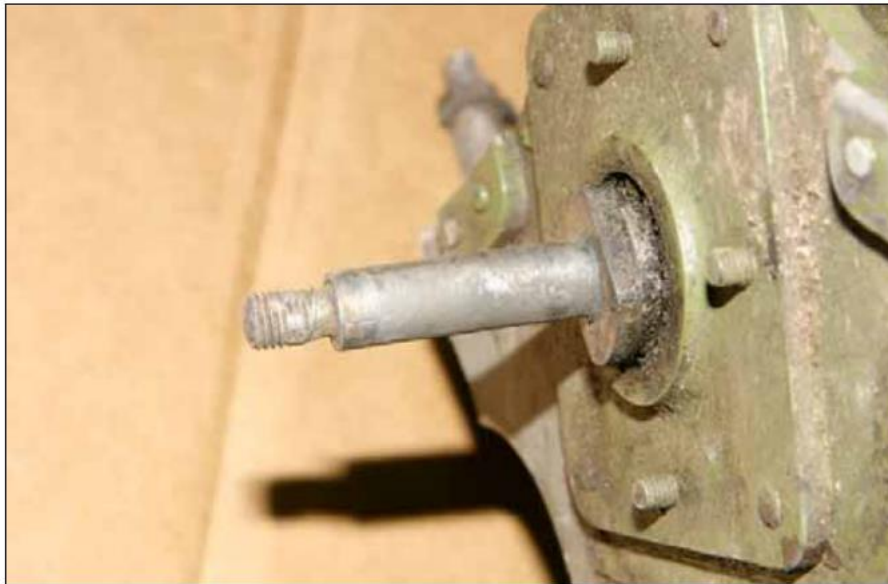
Figure 24: Rudder lower hinge pin

It is possible that the separation of the rudder and mass balance assembly may have been the result of a failure or loss of the rudder lower pintle pivot pin castellated securing nut (Appendix 1 Fig 23). Such a loss or failure could be caused by:

- 1) With access to the lower pivot pin assembly, check the castellated top and bottom nuts for correct installation, torque/tightness, and the presence of a locking split pin.
- 2) With the rudder assembly and jet pipe removed, inspect the condition of the securing nuts and threads on the pin. Inspect the surface condition of the nuts and the threads for corrosion or damage.
- 3) If during inspection, any defects to the nuts, pins or threads are found, take corrective measures by way of suitable repair or replacement of defective parts, and report to CAA GA Unit in Section 3 below.

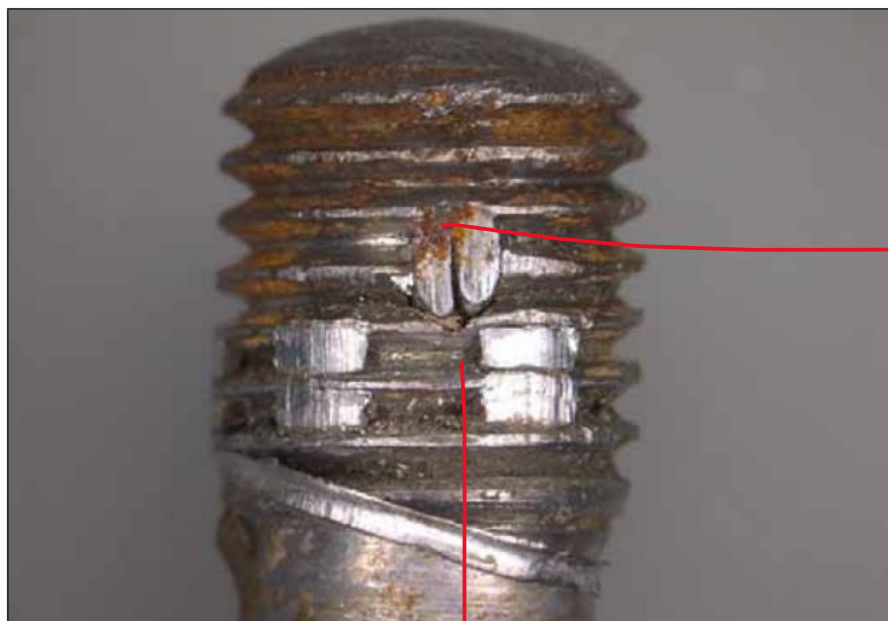
Figure 25: Thread remnants on rudder lower hinge pin

Sheared locking split pin

Thread damage

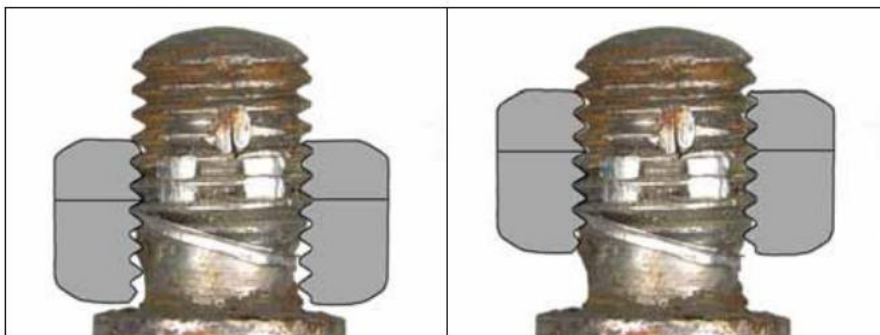
Figure 26: Illustration of over-engaged (left) and normally-engaged (right) pivot pin nuts

The ATSB found that the lower castellated nut had been screwed down the threaded shank such that only one full thread of the nut body had engaged the pin threads. The majority of the nut threads had entered the unthreaded, reduced-section shank between the threads and the main body of the pin (Figure 26).
