MANDATORY PERMIT DIRECTIVE

Number: 2022-003

EUROPA AIRCRAFT COMPANY Ltd

ATA 52 - Aircraft Doors - Bracket - Modification

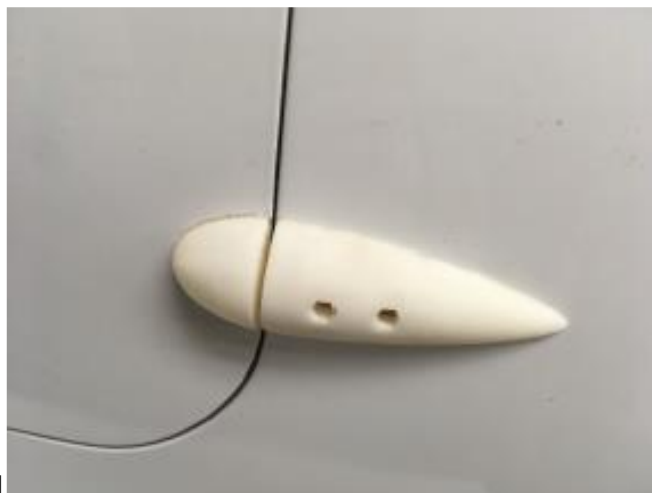
Figure 1

The leaflet contains information for LAA standard modification SM15833 and accomplishment instructions, which introduces the installation of an aerodynamically shaped 'stop' attached to the outer fuselage skin immediately aft of the canopy door rear locking bolt guide, and part of the fairing on the door. (See Appendix 1, figure 1).

This stop prevents the rear tapered locking shoot bolt from misaligning with its guide and riding over the outside fuselage skin when operating the lock lever, after canopy door closure. The stop baulks the shoot bolt should it attempt to misalign with its locking guide and ride over the outside skin of the door frame, to cause an unsafe condition. While the shoot bolt is baulked by the stop, the door operating lever is prevented from travelling its full distance to the indicated 'locked' position - in this condition the pilot or passenger is therefore unable to move the lever to the pre flight check 'locked' position (to confirm that the canopy door is correctly closed and locked) until the canopy door is correctly closed, allowing it to be properly locked.

Modification. Addition of a door rear lock shoot bolt stop.
LAA Standard Modification SM15833

- 1) From the effective date of this MPD within 5 flying hours or the next Permit to Fly revalidation, whichever is the sooner, determine if modification SM15833 has already been embodied by way of visual inspection. If the modification has not been embodied, comply with mandatory LAA Airworthiness Information Leaflet (MOD/247/012) and carry out Modification SM15833.
- 2) Action 1 as above, must be carried out by an appropriate person, and upon completion be inspected and certified with a Permit Maintenance Release statement by an LAA inspector.
- 3) Ensure compliance with this MPD is recorded in the aircraft logbook.
