**Civil Aviation Authority**  
**SAFETY NOTICE**  
**Number: SN-2022/004**

**Issued: 17 June 2022**

**North American P51 Mustang (All Marks)**  
**Undercarriage leg pivot shafts**

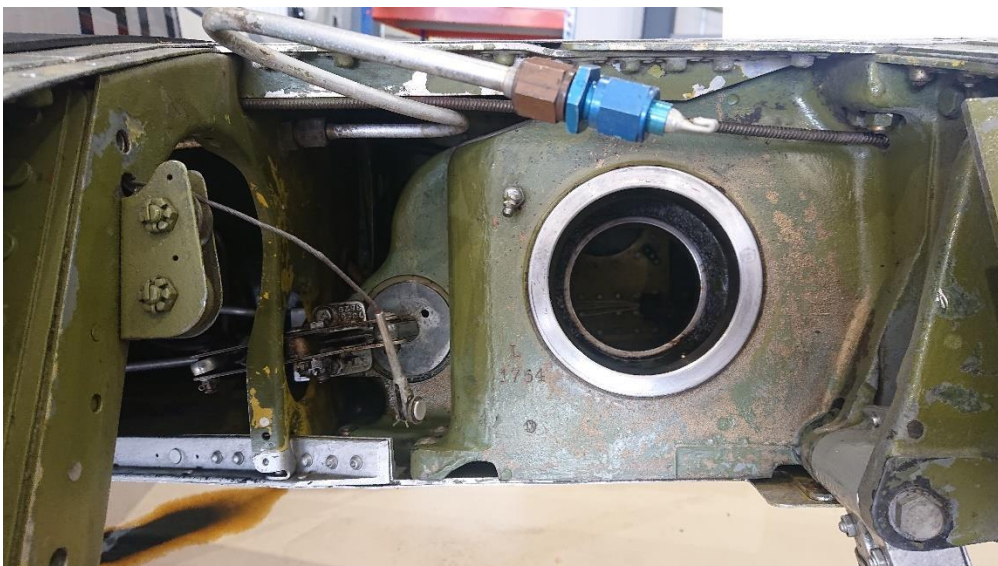
**Figure 2:** Wing casting and pivot shaft bushes

- 1) Jack and trestle the aircraft as required, in order to remove the aircraft MLG legs.
- 2) Remove the pivot shafts from the undercarriage legs as required.
- 3) Using a NDT MPI process, examine and inspect the pivot shafts for cracks and damage at the intersection of pivot and landing gear receptacle. This should be carried out on both 'Light' and 'Heavy' pivot shafts. (See [Appendix 1](#) Figures 3, 4 and 5).
- 4) If evidence of cracking or damage are found, the pivot shaft should be removed from service and replaced with serviceable items prior to further flight.
- 5) While the MLG leg and pivot shaft are removed from the aircraft, it is recommended that the wing pivot shaft bushes – (part number 73-33109) are also examined for wear (See Figure 2).

**Note:** An initial indication of excessive wear in the bushes may be detected before the MLG is removed from the aircraft. This may be achieved by removing the operating lever from the rear of the gear leg and rocking the landing gear fore and aft while the aircraft is jacked clear of the ground – fore aft looseness or movement of the leg may indicate excessive wear to the pivot shaft bushes. Wear in the bushes may initiate or accelerate cracking to the pivot shaft.

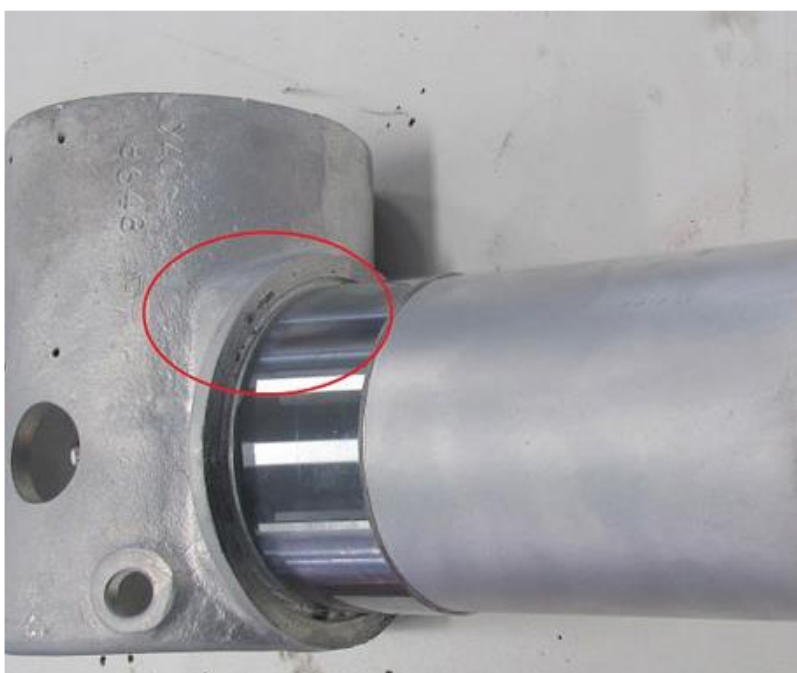
**Figure 3:** Pivot shaft to landing gear receptacle interface

- 1.3 While main undercarriage legs were removed for maintenance, MLG pivot shafts were subjected to NDT MPI (Magnetic Particle Inspection) and found to be cracked along the base of the shafts (See [Appendix 1](#) Figure 3). It has not been established what the exact cause of the cracking is - but heavy landing, fatigue and age-related wear of the pivot shaft and associated shaft spherical bushes are possible.
