OCCURRENCES

Cracking job

Sorting a problem doesn't have to be an issue

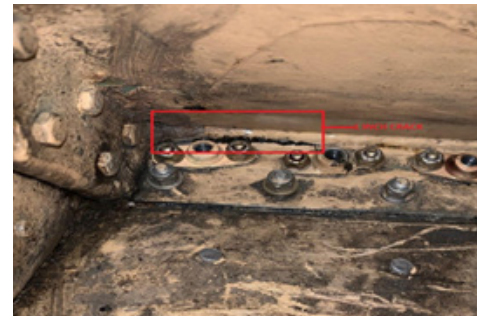
During an annual maintenance inspection on an Avions Max Holst MH 1521 'Broussard' in 2021, longitudinal cracks were found in an undercarriage bracket.

The engineers were initially alerted to the problem due to a deformation or skin ripple effect forward of the 'letterbox' fitting, initially on the left-hand side and then subsequently in the starboard undercarriage leg outboard lower support bracket ('letterbox bracket').

A CAA Safety Notice was subsequently drafted and sent out for consultation. Following the consultation's completion [Safety Notice SN-2021/013 \(caa.co.uk\)](https://www.caa.co.uk/Safety-Notice/SN-2021/013) was published and the MOR was closed.
