Civil Aviation Authority

SAFETY NOTICE

Number: SN-2024/002

Piper PA-28 and PA-32 Undercarriage Inspections

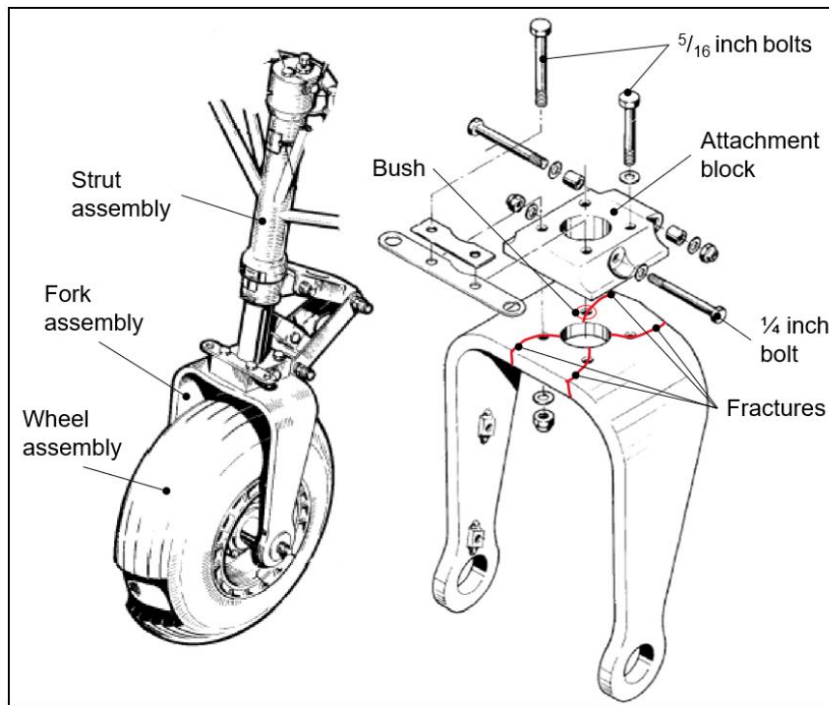
Figure 1 Nose Wheel Fork Assembly

- 1.2 The first incident involved the failure of both upper torque link attachment lugs on the main landing gear cylinder due to fatigue cracking (Figure 2). The second incident involved the nose wheel fork assembly fracturing because of fatigue cracks from corroded bolt holes in the fork assembly. Following both accidents, the undercarriage components were removed from the aircraft and were subject to an AAIB investigation (AAIB reports AAIB-29130 and AAIB-29086 refers). These types of failures can remain undetected until the aircraft touches the ground during landing, leading to the collapse of the landing gear, consequential airframe damage and loss of control. These events could carry the risk of injury.

- In accordance with the Aircraft Maintenance Manual (AMM) remove the nose wheel fork assembly fork attachment block (Appendix 1 Figure 1).
- Visually inspect the area for corrosion, signs of wear and cracking around the attachment block bolt holes. Consideration should also be given for inspecting the area by applying a liquid penetrant dye to detect any signs of cracking.

- If no defects are found, clean and re-protect the area as required in accordance with the AMM.
- If defects are found, rectification is to be carried out in accordance with the AMM. If cracking is found as noted in Appendix 1 Figure 1, the CAA should be notified using the following email address - certification.gau@caa.co.uk.

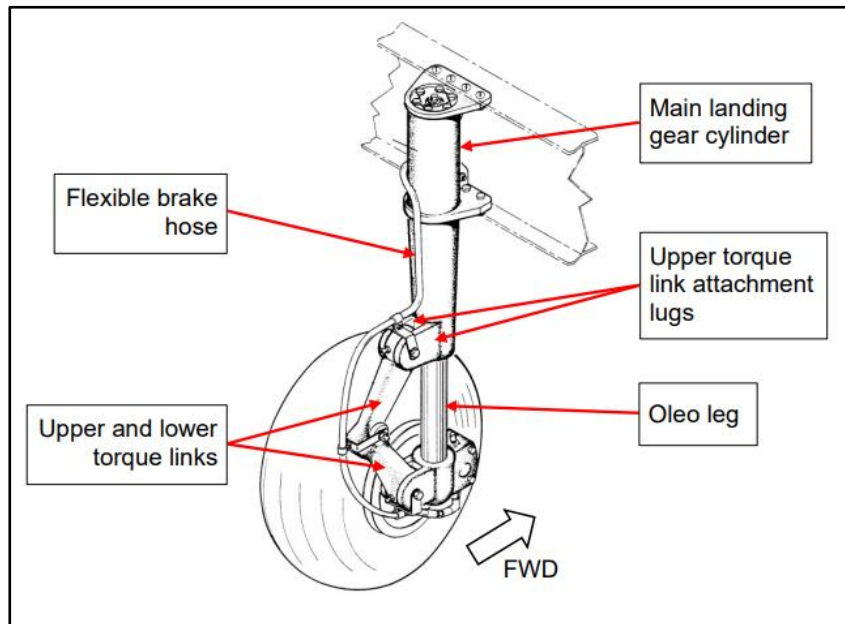
Figure 3 Main Landing Gear Leg Assembly

- To verify compliance with Piper Service Bulletin SB1131A (if applicable) and to incorporate the SB into the aircraft maintenance programme.
- At the next routine maintenance inspection, to visually inspect the areas highlighted in Appendix 1 Figures 2 and 3 for corrosion, signs of general wear as well as cracking around the attachment upper and lower torque link attachment lugs in accordance with the AMM.

- It is also important to note that fatigue cracking of the torque link attachment lugs has been known to occur on the cast main landing gear cylinders fitted to PA-28 and PA-32 aircraft manufactured between 1961 and 1977. Aircraft manufactured since 1977 were fitted with a forged cylinder which can be used as a replacement for the cast cylinders.

- If defects are found, rectification is to be carried out in accordance with the AMM. If cracking is found as noted in Appendix 1 Figure 2, the CAA should be notified using the following email address - certification.gau@caa.co.uk.
