Civil Aviation Authority

SAFETY NOTICE

Number: SN-2024/002

Piper PA-28 and PA-32 Undercarriage Inspections

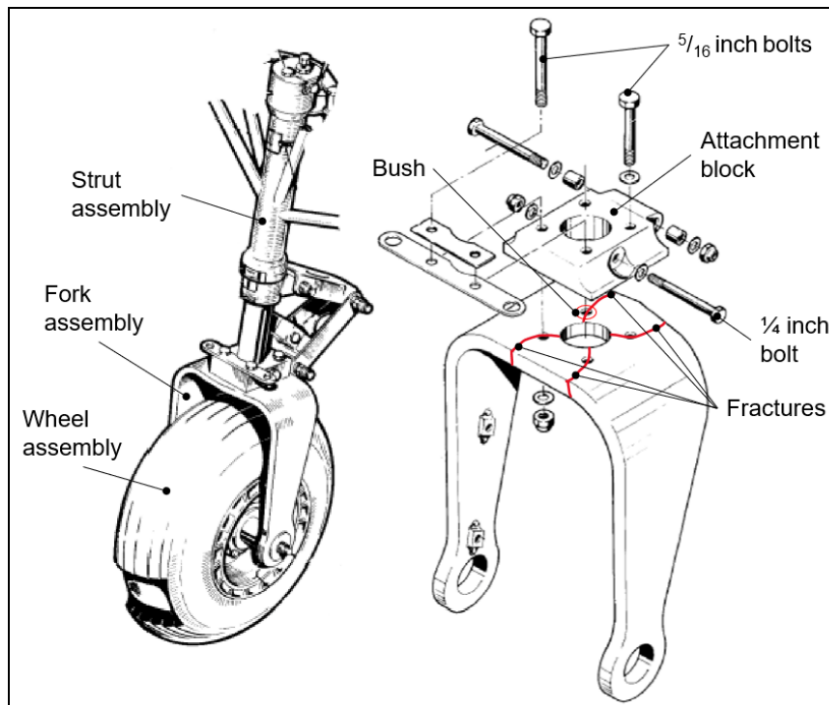
Figure 1 Nose Wheel Fork Assembly

- 1.2 The first incident involved the failure of both upper torque link attachment lugs on the main landing gear cylinder due to fatigue cracking (Figure 2). The second incident involved the nose wheel fork assembly fracturing because of fatigue cracks from corroded bolt holes in the fork assembly. Following both accidents, the undercarriage components were removed from the aircraft and were subject to an AAIB investigation (AAIB reports AAIB-29130 and AAIB-29086 refers). These types of failures can remain undetected until the aircraft touches the ground during landing, leading to the collapse of the landing gear, consequential airframe damage and loss of control. These events could carry the risk of injury.

- In accordance with the Aircraft Maintenance Manual (AMM) remove the nose wheel fork assembly fork attachment block (Appendix 1 Figure 1).
- Visually inspect the area for corrosion, signs of wear and cracking around the attachment block bolt holes. Consideration should also be given for inspecting the area by applying a liquid penetrant dye to detect any signs of cracking.

- If no defects are found, clean and re-protect the area as required in accordance with the AMM.
- If defects are found, rectification is to be carried out in accordance with the AMM. If cracking is found as noted in Appendix 1 Figure 1, the CAA should be notified using the following email address - certification.gau@caa.co.uk.

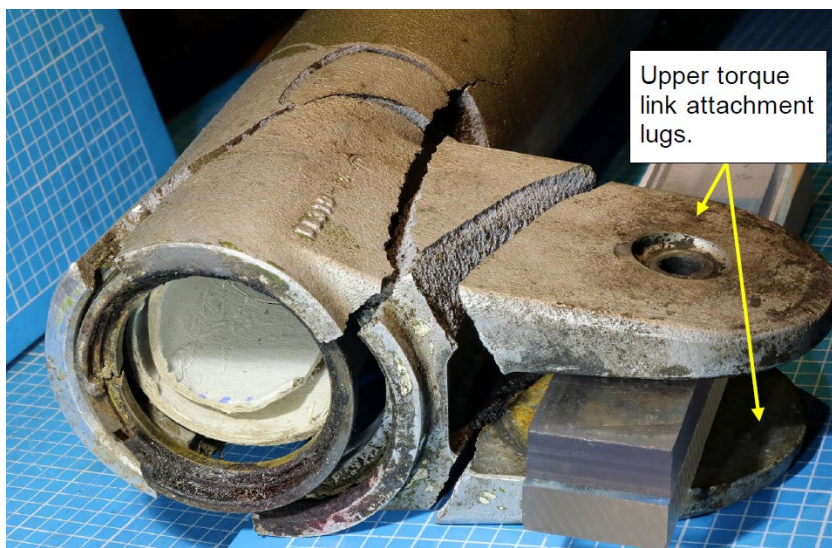
Figure 2 Lower Main Landing Gear Cylinder

- To verify compliance with Piper Service Bulletin SB1131A (if applicable) and to incorporate the SB into the aircraft maintenance programme.
- At the next routine maintenance inspection, to visually inspect the areas highlighted in Appendix 1 Figures 2 and 3 for corrosion, signs of general wear as well as cracking around the attachment upper and lower torque link attachment lugs in accordance with the AMM.

- It is also important to note that fatigue cracking of the torque link attachment lugs has been known to occur on the cast main landing gear cylinders fitted to PA-28 and PA-32 aircraft manufactured between 1961 and 1977. Aircraft manufactured since 1977 were fitted with a forged cylinder which can be used as a replacement for the cast cylinders.

- If defects are found, rectification is to be carried out in accordance with the AMM. If cracking is found as noted in Appendix 1 Figure 2, the CAA should be notified using the following email address - certification.gau@caa.co.uk.
