Civil Aviation Authority
SAFETY NOTICE
Number: SN-2024/005

Issued: 20 August 2024

A320 Family Aircraft
Third Occupant Seat Harness Correct Routing

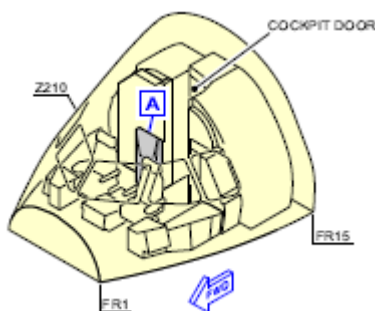
Figure 1

The purpose of this Safety Notice is to alert owners and operators of affected aircraft types, as detailed in Section 1 above, to highlight the correct routing of the third occupant seat harness through the slots in the headrest assembly.

- 4.1 The CAA requests that operators carry out a fleet check of their affected aircraft to ensure correct routing of the seat harness in accordance with AMM 25-11-73 and continue to monitor the routing for any in-service change.
- 4.2 The CAA advises operators and maintenance organisations to make pilots and engineers aware of the incorrect routing so that a harness defect can be quickly recognised and rectified.
- 4.3 The CAA advises operators that it may be beneficial to introduce this check as part of the pilot or engineer pre-flight checklist.
- 4.4 Please feedback the result of fleet checks to your CAA allocated Surveyor.

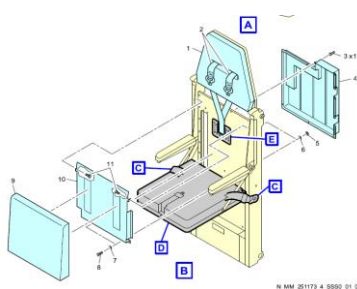
Figure 4

The CAA are aware of significant number of reports of the third occupant seat harness being incorrectly routed through the top of the seat backrest instead of through the slot in the headrest.

There has been an explanation put forward that when the seat headrest is folded down to gain access to the circuit breaker panel, the harness can pull back through the slot and fall between the hinged headrest and the seat backrest.

Incorrect routing over the backrest structure may cause component failure and is not a safe configuration for the occupant, in the event of a rapid deceleration.
