CAA PAPER 93013

**DUAL CHILD OCCUPANCY OF AN AIRCRAFT SEAT**

Roger N Hardy

PREPARED BY CRANFIELD IMPACT CENTRE LTD
AND PUBLISHED BY
CIVIL AVIATION AUTHORITY LONDON JULY 1993

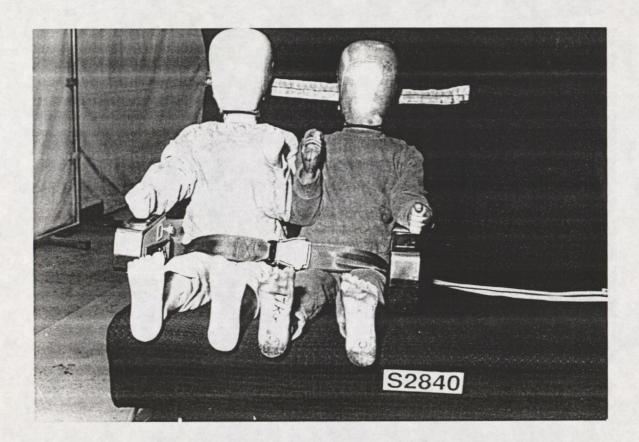
Figure 5 Positions of the two 3 year dummies on the aircraft seat

It was just possible to position the two 3 year dummies on the standard width seat in a shoulder to shoulder position. However, this was only possible by positioning the non-adjacent arms of the dummies on the arm rests. The bodies of the two dummies completely filled the available space between the arm rests, as shown by the photograph in Fig 5. In addition, the buckle of the lap belt lay between the two dummies, in a position where, in the case of children, it could easily be tampered with.

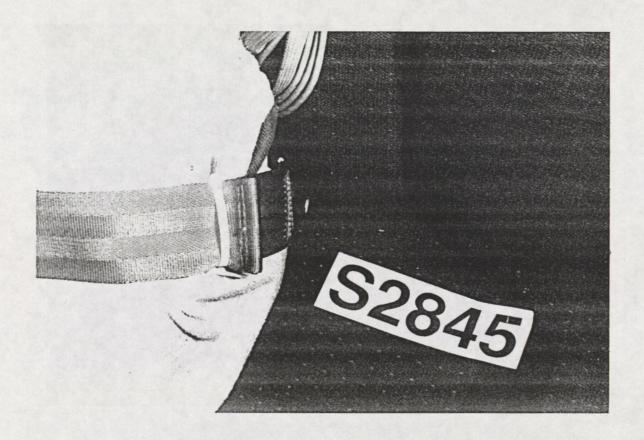
Figure 7 Wrapping of the lap belt around the left hip of the 6 year dummy

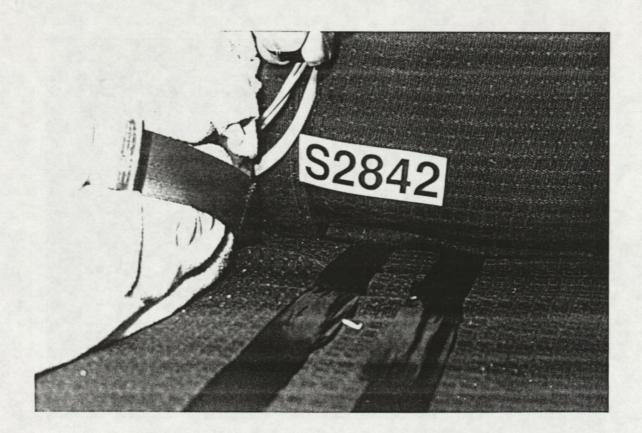
Figure 9 Wrapping of the lap belt around the left hip of the 10 year dummy

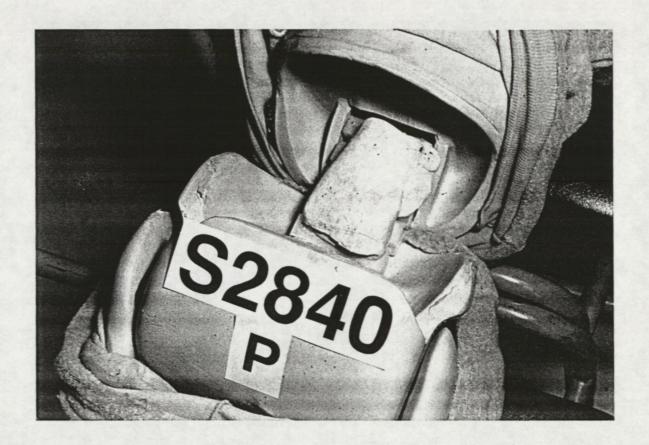
Figure 17b Distortion of plasticine after test

The plasticine located behind the abdomen insert of the left dummy was only slightly changed in shape after the test. However, in the case of the right dummy, the plasticine was badly distorted at the top left corner, see Fig 17b, indicating that, for a child, considerable force had been imposed on part of the abdomen region – probably by the belt buckle.

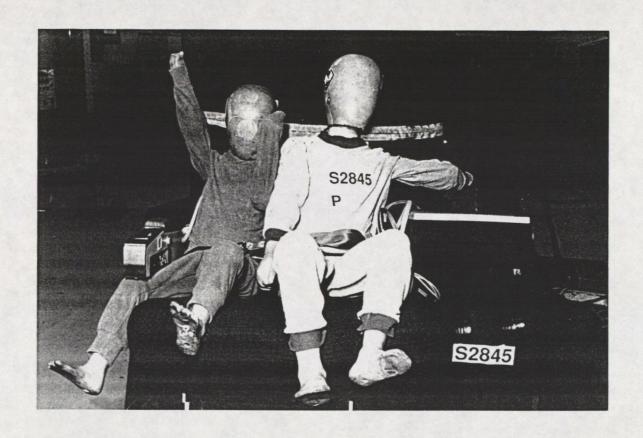
Figure 18a Positions of the 3 year and 6 year dummies after test

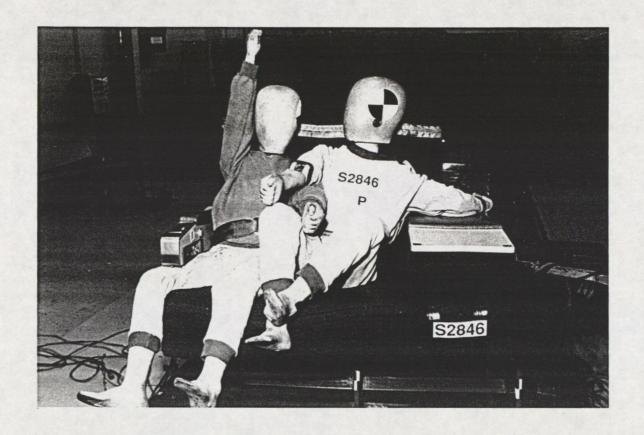
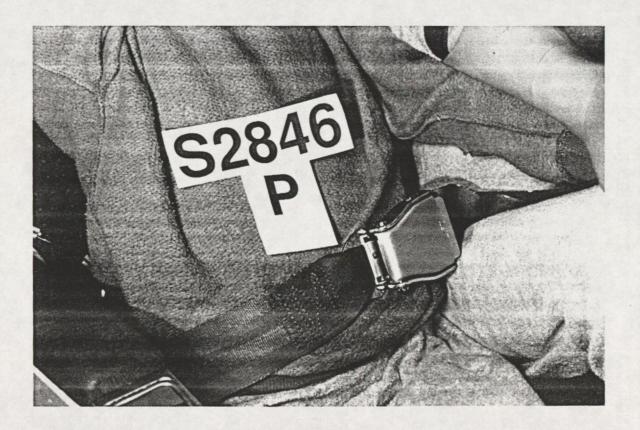
Figure 20a Positions of the 6 year dummies after test
