**CAA PAPER 2003/7**

**Effect of Helicopter Rotors on GPS Reception**

**December 2003**

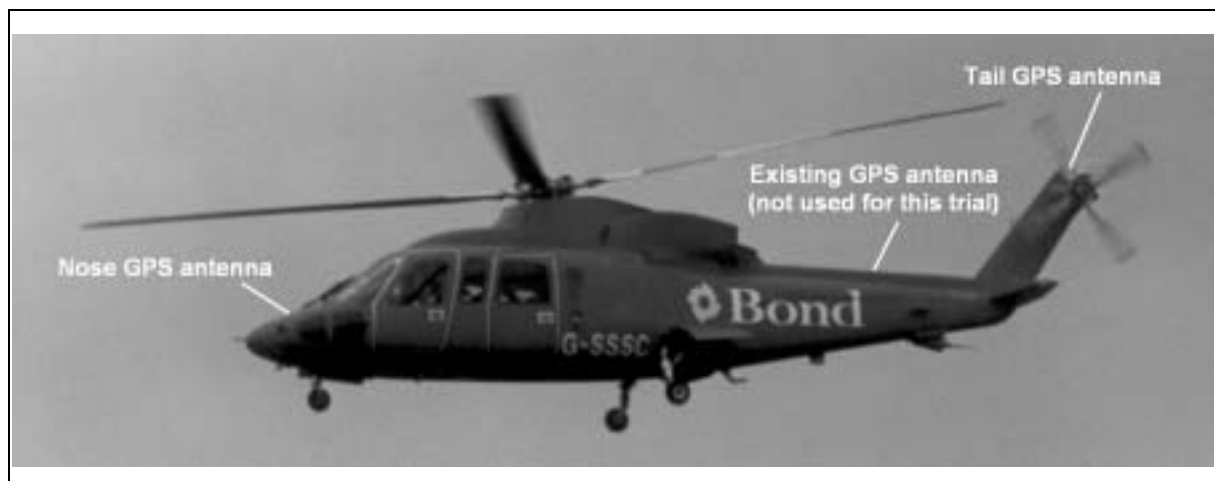
On G-SSSC, an existing antenna is presently located close to the midpoint of the tailboom which is used by the aircraft's 'normal' GPS receiver. As may be observed from Figure 1, in this position the antenna is below the main rotor disc and is also close to the tail rotor. Installation of GPS antennas in similar locations appears to be common on several other UK offshore aircraft: for example, Figure 2 shows the antenna position on a Super Puma aircraft operated by Bristow Helicopters Ltd.

**Figure 1** GPS antenna locations on Sikorsky S76C G-SSSC

The re-use of these two antenna positions was partly dictated by the desire to replicate the 'interference' effects which had been observed on the previous trials, but it also provided good geometry for investigating the effect on GPS satellite signals when passing through either the main rotor (nose antenna) or tail rotor (tail antenna).

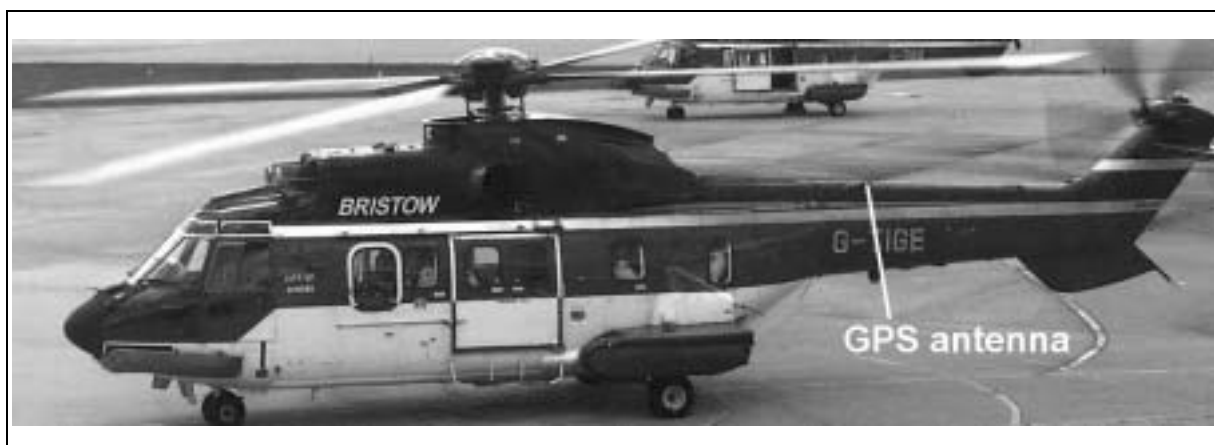
**Figure 2** GPS antenna location on Super Puma G-TIGE

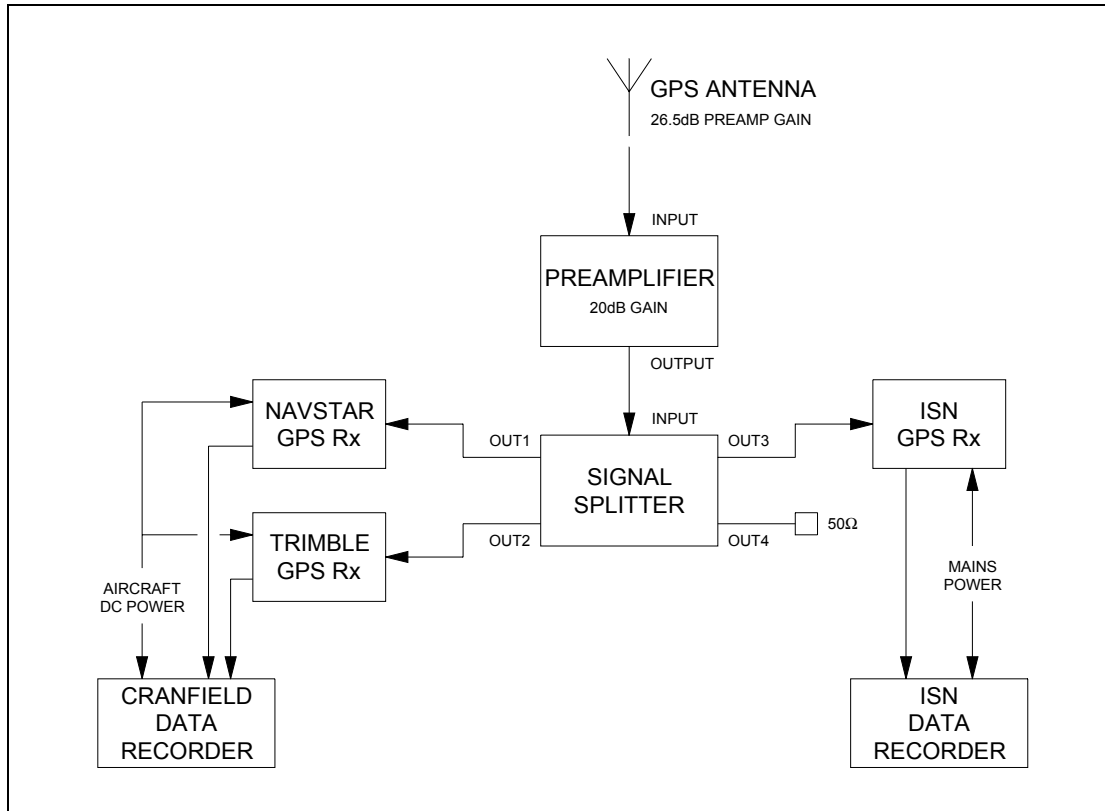
A block diagram of the experimental equipment installation is shown in Figure 5. Although two different GPS antenna positions (nose and tail) were available, only one was used at any one time with the selection between the two being undertaken manually. The output from the selected GPS antenna was fed to a preamplifier/splitter arrangement which was identical to that employed for the earlier DGPS test flights [1].

**Figure 5** Experimental equipment configuration

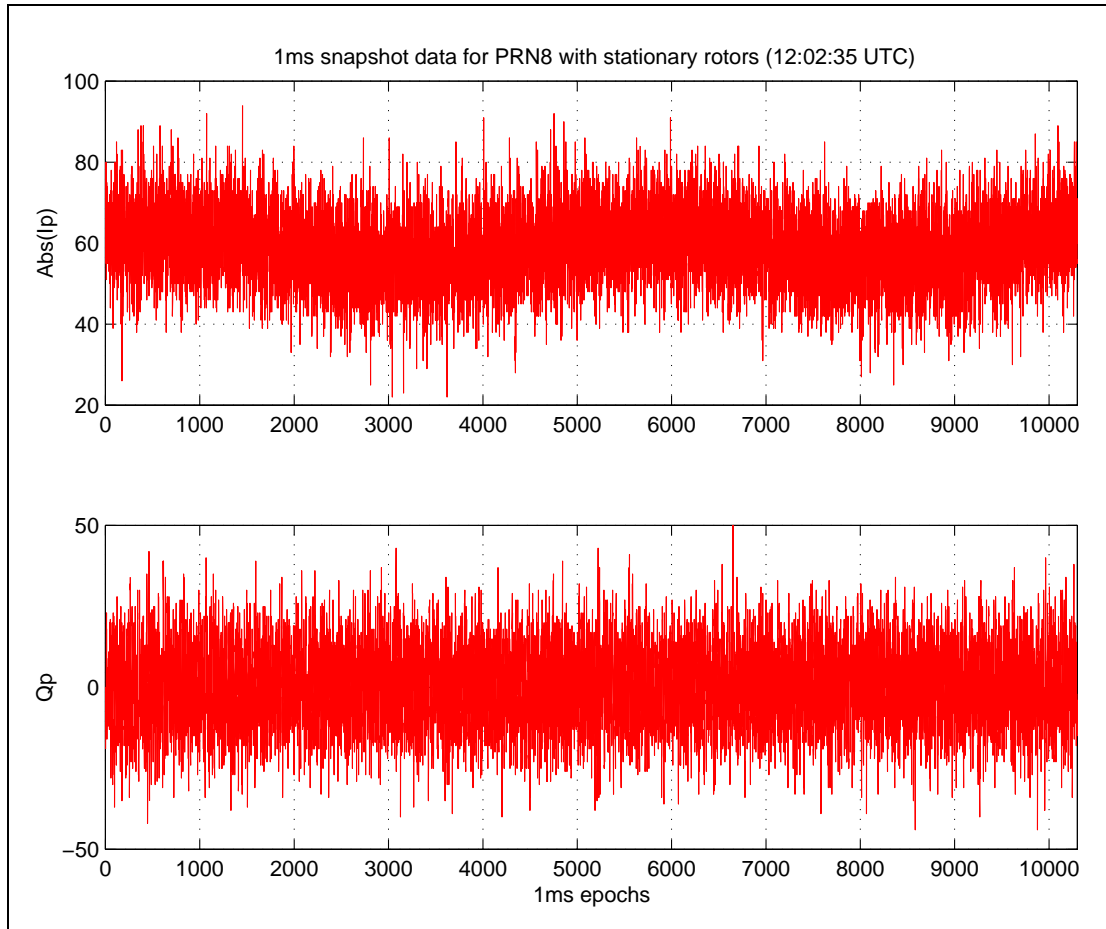
In order to further characterise the snapshot data for periods when the rotors were stationary, data from three other satellites are presented. In Figure 8 are the  $I_p$  and  $Q_p$  data for PRN 8. All signal energy is being tracked in the in-phase channel, with the quadrature-phase channel containing zero-mean Gaussian noise only. The spectrum of the PRN 8 envelope ( $P(f)$ ), is shown in Figure 9. Again it is clear that there are no discernible deterministic signal components in the frequency range shown (other than DC). Use of the CNR estimator discussed previously results in an estimated CNR value of 41.4dBHz for PRN 8 during the time at which this snapshot was taken, when the satellite was at an elevation angle of approximately  $27^\circ$ .

**Figure 8** 1ms snapshot data for PRN 8 with rotors stationary

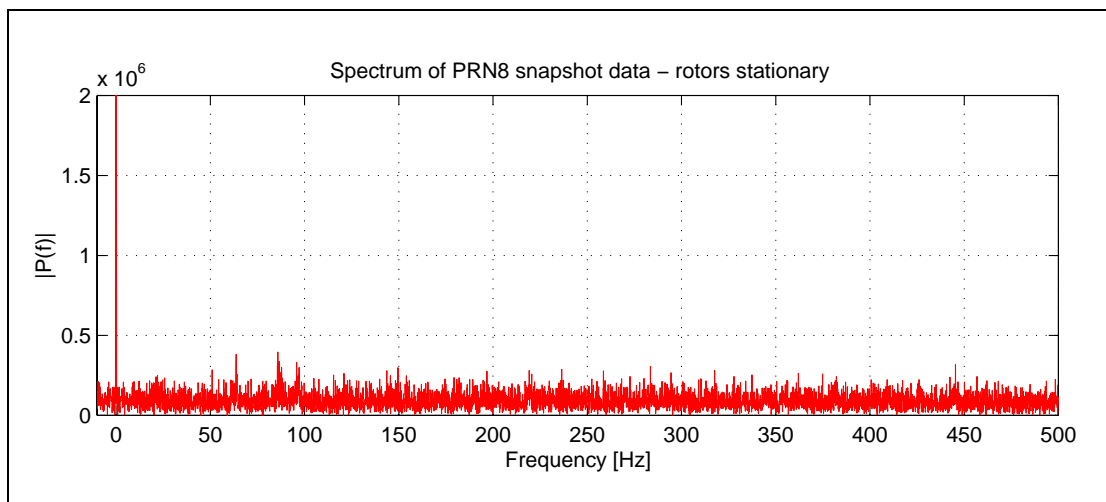
**Figure 9** Spectrum of PRN 8 snapshot data with rotors stationary

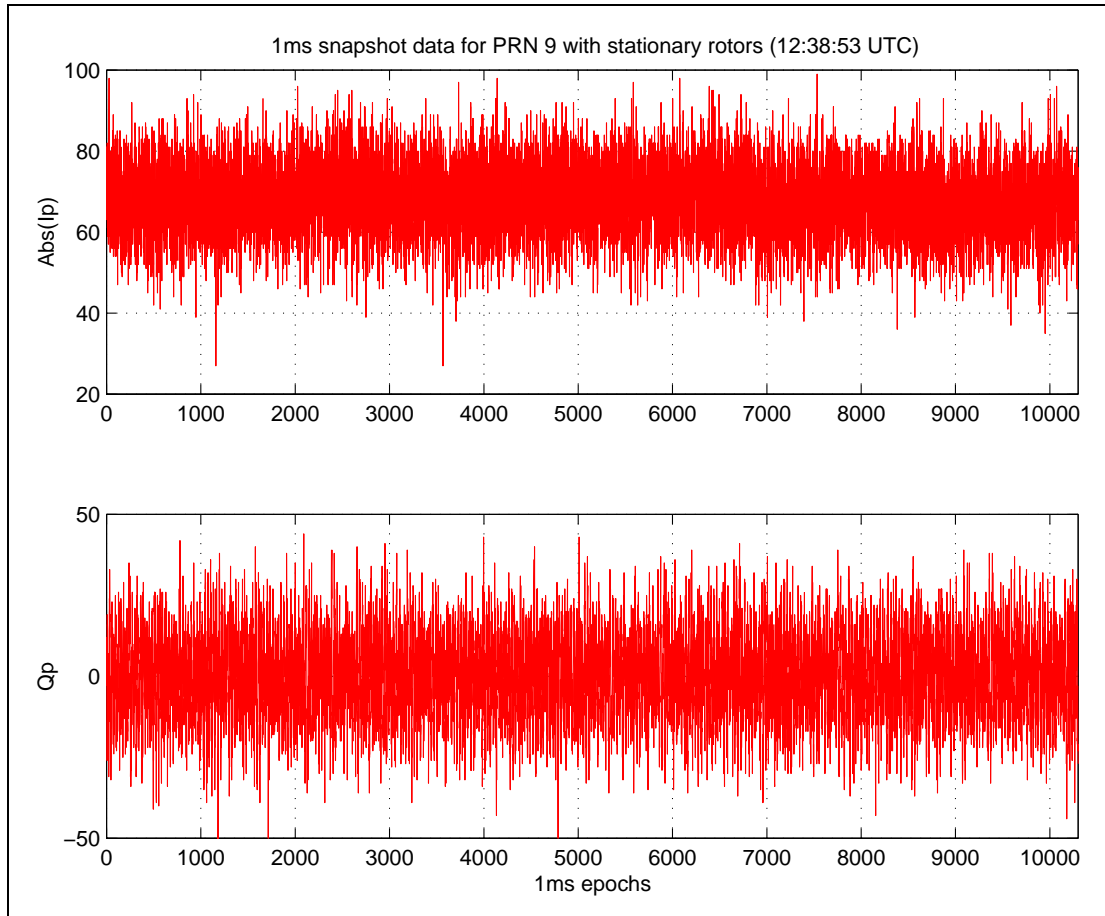
The snapshot correlation data for PRN 9 is shown in Figure 10, and the corresponding frequency spectrum of that data is shown in Figure 11. Again it is clear that the signal is being accurately tracked into the in-phase channel. There are no detectable signal components at frequencies other than DC. For reference this satellite was at an approximate elevation angle of 42°. The estimated CNR for this data set was 42.6dBHz.

**Figure 10** 1ms snapshot data for PRN 9 with rotors stationary

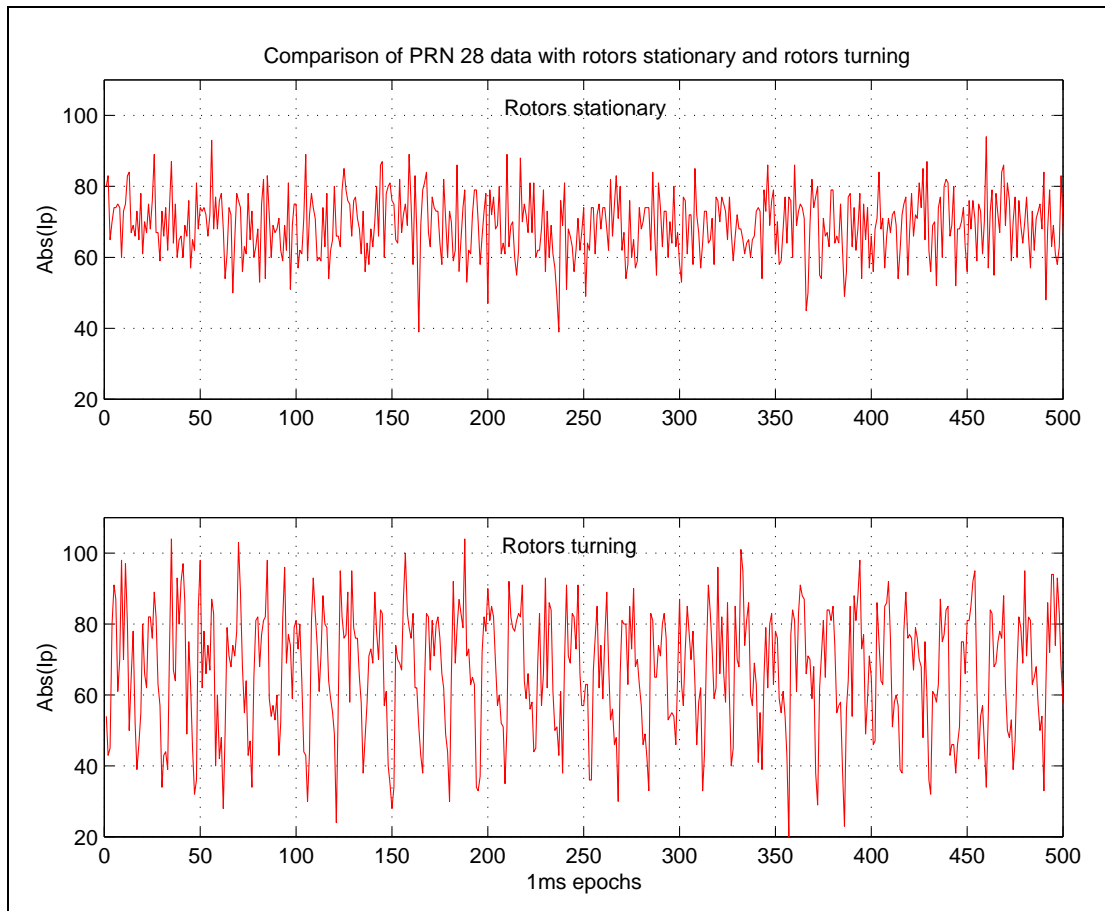
This snapshot began only 2 minutes and 24 seconds after the start of the snapshot shown in Figure 6 when the rotors were stationary. The axes have been made as similar as possible to those used in Figure 6, in order to clearly demonstrate the effect the rotors have on the correlation data. The correlation data noticeably increases in variance when the rotors are turning. This is particularly the case for the  $I_p$  data. Comparing the two data sets the standard deviation of the  $I_p$  data increases by almost a factor of two, whilst the standard deviation of the  $Q_p$  data increases by 43%. The most obvious reason for an increase in variance would be that the received signal power had reduced. However, in that case it would be expected that the increase in the variance of the  $I_p$  and  $Q_p$  data would be more similar. Closer inspection of the correlation data is therefore required in order to determine the cause of the increased variance. The first 500ms of the  $I_p$  correlation data from Figure 14 when the rotors were turning at approximately 62.5%  $N_r$ , together with the first 500ms of data from Figure 6 when the rotors were stationary, are presented in Figure 15.

**Figure 15** Comparison of PRN 28 snapshots with rotors turning and rotors stationary

The observed oscillatory behaviour would suggest that the rotors are causing attenuation of the signal as they obscure the signal path. However, before investigating this theory further it is necessary to more fully characterise the observed oscillations. The spectrum of the received signal envelope for the data with the rotors turning is shown in Figure 16. It should be noted that, for clarity, the limits of the y-axis in the upper plot have been increased from those used in Section 5.2.

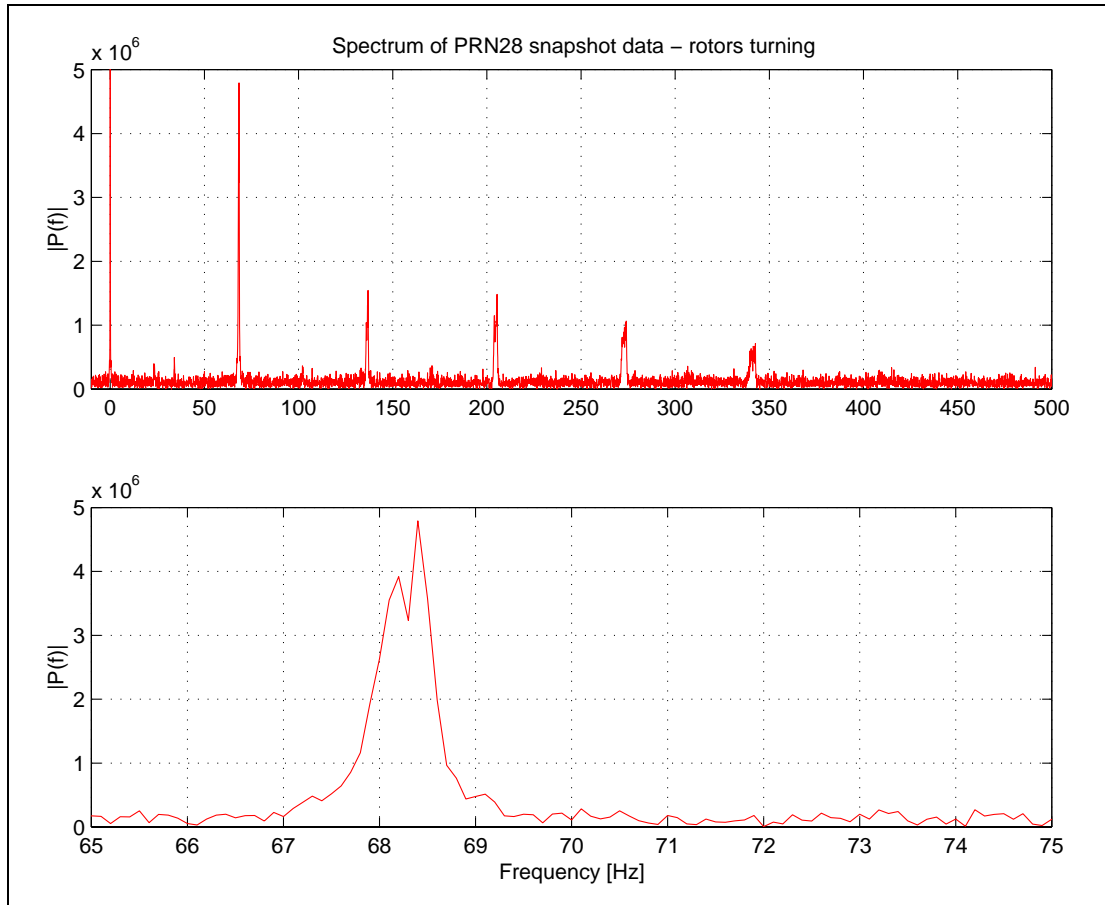
**Figure 16** Spectrum of PRN28 data with rotors turning

Given the accuracy of the recorded rotor speed and the reference timebase, this value is clearly very close to the fundamental frequency of the oscillations observed in the correlation data. This result suggests that the oscillations observed in the correlation data are caused by the passage of the rotor blades between the antenna and the incoming signal wavefront.

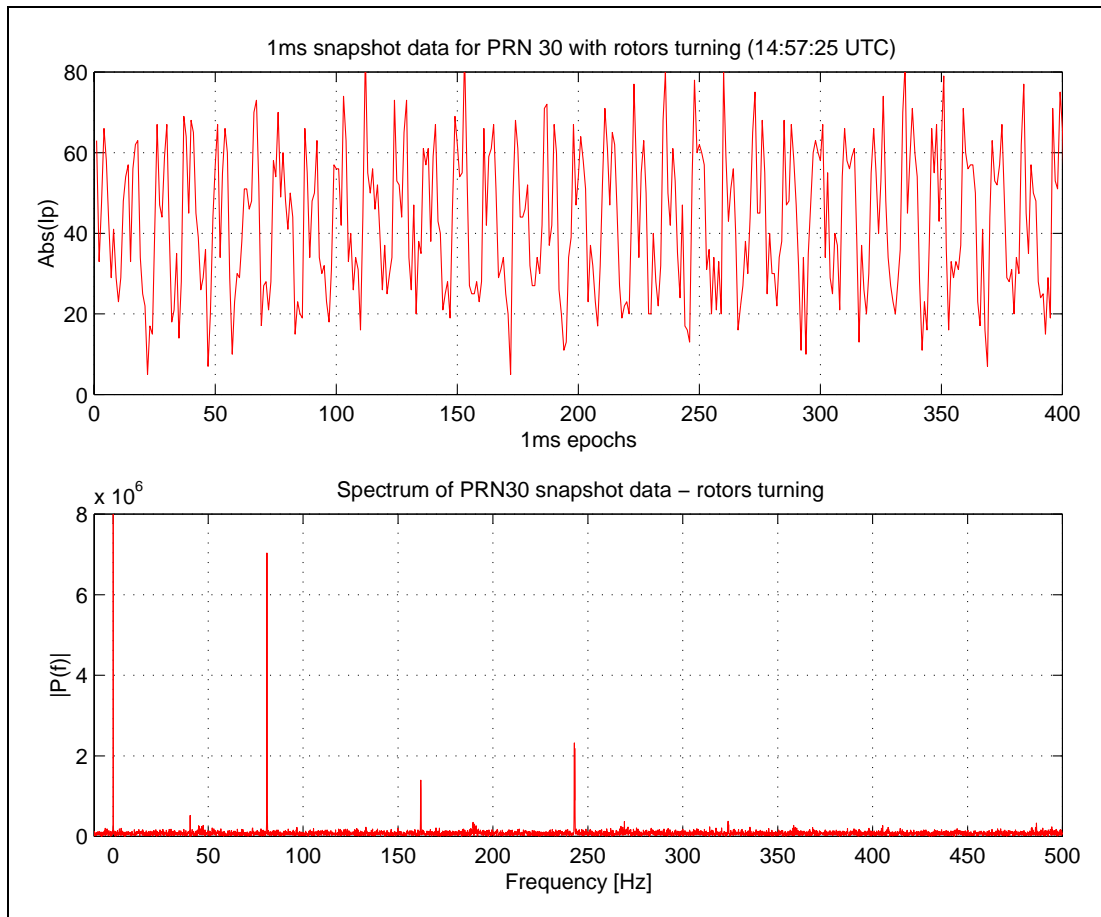
Further evidence of the effect of the tail rotors on the correlation data is present in the correlation data for PRN 30. This data was recorded during a period when the rotor speed was held constant at a value of 74.5% Nr, and is presented in Figure 17. The frequency domain representation of the received signal envelope is also shown.

**Figure 17** Snapshot data and frequency representation for PRN 30 with rotors turning

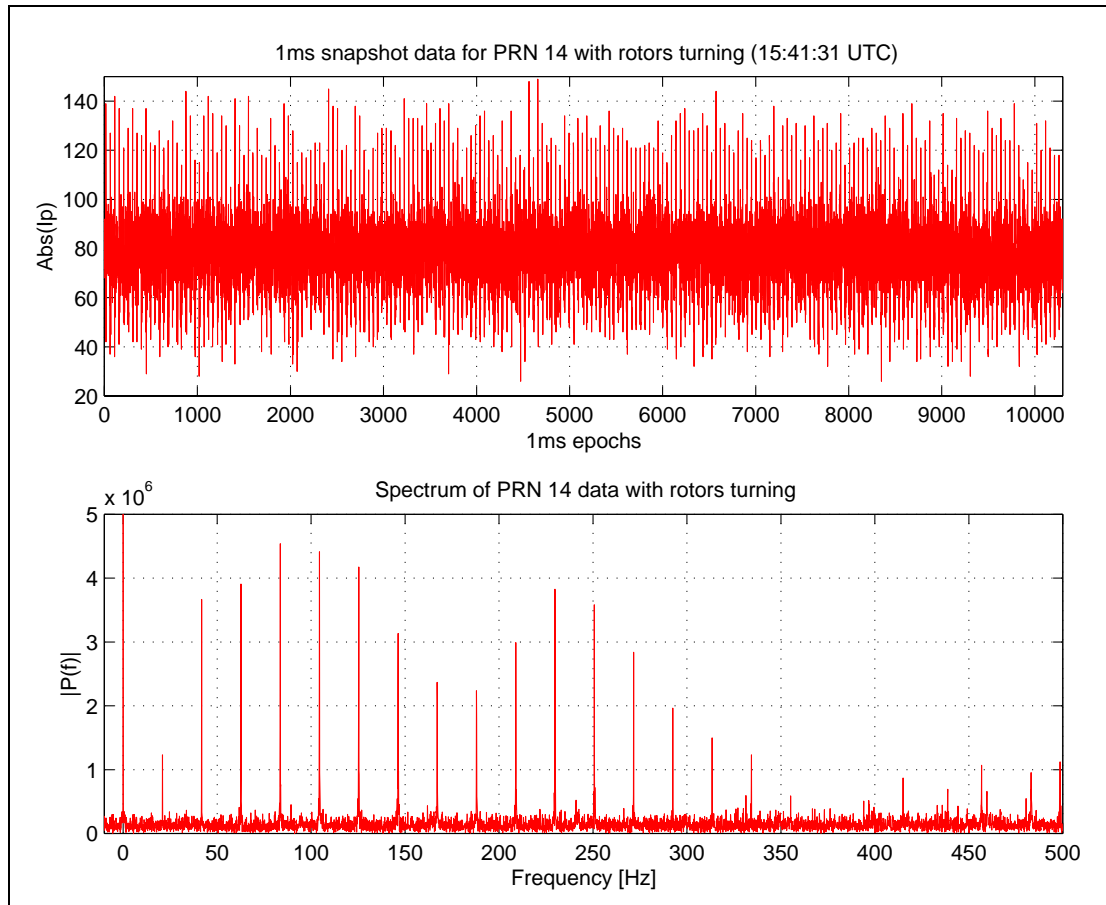
Tests were performed to investigate if the observed 'interference' caused by rotation of the tail rotor is also produced by the main rotor. The common antenna used by the receivers during the trial was switched from that on the tail fin to that on the nose of the aircraft. Snapshot data was then gathered for a number of different scenarios. Figure 18 gives the correlation totals for PRN 14 during a period when the rotors were turning at a recorded speed of 105.8% Nr. The satellite was at an elevation angle of approximately  $45^\circ$ , and a relative azimuth of approximately  $330^\circ$  at this time.

**Figure 18** Snapshot data and frequency representation for PRN 14 with rotors turning

The  $I_p$  correlation totals are clearly being affected during this period of time, with a significantly increased variance in comparison to the data sets, shown previously in Section 5.2, when the rotors were stationary. It can be seen that there are again oscillations in the data. However, it is important to note that as well as there being oscillations that cause reductions in the signal level, there are also those that cause increases in the signal level. Consequently, this large number of oscillations leads to there being many large components in the frequency domain representation of the received signal envelope data, as shown in the lower plot. The first significant frequency component is at 20.9Hz; the remaining components are harmonics of this frequency. However, it is important to note that the signal at the fundamental frequency (20.9Hz) is not the dominant signal, as was the case with the tail rotor data. This suggests that there are multiple effects occurring as each main rotor blade passes between the incoming signal wavefront and the antenna. The estimated blade passing frequency for this data set is 20.7Hz. Hence the 'interference' effect observed in the correlation data gathered on the main rotor is also clearly a function of the rotor speed, or more specifically, the blade passing frequency.

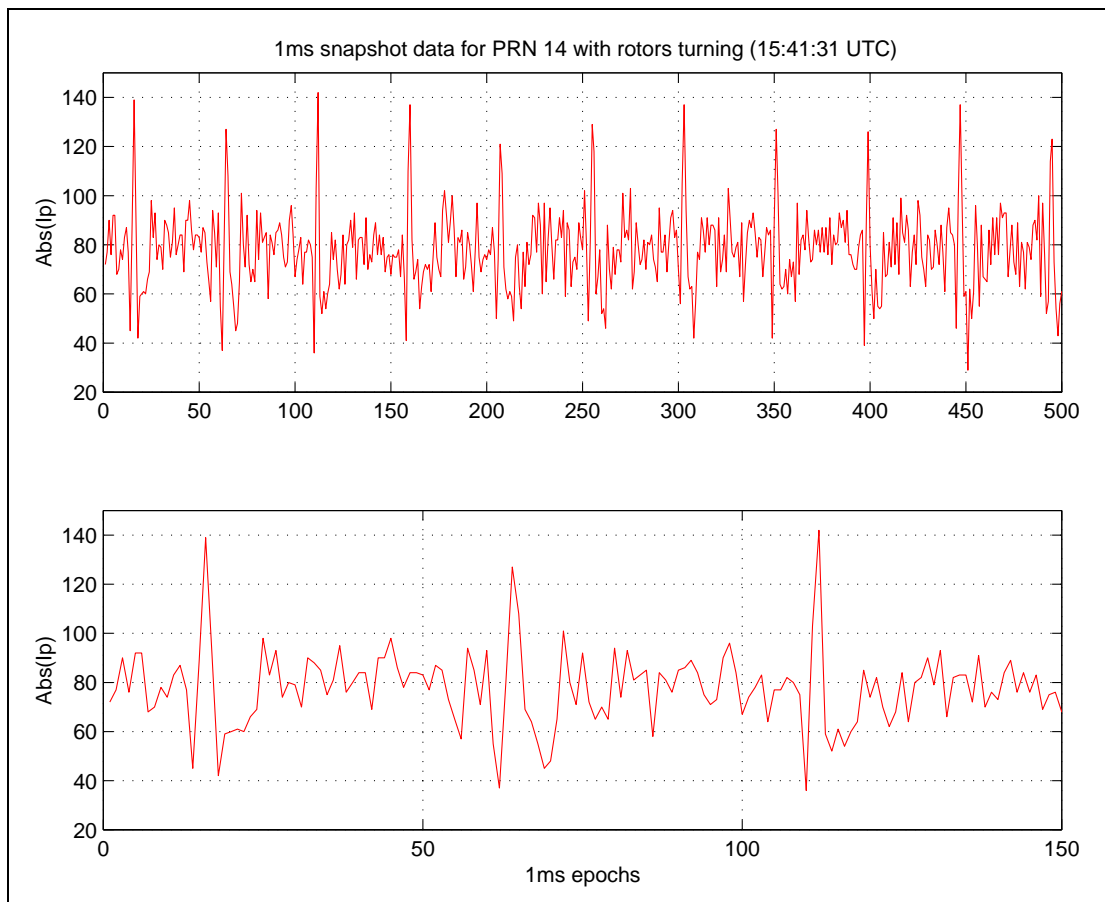
The complex nature of the correlation data for this data set is shown in Figure 19 where a more detailed examination of the profile is presented. As the estimated blade passing frequency is 20.7Hz, the period between rotor blades is 48.4ms. For this particular satellite at the elevation and azimuth at which the signal pierces the main rotor disc, the percentage of time that the rotor blade will 'block' the signal path is very small (approximately 5%). Both effects can clearly be seen in this data set. When the blades 'block' the signal path there is first a fast reduction in the signal level followed by a very large increase. This is subsequently followed by a reduction before the signal level returns to normal. The increase in signal level is very large indeed. When considering the received power profile ( $I_p^2 + Q_p^2$ ) these increases are typically in excess of 100% of the power when the rotor blades are not 'blocking' the signal. This effect was also observed for the same satellite when the rotor was turning at a speed of approximately 70%  $N_r$ .

**Figure 19** Close up of PRN 14 data for main rotor

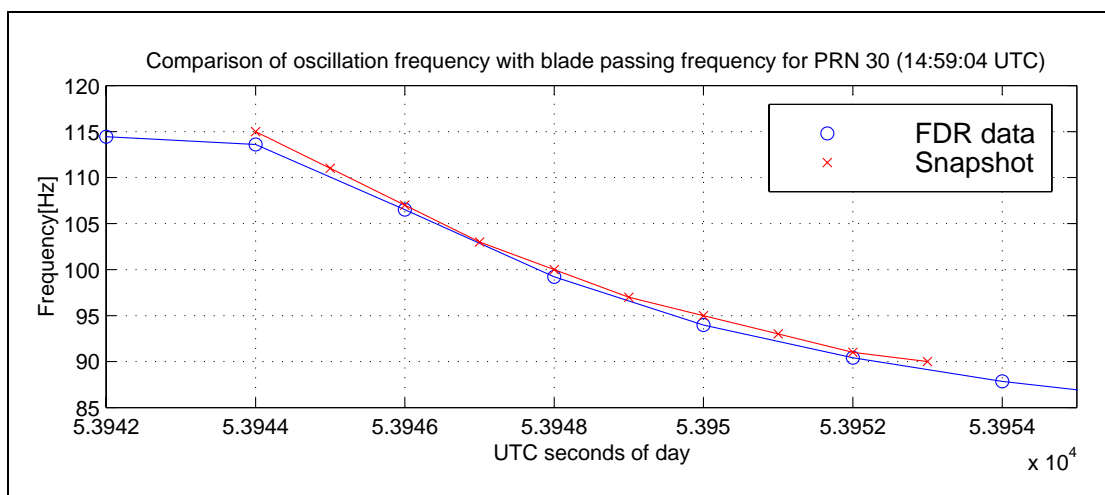
The first data set to be shown is that during a reduction in rotor speed from full speed. The satellite being tracked was PRN 30 which was at an approximate elevation angle of  $24^\circ$  and a relative azimuth of  $270^\circ$ . For the 10 seconds of snapshot data 10 individual 1 second data sets were formed, allowing the frequency of the oscillations in the snapshot data to be determined during this time period. The frequency is established by identifying the largest component in the frequency domain representation of the received signal envelope,  $P(f)$ , excluding that at DC. The resolution of each of the 10 frequency estimates is 1Hz. The frequency of the oscillations produced in the  $I_p^2+Q_p^2$  data is shown in Figure 20. The blade passing frequency is also shown, which has been calculated from the recorded rotor speed data.

**Figure 20** Comparison of oscillation frequency with blade passing frequency for PRN 30

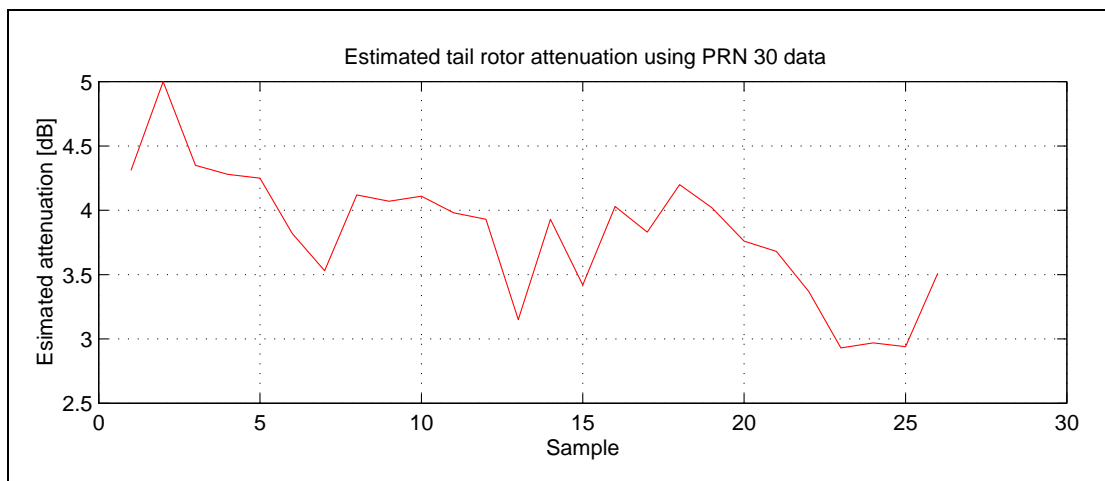
The estimated attenuation level obtained from the snapshot data gathered for PRN 30 is now presented. The PRN 30 data was gathered between 14:55:29 UTC and 15:23:46 UTC. At the beginning of this period the satellite was at an approximate elevation angle of  $24^\circ$  and a relative azimuth of  $270^\circ$ . At the end of this period the approximate elevation angle was  $36^\circ$  and the relative azimuth was  $265^\circ$ . In total 26 snapshots were captured during this time. The majority of these were with the rotors turning at full speed, although others were captured during times when the rotor speed was changing, i.e. a start-up or shutdown procedure. The estimated attenuation for these snapshots is shown in Figure 25. The mean of these estimates is 3.82dB.

**Figure 25** Estimated tail rotor attenuation using PRN 30 data

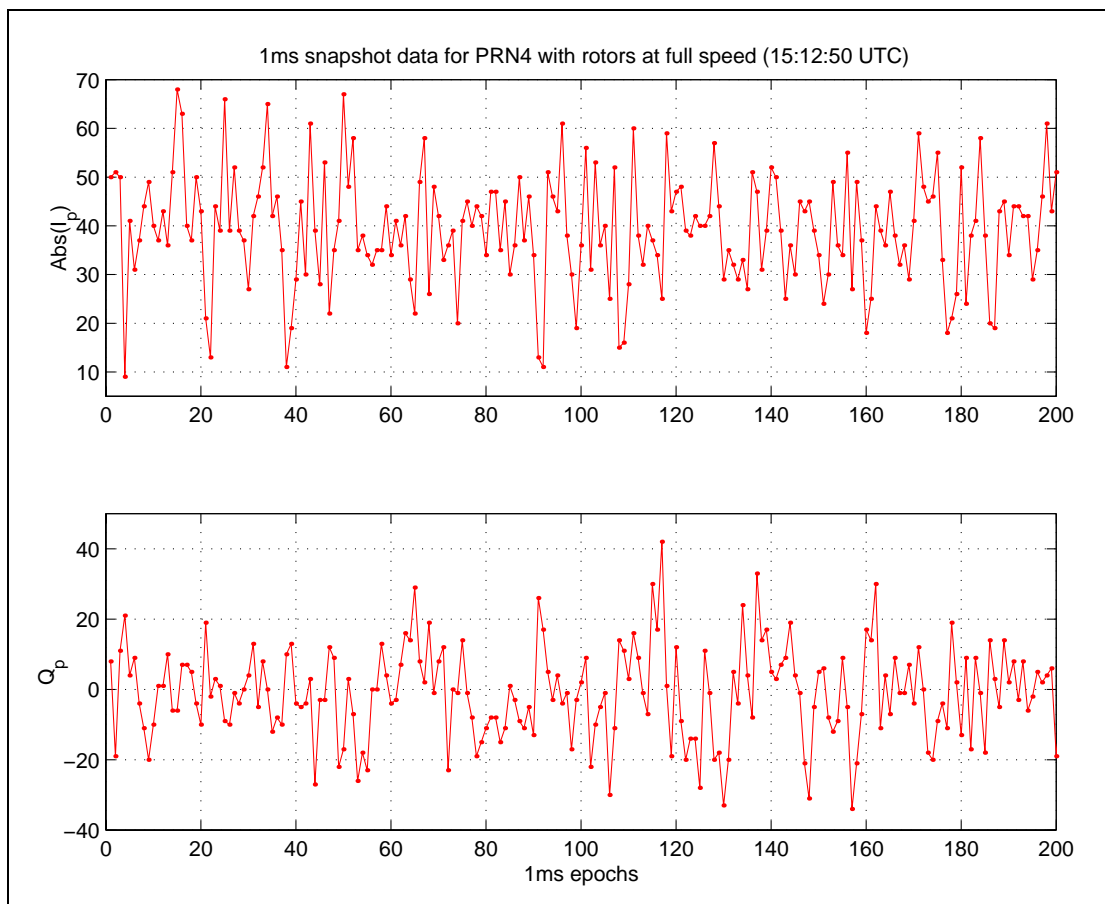
Whilst analysing the snapshot data obtained on the tail rotor an unexpected result was obtained. The satellite for which snapshot data was obtained was one whose signal reached the antenna directly, i.e. without passing through the rotor disc. This satellite was being tracked during the trial in order to obtain control data, showing the 'normal' behaviour of signals not propagating through the rotor disc. The correlation data for this satellite, PRN 4, is shown in Figure 26 over a 200ms period. The satellite was at an elevation angle of approximately  $24^\circ$  and a relative azimuth of approximately  $90^\circ$ . The recorded rotor speed at this time was 105.9%  $N_r$ , corresponding to a blade passing frequency of 113.6Hz. There are clear oscillations in the  $I_p$  data that are similar to those shown previously in Section 5.3. Inspection of the frequency domain representation of this data set reveals that the oscillation is at a frequency of 115Hz, which is again essentially the blade passing frequency, given the accuracy of the recorded rotor speed. Therefore, even though the signal is not propagating through the tail rotor disc, the tail rotor is still having an effect on the received signal. It should also be noted that there is a significant frequency component at 57.5Hz for this data set, although it is not as large as that at 115Hz. This can clearly be seen in the data set as an oscillatory effect with a period in the region of 17.4ms. The implication is that there is some component of the tail rotor assembly which is providing a contribution to the modulation with a period corresponding to alternate blade passages.

**Figure 26** 1ms snapshot data for PRN 4 with rotors at full speed

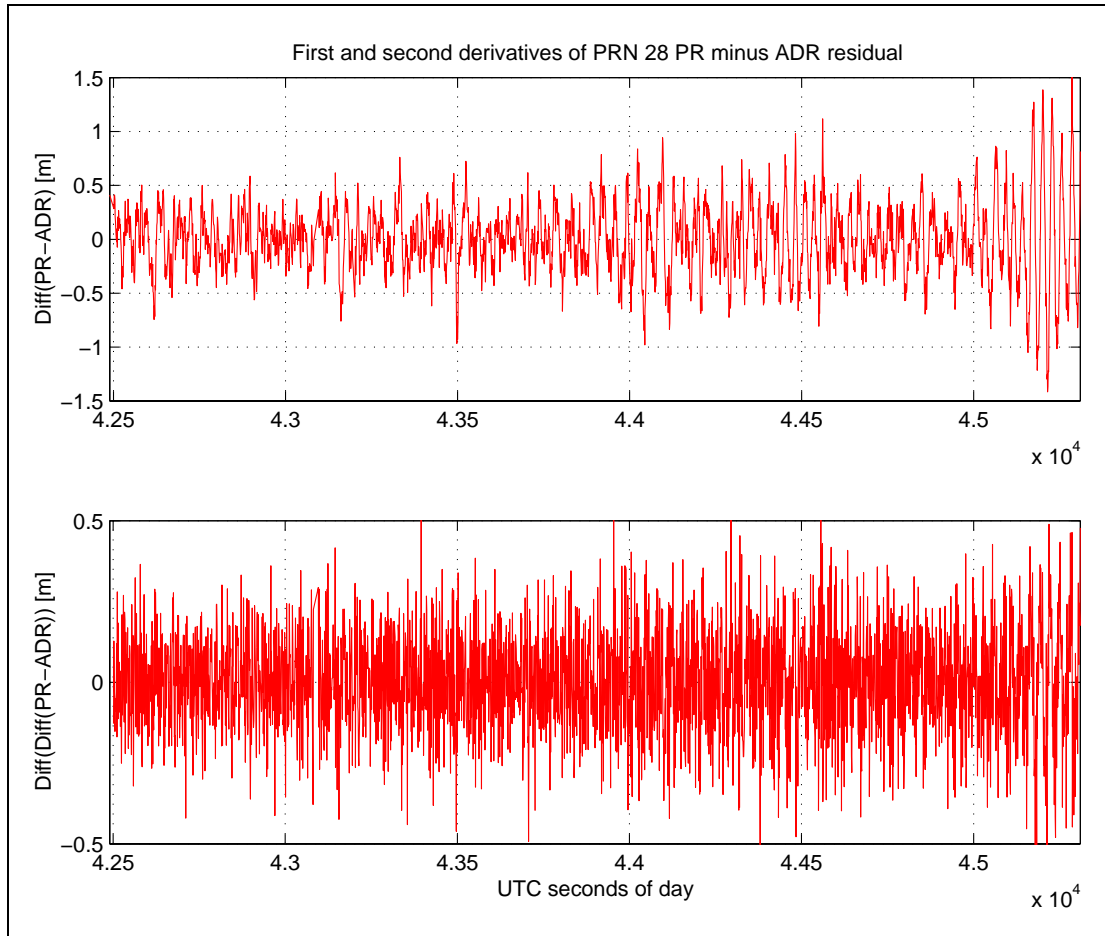
**Figure 28** First and second derivatives of PRN 28 pseudorange minus ADR residuals

It can be seen that there are no discernible increases in code tracking noise when inspecting these derivatives. Therefore it has been found that, for this data set, the motion of the tail rotors does not cause any significant effects on the code tracking performance. Consequently the positioning performance of the receiver would not be adversely affected when processing such pseudorange data. However, further analysis of the pseudorange data is required before more definitive conclusions can be drawn.

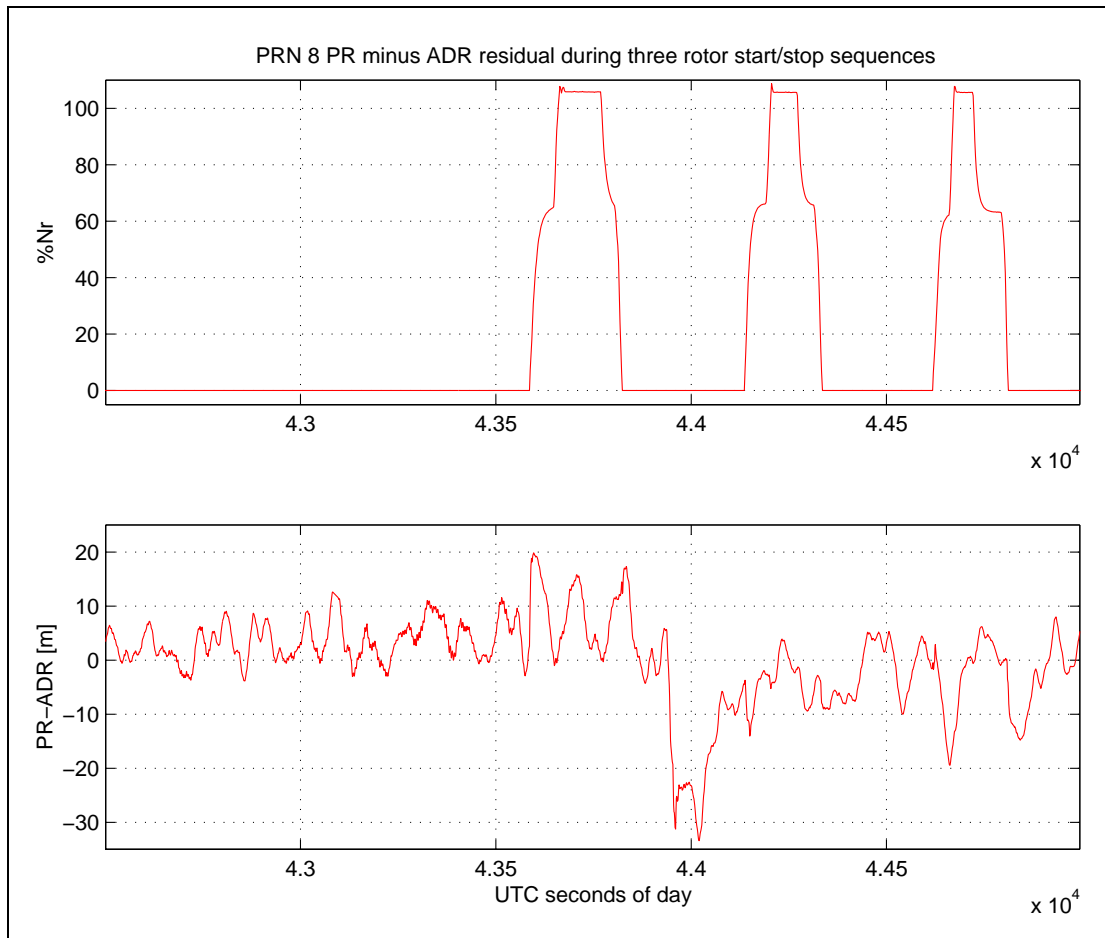
Figure 29 gives the pseudorange minus ADR residuals for PRN 8 during the same three start/stop sequences shown in Figure 27. In this case the data set shown begins at 11:48:21 UTC and ends at 12:29:55 UTC, as this was a period during which the carrier phase data was continuous.

**Figure 29** PRN 8 pseudorange minus ADR residuals for Navstar receiver

Again, the receiver is able to track this satellite through all three start/stop sequences. There is again no clear increase in code tracking noise, although the large code multipath errors may be masking such effects. The first and second derivatives of the residual data are given in Figure 30.

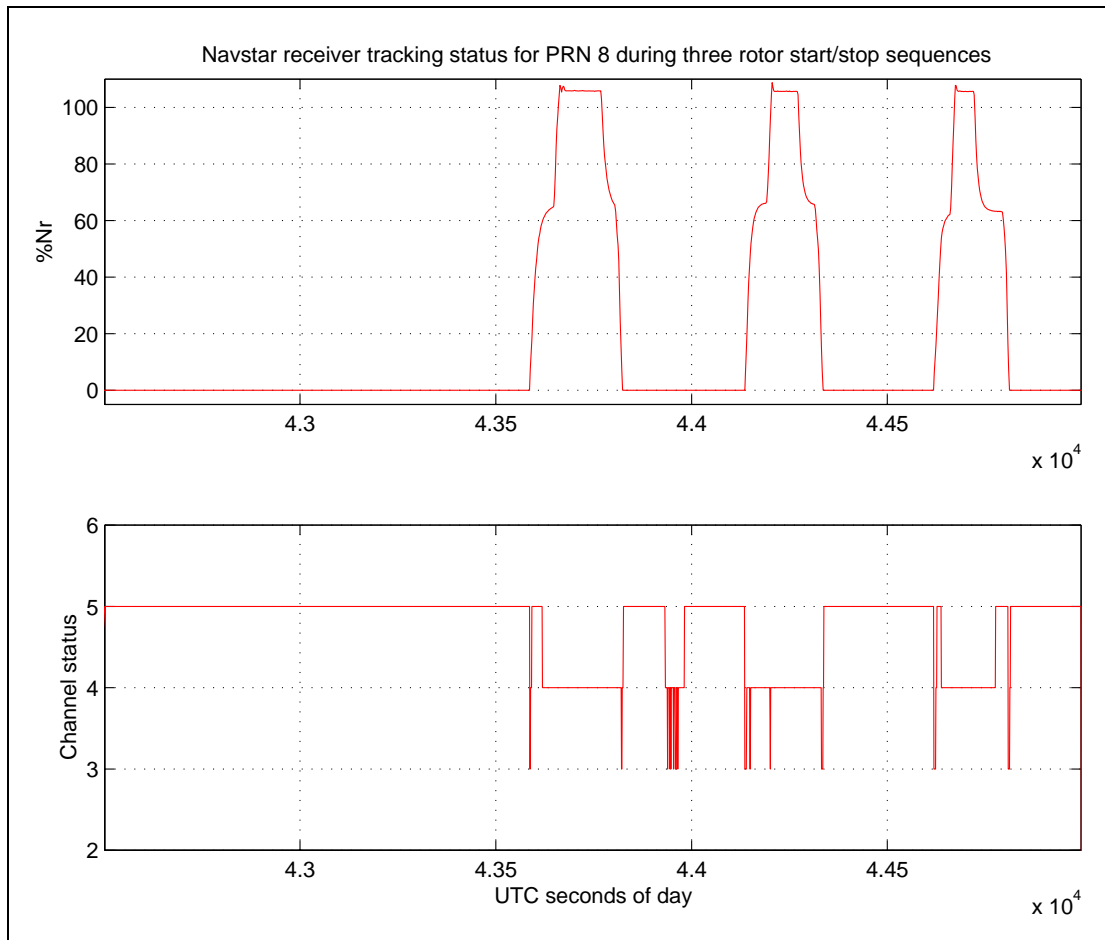
**Figure 31** Navstar tracking status for PRN 8 during three rotor start/stop sequences

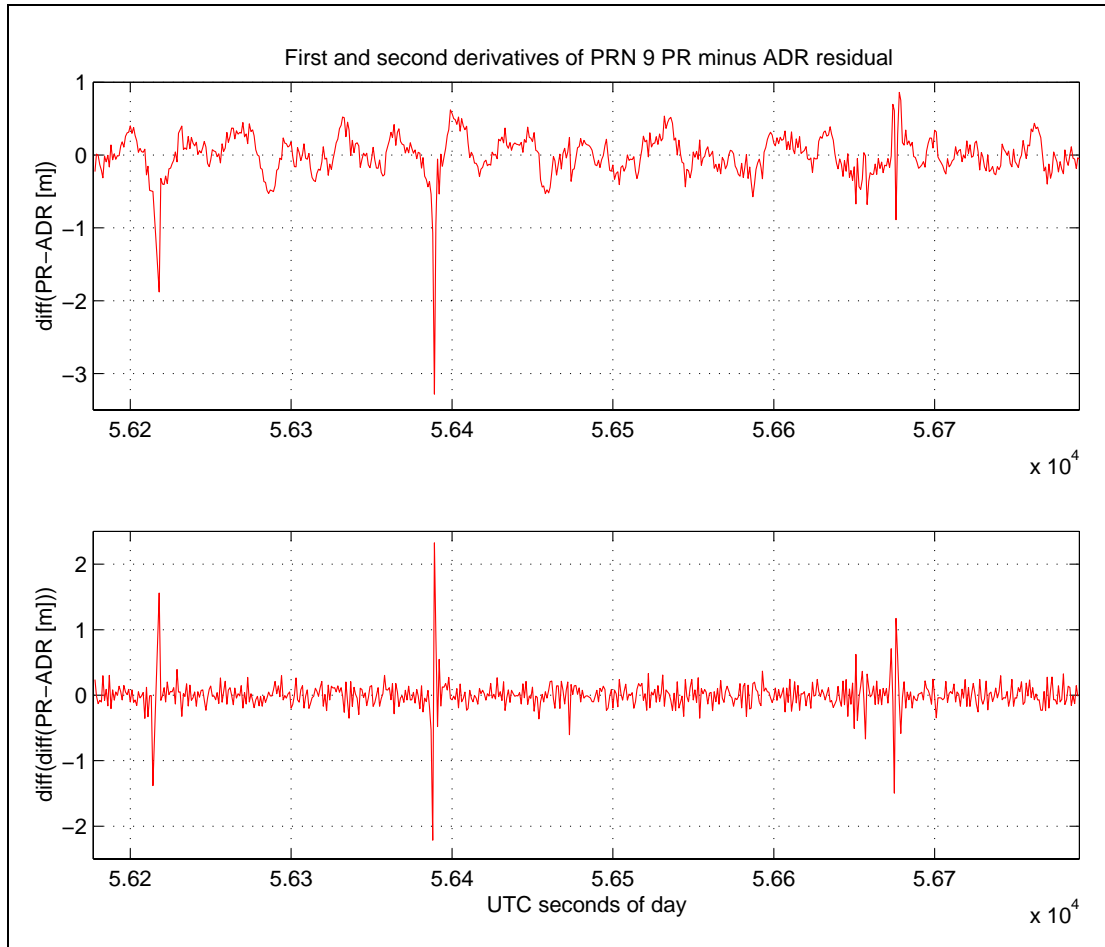
The first and second derivatives for PRN 9, during the same time period as was used for PRN 14 are shown in Figure 34. During this time the satellite was at an approximate elevation angle of  $53^\circ$  and a relative azimuth of  $167^\circ$ . Again, there is no identifiable increase in the range measurement noise. However, there are again clear spikes in the derivatives as the rotors start and stop.

**Figure 34** First and second derivatives of PRN 9 pseudorange minus ADR residuals

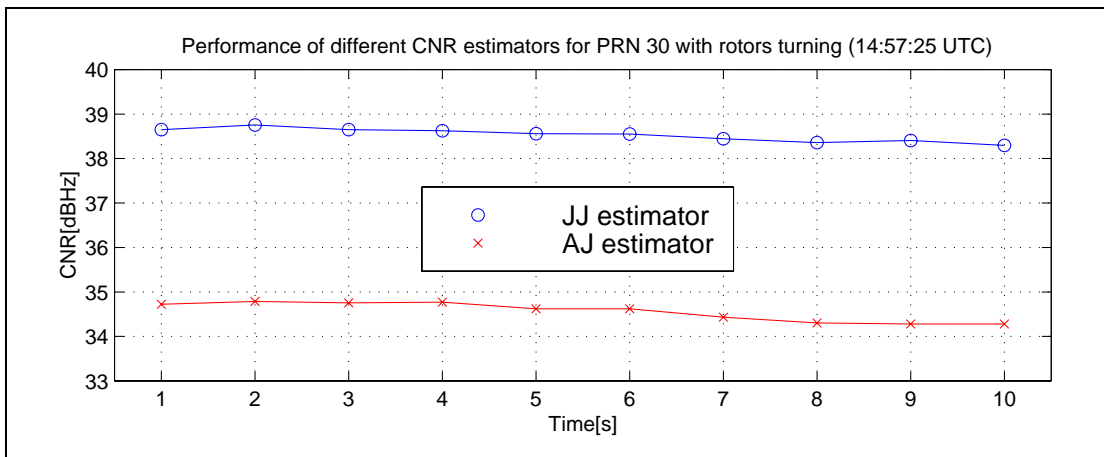
**Figure 4** Comparison of CNR estimators for PRN 30 data - rotors turning
