CAA PAPER 2010/01

The SBAS Offshore Approach Procedure (SOAP)

May 2010

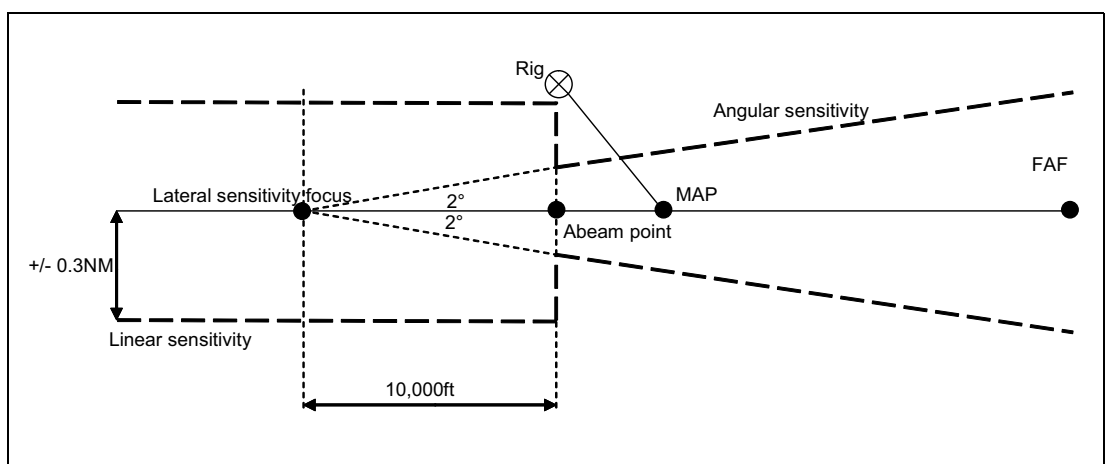
Figure 2.2 Lateral sensitivity

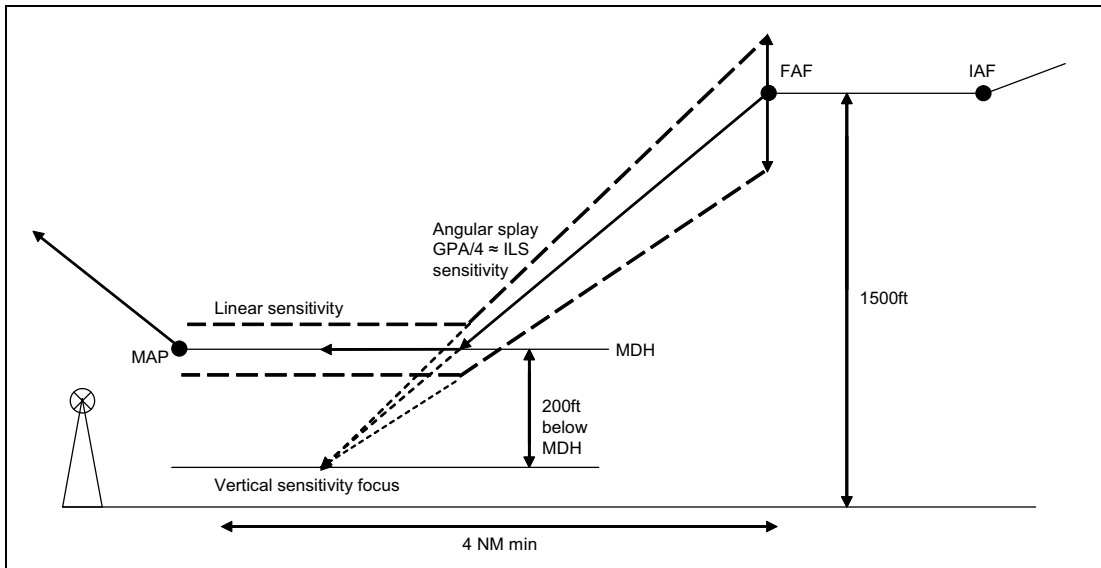
Figure 2.3 Vertical sensitivity

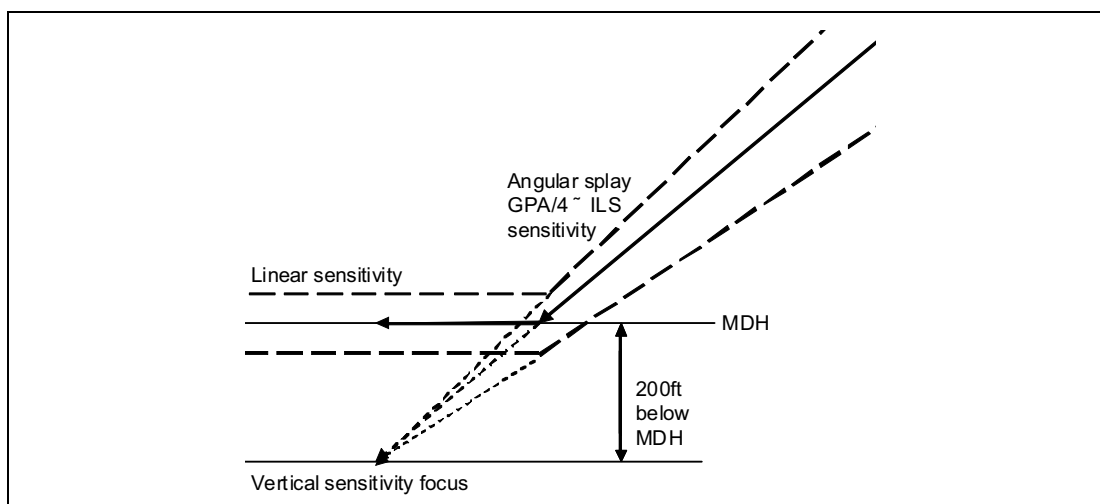
No fairing between the angular and the linear scale was implemented due to time constraints. When approaching the MDA, the pilots were instructed to depart from the glide slope guidance for few seconds in order to smooth the level-off. To assist anticipation of this manoeuvre, a flashing "SLOPE CHANGE" alpha-numeric indication was presented on the PFD at 200 ft above MDA.

Figure 3.4 Vertical display sensitivity

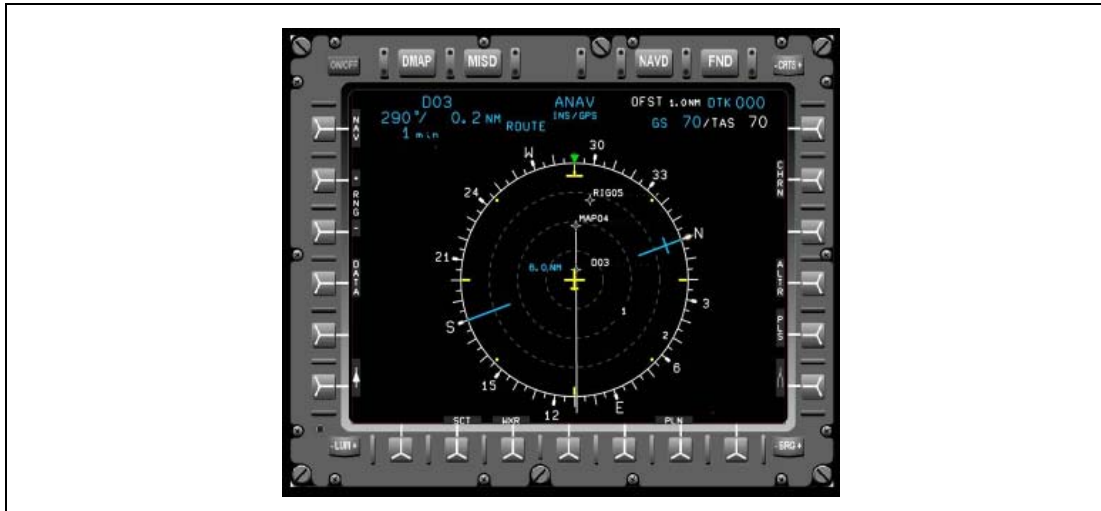
- b) Other relevant information, such as alphanumeric indications of course, distance / time to next waypoint and groundspeed (G/S) were also presented.

Figure 3.5 View of Navigation Display

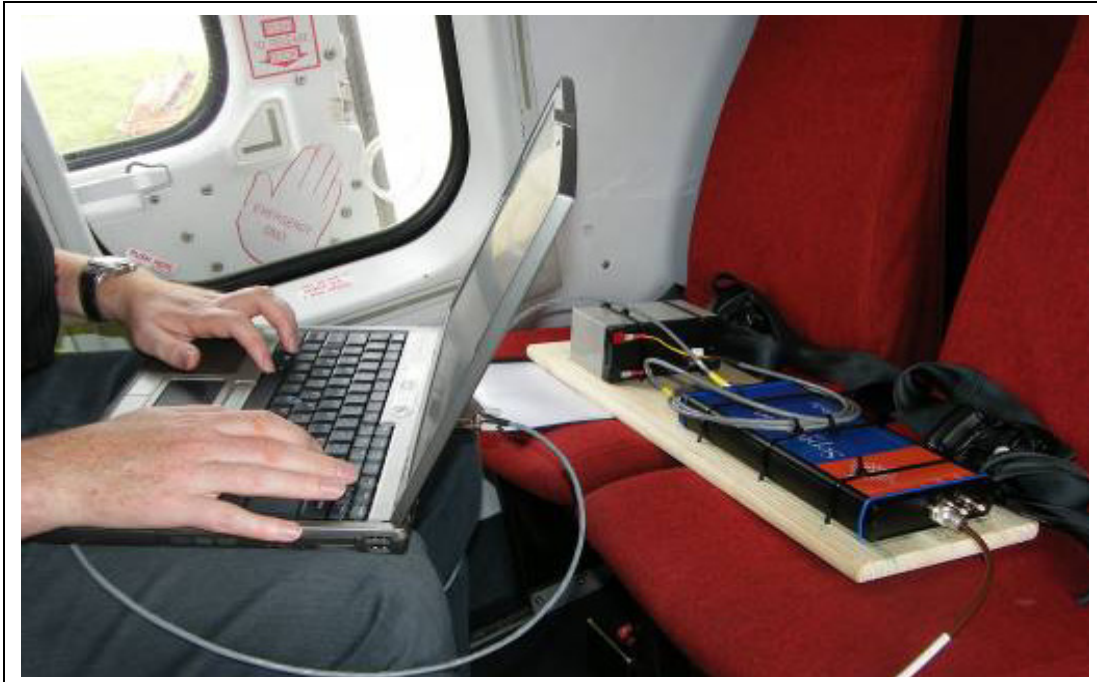
- 5.1.6 On the aircraft the Septentrio receiver was connected to the aircraft's passive GPS antenna via an active splitter to provide appropriate gain for normal operation. The antenna cable was routed through the aircraft cabin to allow the observer to sit with a view of the cockpit (see Figure 5.2). For the static trial the receiver was configured to log all SBAS parameters at a rate of 10Hz. For the flight trial the receiver was configured to log all SBAS parameters at a rate of 1Hz and also to filter psuedoranges and generate protection levels in line with the requirements of the SBAS receiver MOPS DO-299D.

Figure 5.2 Airborne trials installation located in forward passenger seats with connection to aircraft GPS antenna

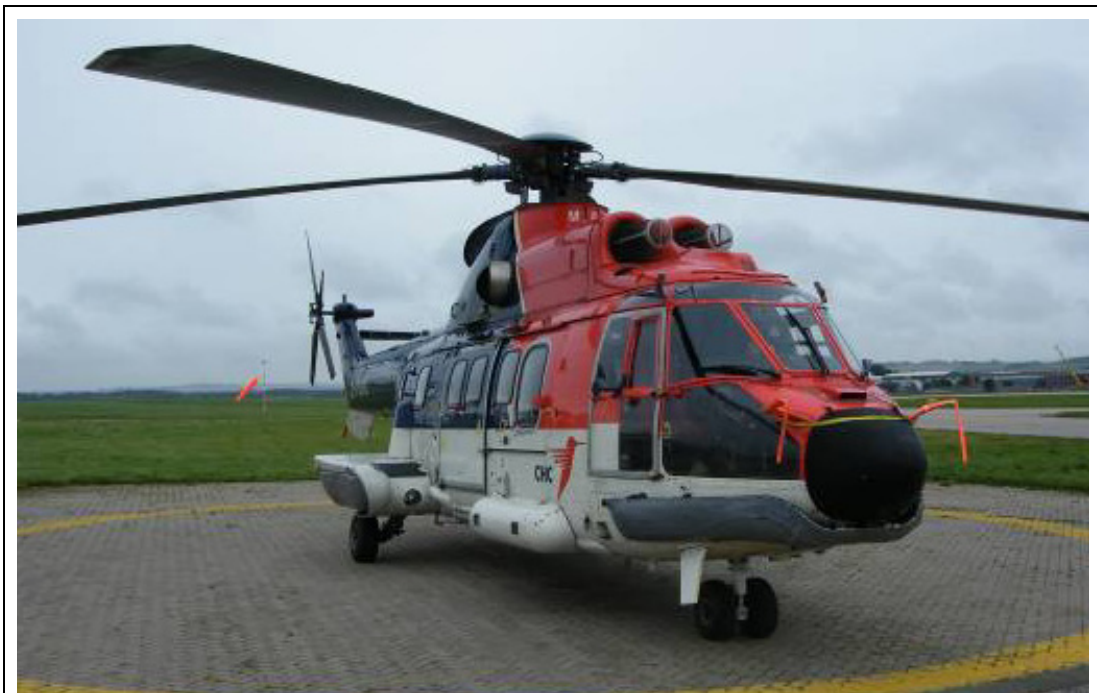
Figure 5.3 CHC Scotia Super Puma G-PUME

- 5.2.1 The static data collection took place during the morning of 12th September 2008 at Aberdeen Airport. The trials platform was an operational Eurocopter Super Puma (AS332L) helicopter registration G-PUME in operational service with CHC Scotia Helicopters (see Figures 5.3 and 5.4). The helicopter was turned to face due West in order to remove the potential effects of airframe masking and to ensure that the signals from all GEOs passed through the plane of the main rotor.

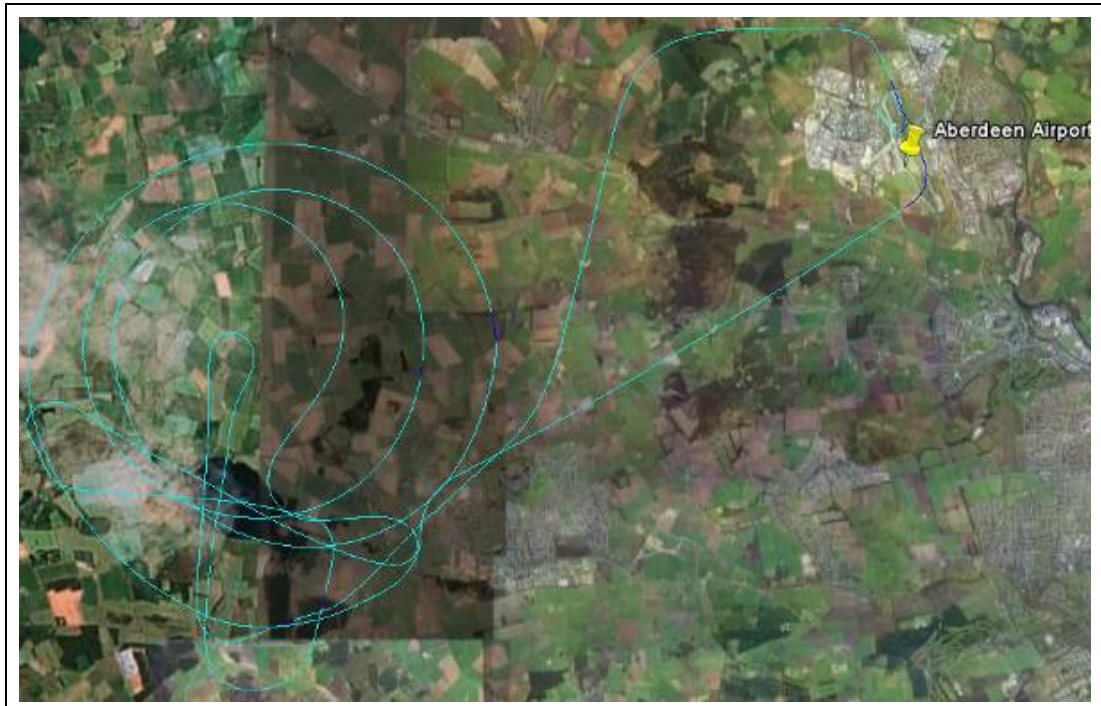
Figure 5.5 Google Earth representation of flight track showing positioning to the West of the controlled airspace around Aberdeen Airport

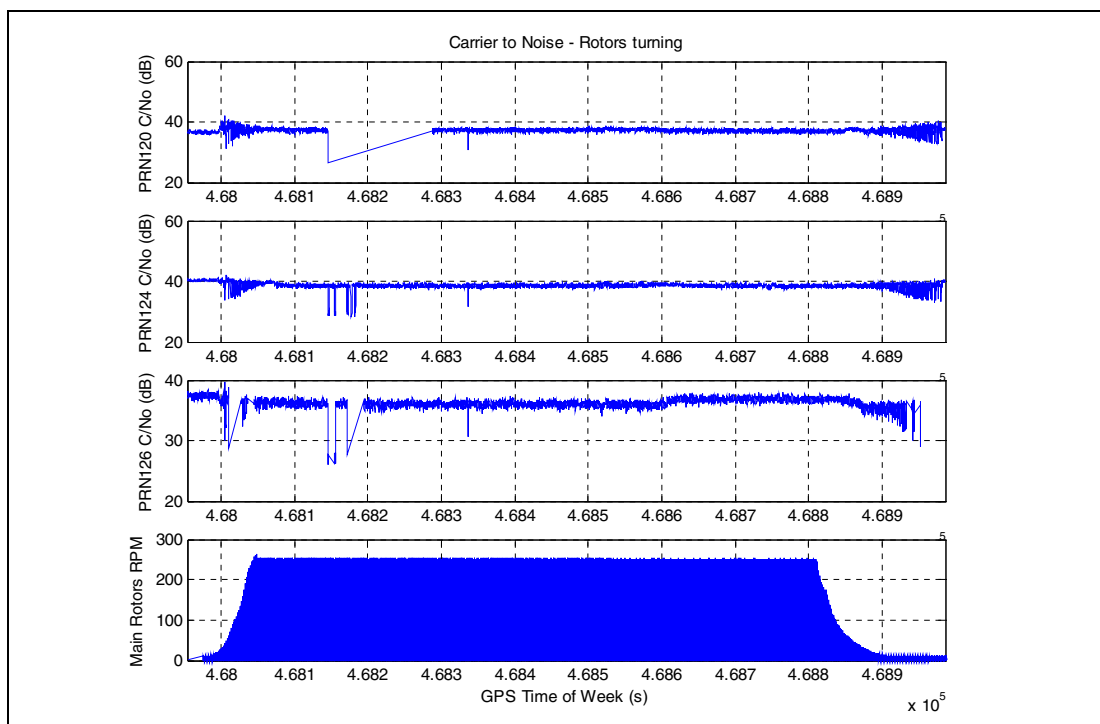
5.4.5 Figure 5.7 shows the measured CNo for each SBAS satellite during the first 'rotors turning' test. It can be seen that there would appear to be significant constructive and destructive interference effects on all satellite measurements as the rotors are turning slowly. This is due to masking of the signals by the rotor blades and shows that, as expected, the satellite signals pass through the plane of the main rotor. This causes a short duration loss of lock on PRN126. Additionally, when the rotors have been at full power for a couple of minutes there are significant drops in CNo resulting in a loss of lock on both PRN120 and PRN126. Only the higher powered PRN124 was tracked through this occurrence. It is not clear what the cause of this event was.

Figure 5.7 Measured CNo with rotors turning (trial 1)

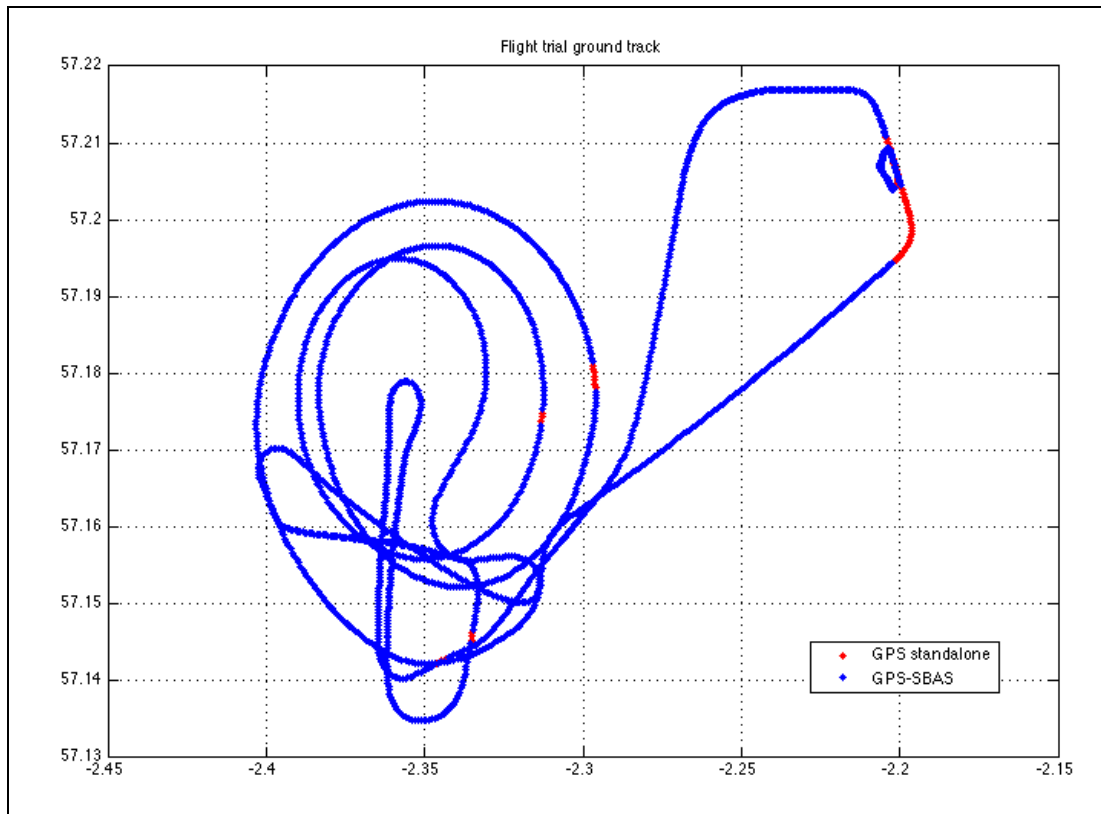
- 5.5.3 Further losses of SBAS positioning were noticed during orbits, during turns onto the SOAP approaches and also during the final landing manoeuvre as shown in Figure 5.14.

Figure 5.14 Flight trial ground track showing both SBAS and standalone GPS positions

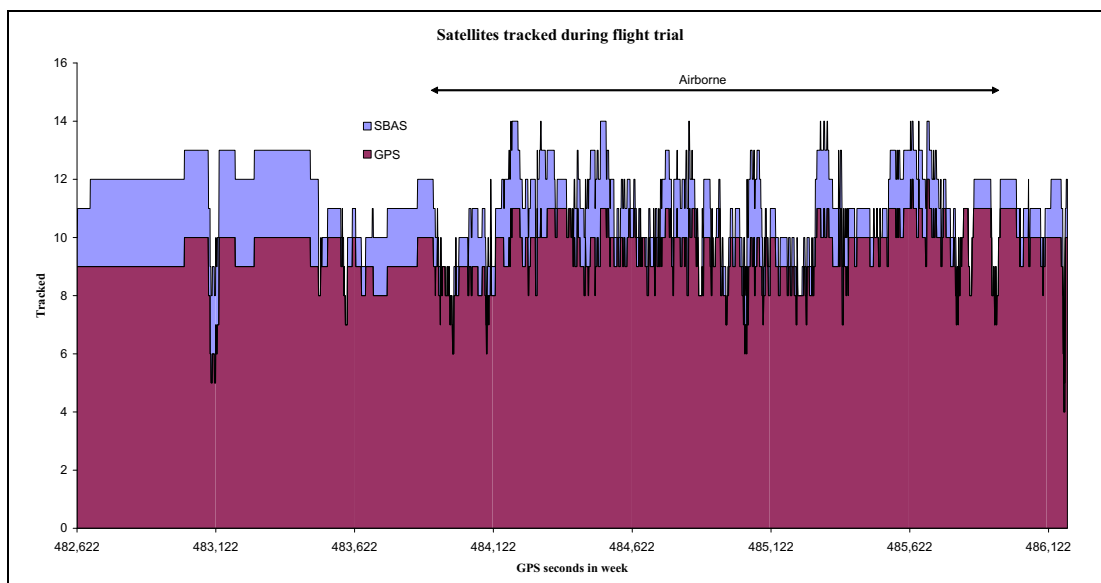
5.5.4 During the test flight the visibility of GPS satellites was excellent and when combined with the SBAS signals meant that the receiver never tracked fewer than seven satellites, generally with a good DOP – more than enough for en-route navigation through to non-precision approach guidance. During engine run up and ground taxiing all three SBAS signals were acquired and tracked without problems. As shown in Figure 5.15, the number of satellites tracked and used during taxi and flight ranged from seven satellite signals up to as many as 14 during a number of epochs.

Figure 5.15 Number of GPS and SBAS satellites tracked by time

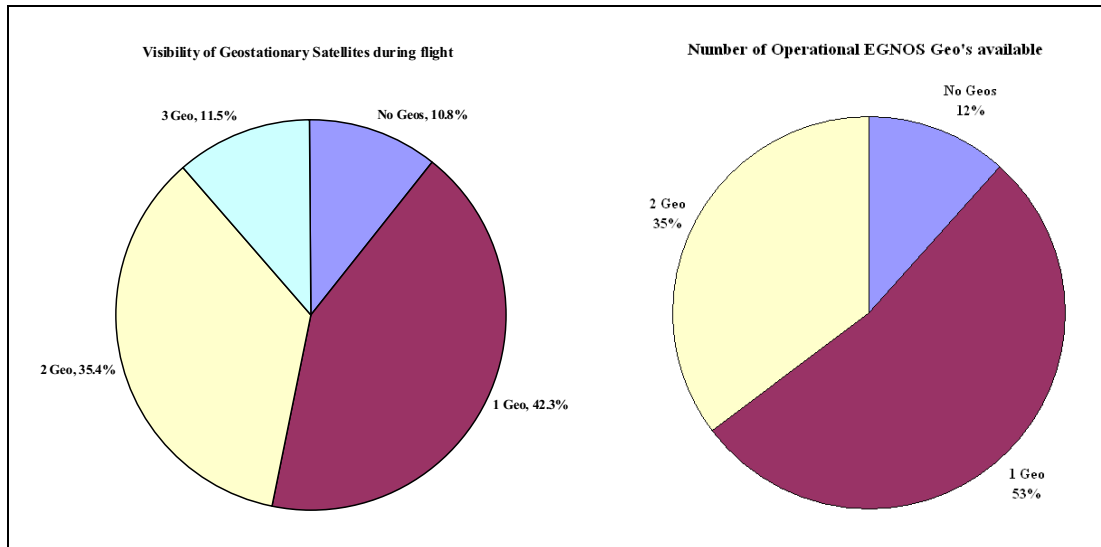
5.5.5 However, of concern in the visibility statistics is the actual visibility of GEO signals during the flight. Of the data points collected when the helicopter was airborne some 11% included no GEO signals, a further 42% saw only 1 GEO signal tracked with the remainder predominantly 2 GEOs (35%) with some 3 GEO tracking (11%). See Figure 5.16 below.

Figure 5.16 Number of satellites visible by proportion of airborne time

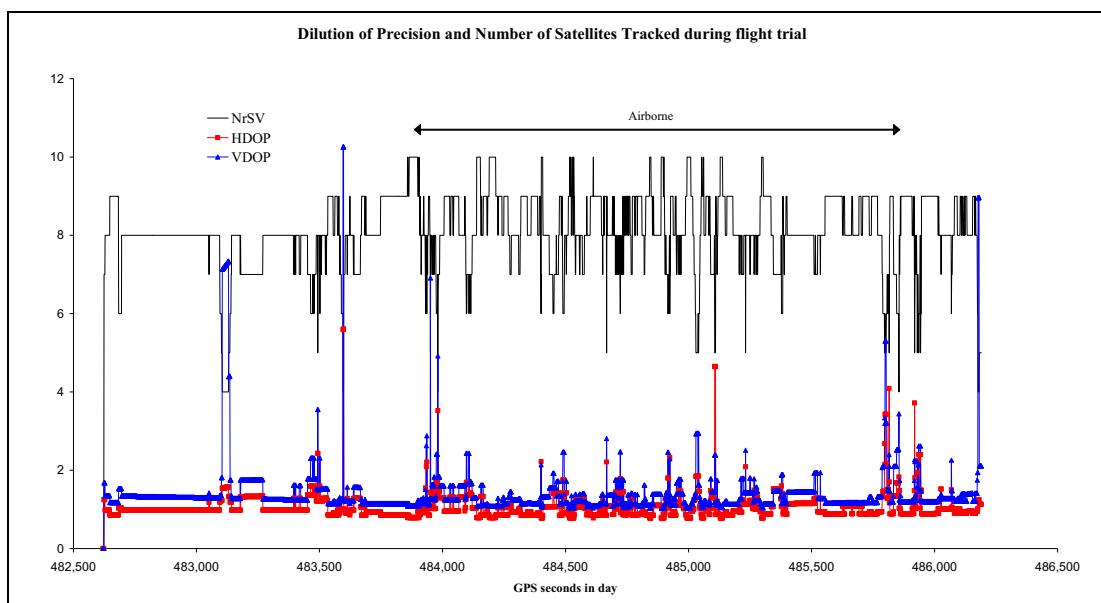
5.5.7 The impact of the high overall number of satellites tracked during the flight is to ensure that the measured Dilution of Precision (DOP) figures are low. This should, in turn, result in good overall performance in terms of accuracy. This is clearly illustrated in Figure 5.17, where the DOP values peak when the number of satellites momentarily dips due to aircraft manoeuvring.

Figure 5.17 Dilution of Precision and number of GPS satellites tracked during flight

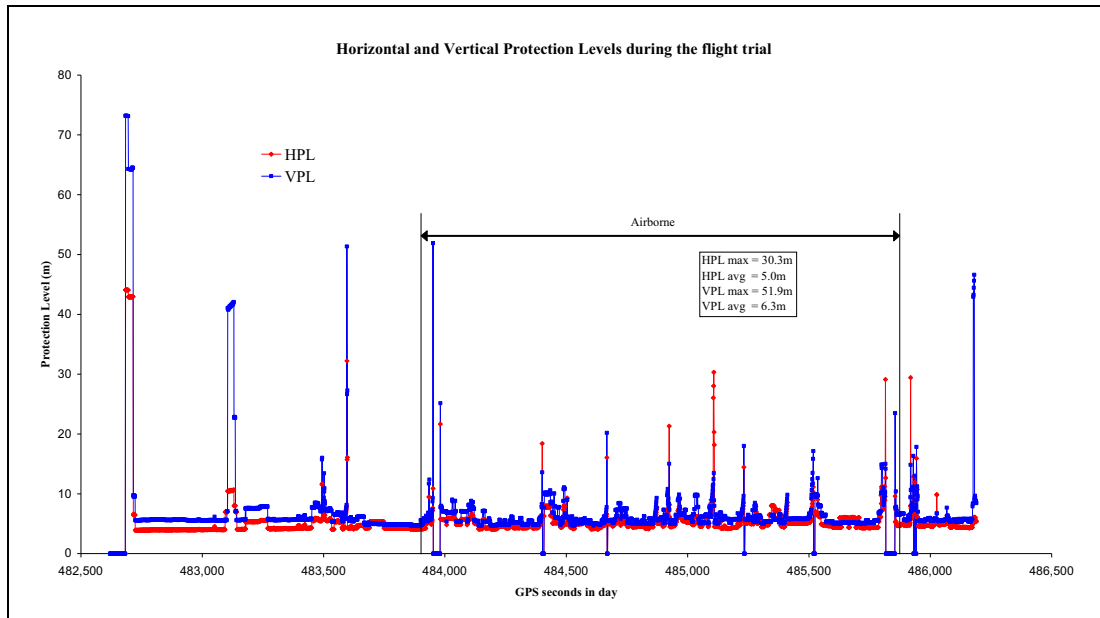
- 5.5.8 The measured horizontal and vertical protection levels (HPL/VPL) calculated by the Septentrio receiver were all comfortably within the requirements for APV approach operations when at least one SBAS GEO satellite was being tracked as shown in Figure 5.18. However, when no SBAS GEO satellites were available there were notable spikes in the protection levels that would result in alarm limits being exceeded for APV-II (20m VAL), LPV200 (35m VAL) and APV-I (50 m VAL) approach. During the SOAP approaches the protection levels were all comfortably within APV-II alert limits.

Figure 5.18 Horizontal and Vertical Protection Levels during flight

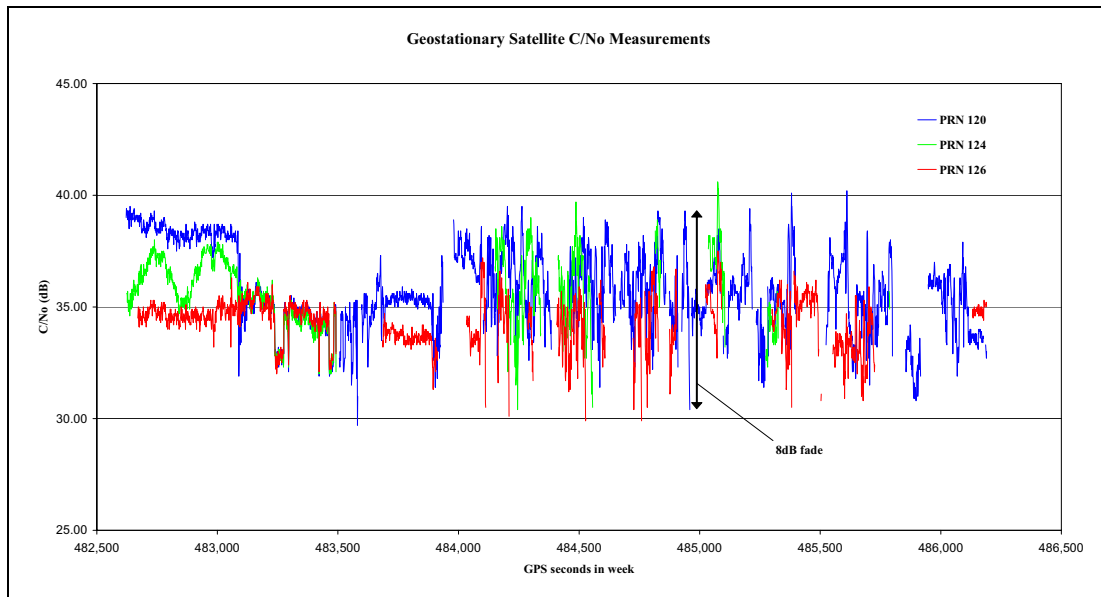
- 5.5.9 The Carrier-to-Noise (CNo) measurements for the Geostationary satellites were strong when the helicopter was stationary. The signals from PRN120 and 124 were higher than for PRN126 due to their higher elevation angles. The CNo measurements vary quite significantly during manoeuvring. This is to be expected, particularly as the passive helicopter antenna installed on the AS332L has a high gain roll-off at lower elevation angles that will accentuate variations in the received power levels. Figure 5.19 shows clear examples of deep fades in the CNo of the received signals. The figure also shows that the loss of tracking of the satellite signals occurs when the signals are formerly being received at high CNo, pointing to airframe masking as the root cause of the loss of lock. Note that the gaps in the traces are due to data loss and not loss of reception.

Figure 5.19 GEO Carrier-to-Noise measurements during flight

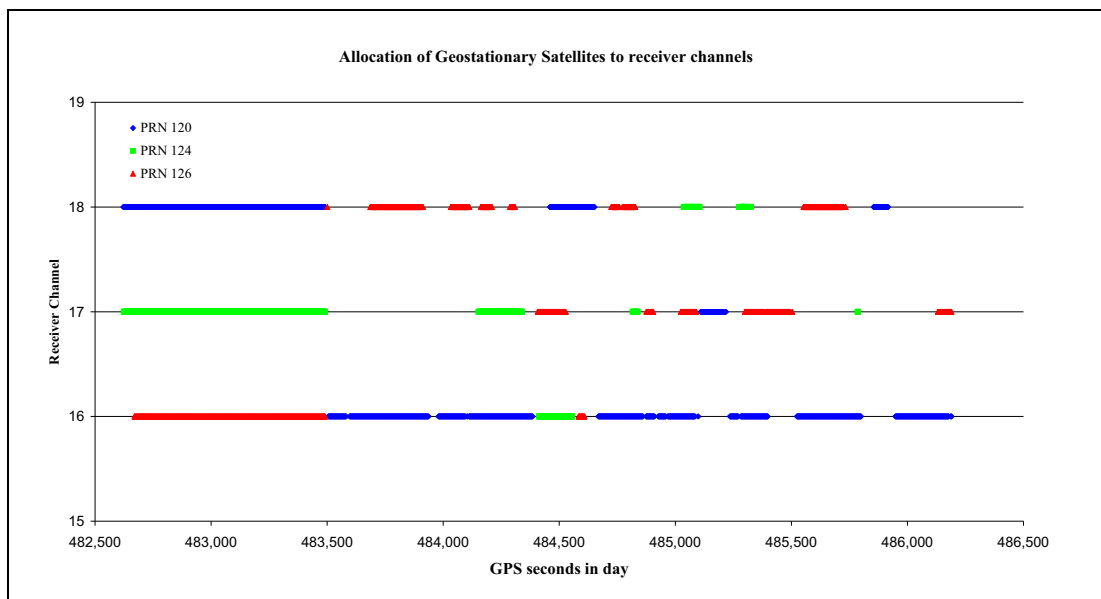
5.5.10 The receiver used for the flight test routinely searches for, acquires and tracks the visible SBAS satellite signals. Figure 5.20 shows that, initially, all three GEOs are being tracked by the receiver and, during the flight, the GEOs are then variously lost and re-acquired on different channels within the receiver.

Figure 5.20 Allocation of SBAS satellites to receiver channels

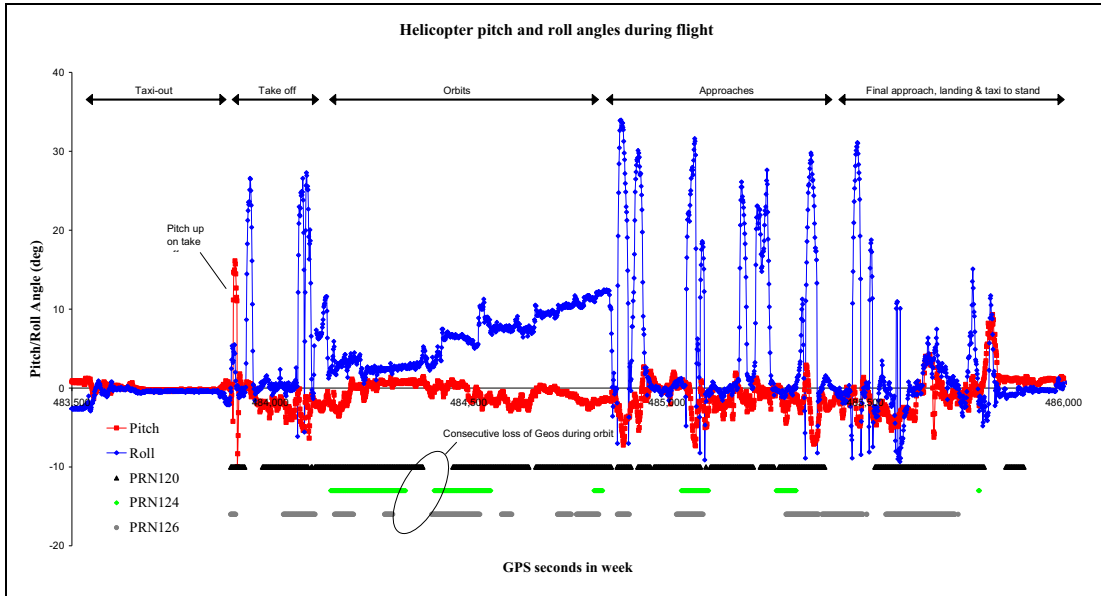
5.5.11 The loss of lock of GEO satellite signals can be correlated to the attitude of the helicopter during the flight. Figure 5.21 shows that an initial loss of lock occurs when the helicopter is located on the southerly runway at Aberdeen and lifts off with a nose high attitude. In this situation the engine cowling is clearly masking all of the GEO satellites.

Figure 5.21 Helicopter pitch and roll during flight

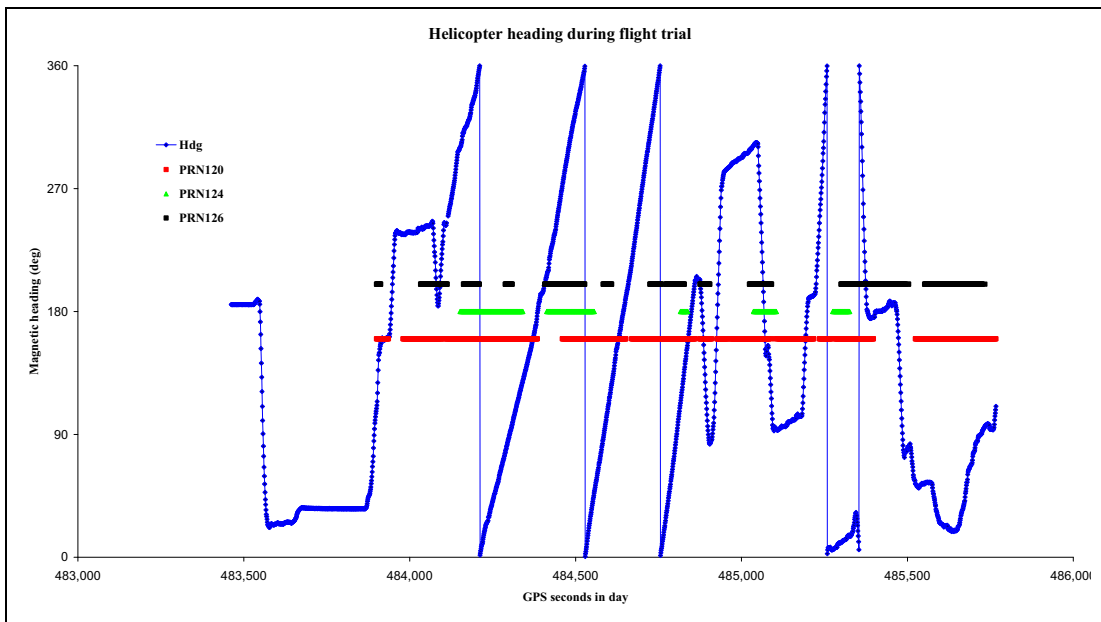
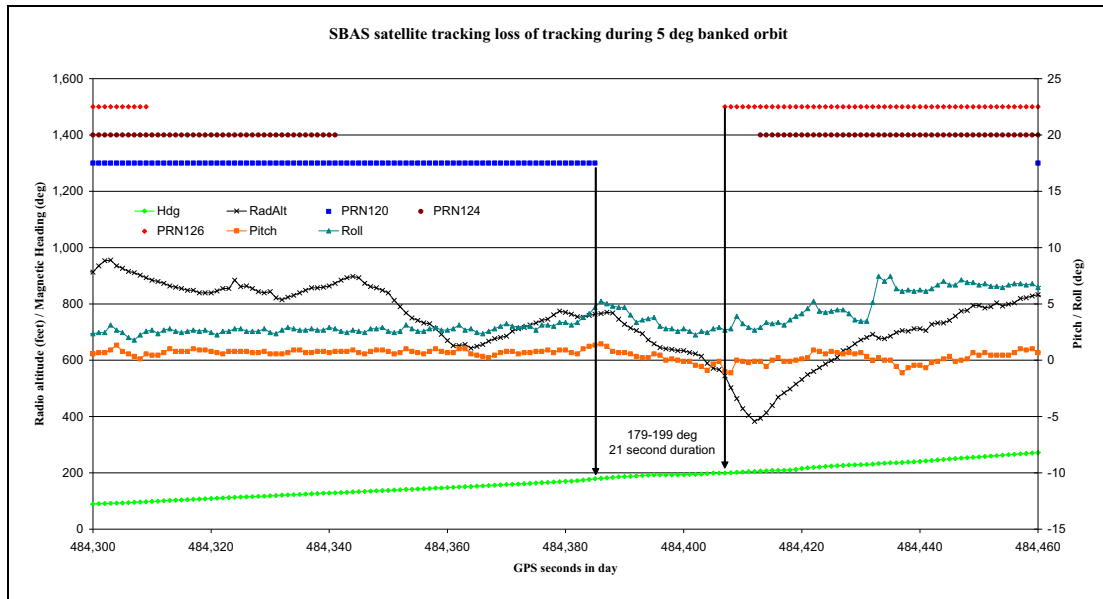
5.5.12 During the orbits the GEOs are dropped in sequence as the helicopter fuselage obscures each signal in turn (IOR–W (PRN126) then ARTEMIS (PRN124) then AOR–E (PRN120) for a clockwise orbit – see Figure 5.22. Figure 5.23 shows a closer examination of the loss of SBAS signals that occurred during the initial 5 degree bank clockwise orbit as the helicopter heading passed through due South. In total, a 21 second loss of all SBAS signals occurred, but each individual satellite signal is being lost for approximately 100 seconds. Here the benefit of a multi-satellite space segment helps to reduce the impact of the outage. At higher bank angles masking was also observed, albeit of a shorter duration.

Figure 5.22 Helicopter heading during flight

Figure 5.23 Loss of SBAS capability during orbit

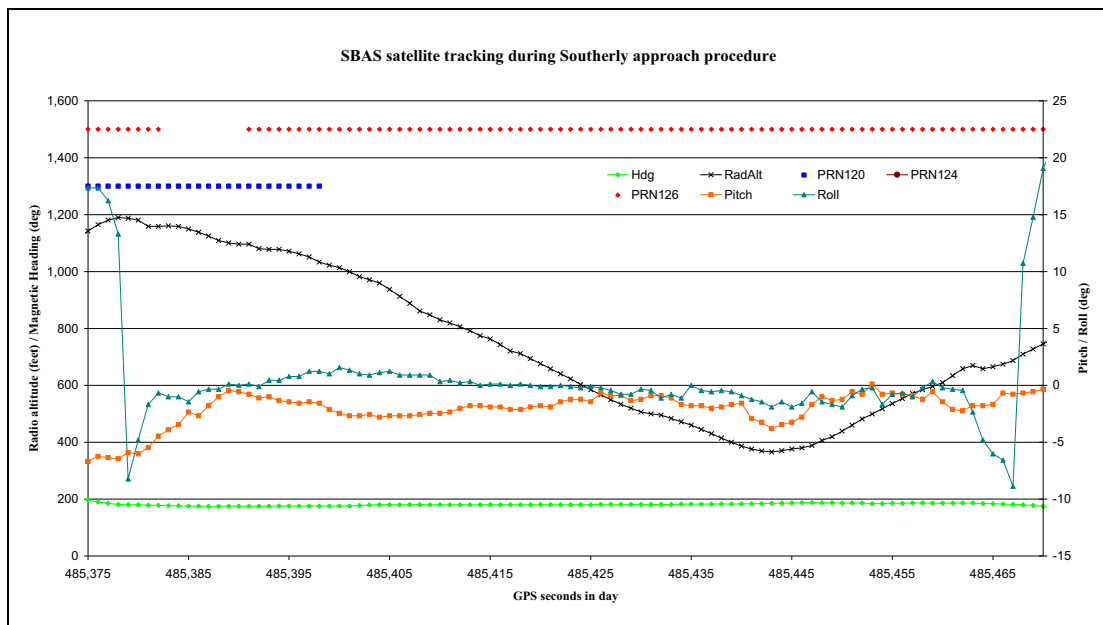
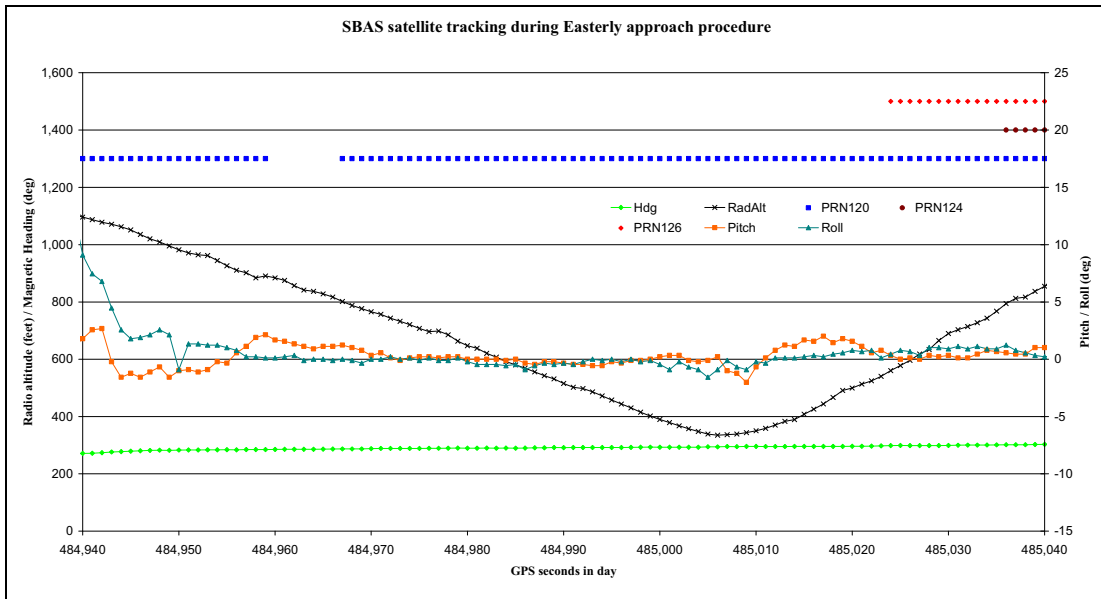
5.5.13 The tracking of SBAS GEO signals also varied during the simulated SOAP procedures as shown in Figures 5.24 to 5.27. Although there were no total outages of SBAS tracking there were instances of loss of lock on individual GEOs. As would be expected, the visibility of GEOs was significantly constrained when the approach was being flown to the South. Similarly, all GEOs were tracked during the approach to the North. Perhaps the most surprising observation was that the approaches to the East and West were entirely dependent upon the AOR-E (PRN 120) satellite for their SBAS capability. This could be due to the low antenna gain characteristics at low elevation angles resulting in successful tracking of the highest elevation satellite only.

Figure 5.24 SOAP procedure flown to the South

Figure 5.25 SOAP procedure flown to the North

Figure 5.26 SOAP procedure flown to the East

Figure 5.27 SOAP procedure flown to the West

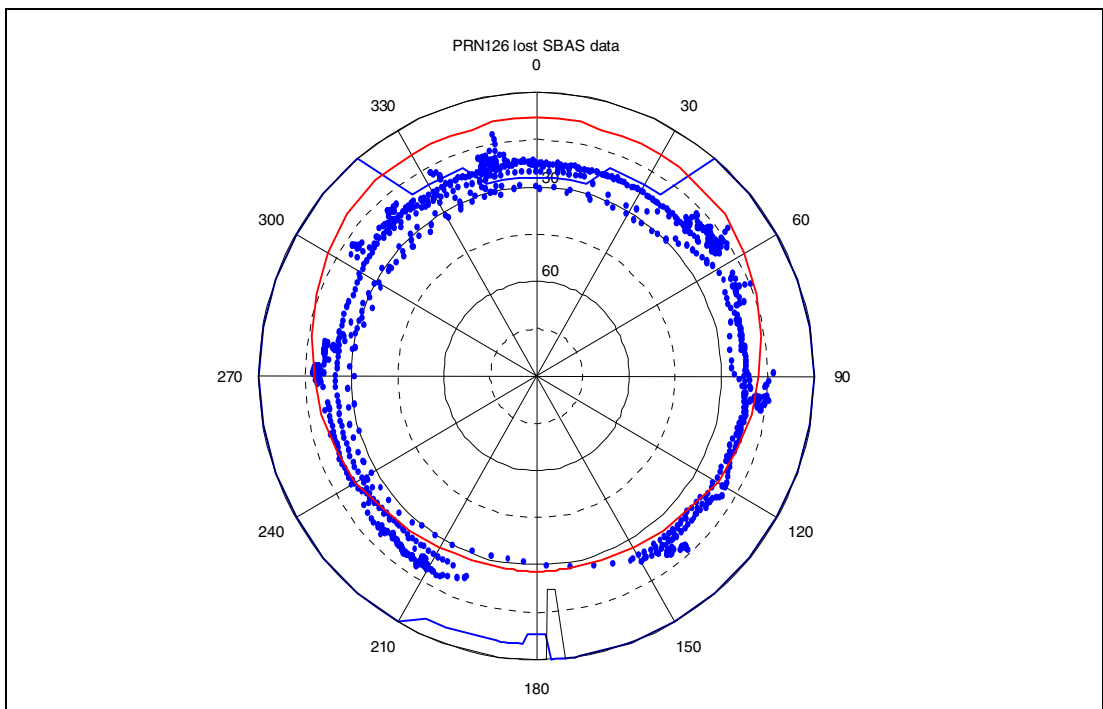
- 5.5.15 It is clear that, for the stronger signal from the PRN 120 satellite, a loss of signal tends to coincide with the location of the engine cowling ahead of the antenna. However, for the other two satellites the loss of signal tends to be largely independent of heading. This implies that loss of lock with lower power signals relates to more than just airframe masking, e.g. the effects of the main rotor – see CAA Paper 2003/7 [Ref 7].

Figure 5.28 PRN120 lost signals by elevation and azimuth

Figure 5.29 PRN124 lost signals by elevation and azimuth

Figure 5.30 PRN126 lost signals by elevation and azimuth

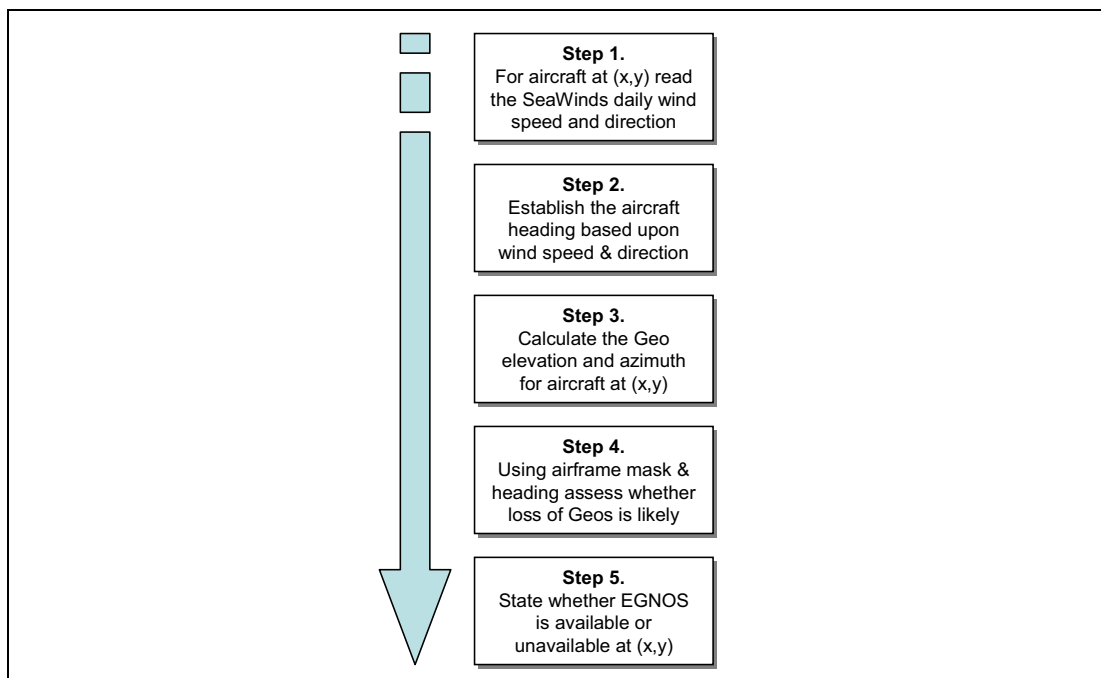
6.2.9 The simulation of EGNOS availability is calculated at a number of points on a 0.25° x 0.25° degree grid across the North Sea as illustrated in Figure 6.3. For each day during the period 2000 through to 2008 it calculates an estimate of the availability of EGNOS across the entire region as well as at each grid point.

Figure 6.3 Overview of processing steps

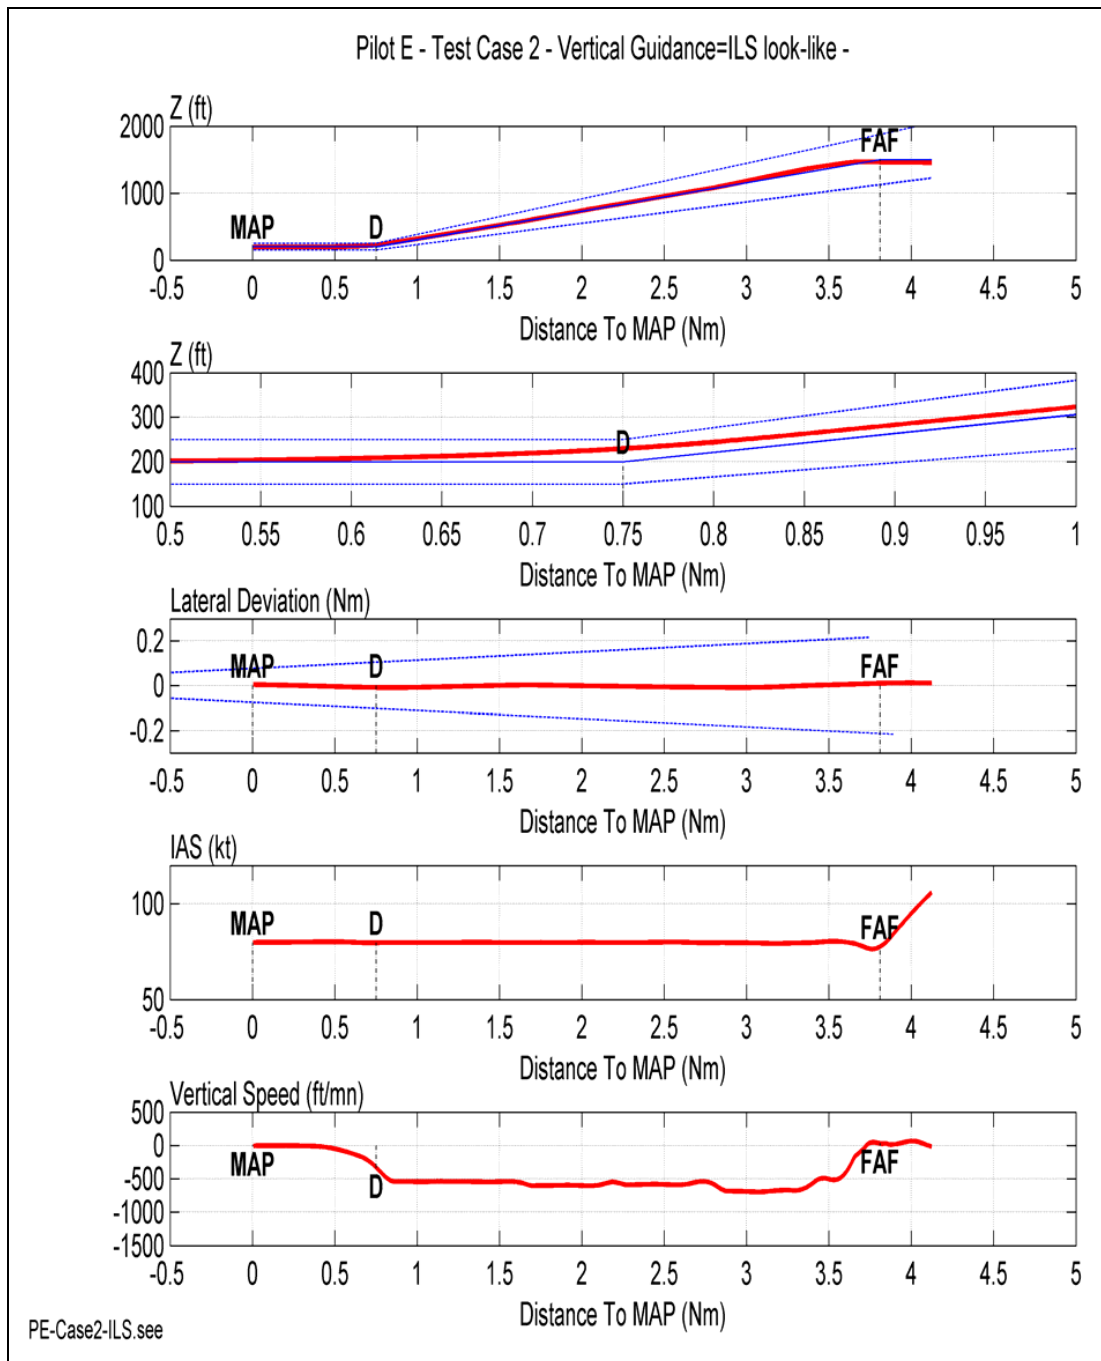
Figure B.1 Simulation results FAF to MAP – Test case 2

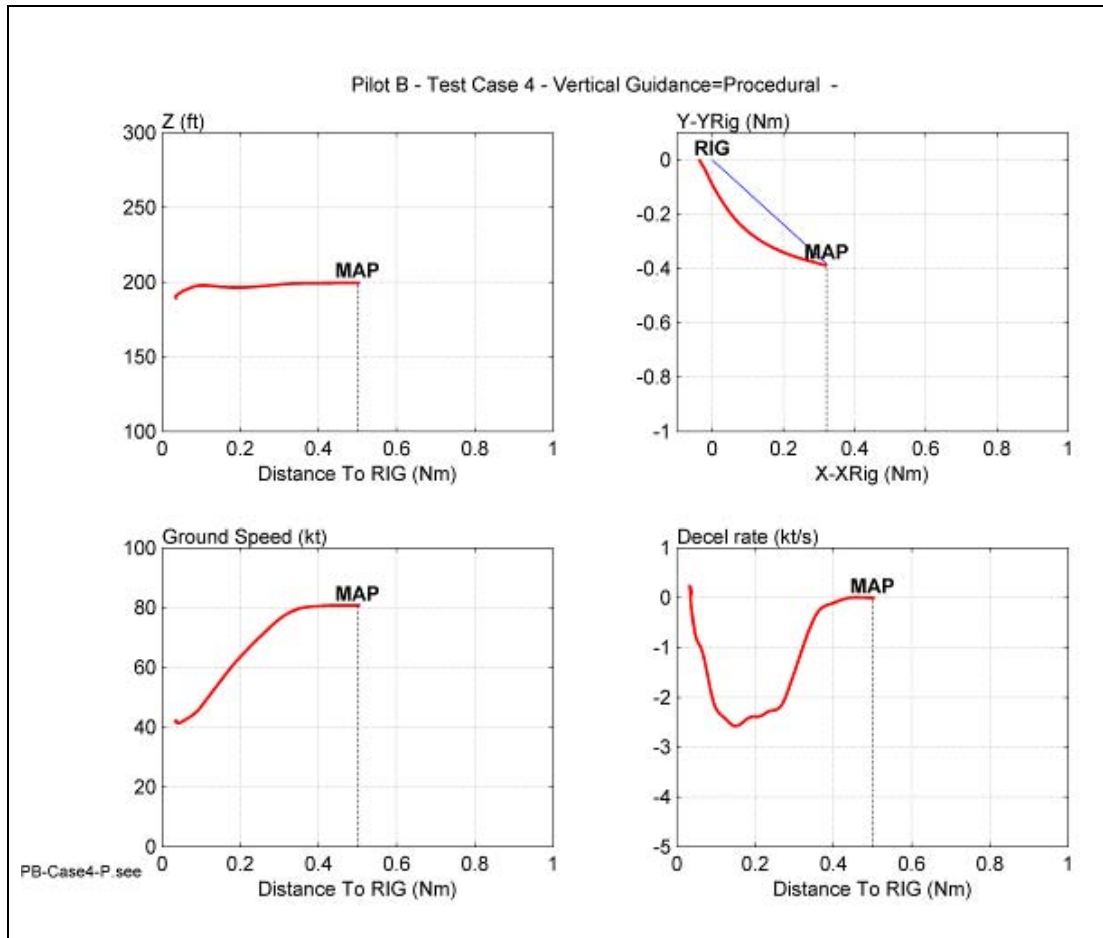
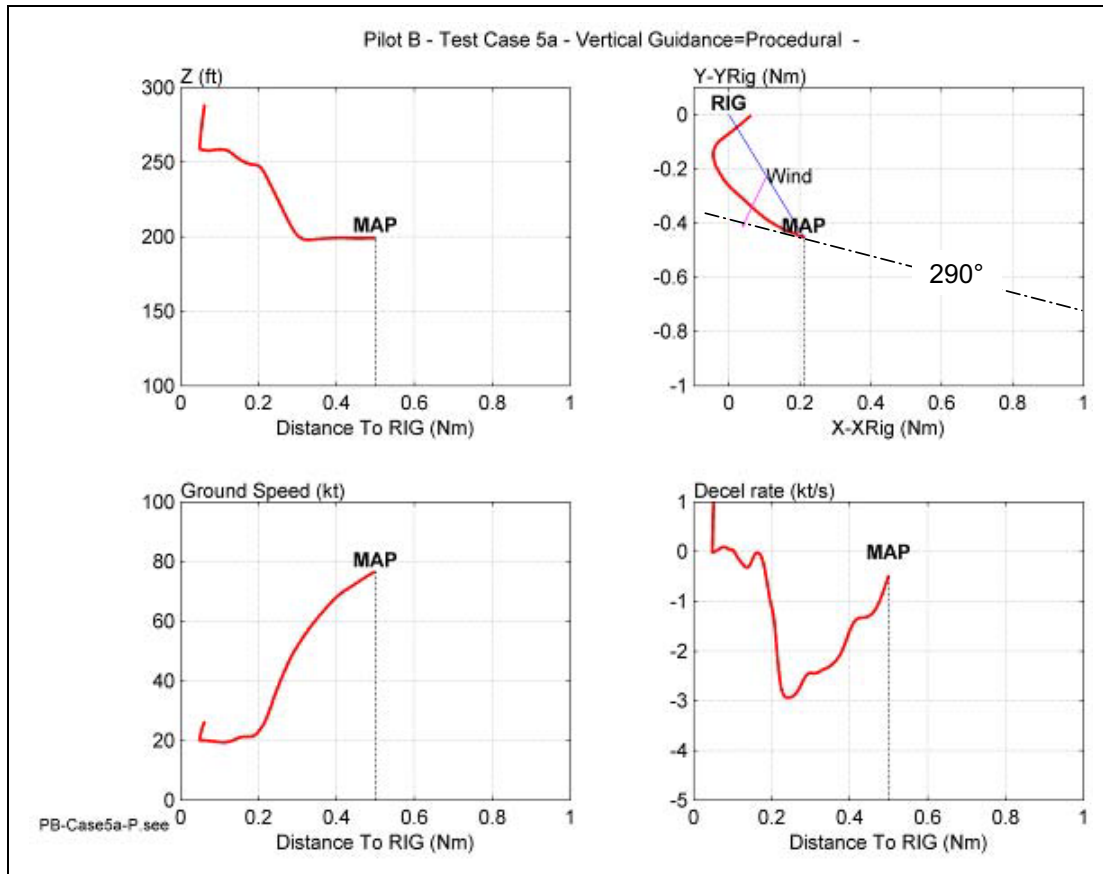
Figure B.7 Simulation results MAP to RIG – Test case 4

Figure B.8 Simulation results MAP to RIG – Test case 5a

Figure B.9 Simulation results MAP to RIG – Test case 7a

Figure B.10 Simulation results MAP to RIG – Test case 8
