NATS

Edinburgh Simulator Validation Report

Version 2.1 – 20 July 2018

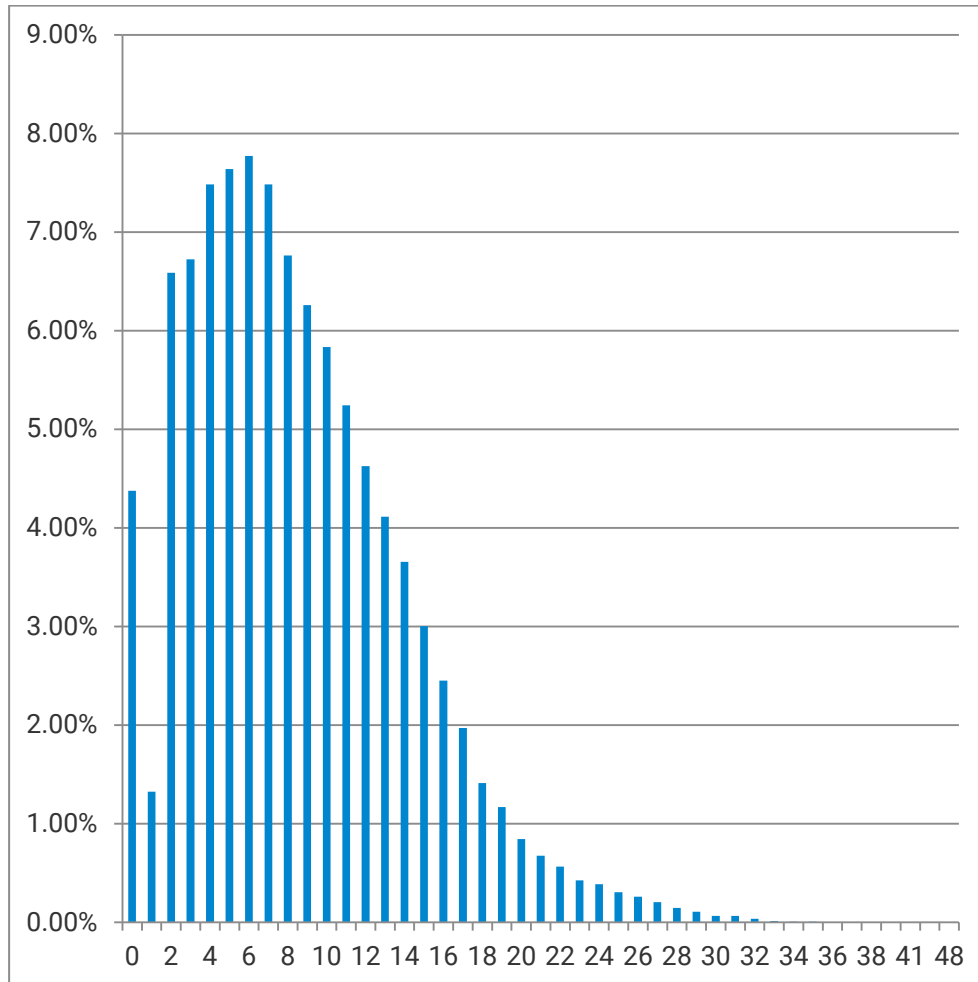
Figure 2: Wind Speed (kts)

As can be seen from Figure 2, winds rarely go above 30kts with wind speeds averaging 8.5kts over this period. For the purposes of testing the procedures in the most extreme conditions we have used a maximum wind speed of 30kts. For “worst case” climb conditions we have therefore used 30kts for the crosswind. For “best case” climb conditions we have used 30kts for the average headwind.

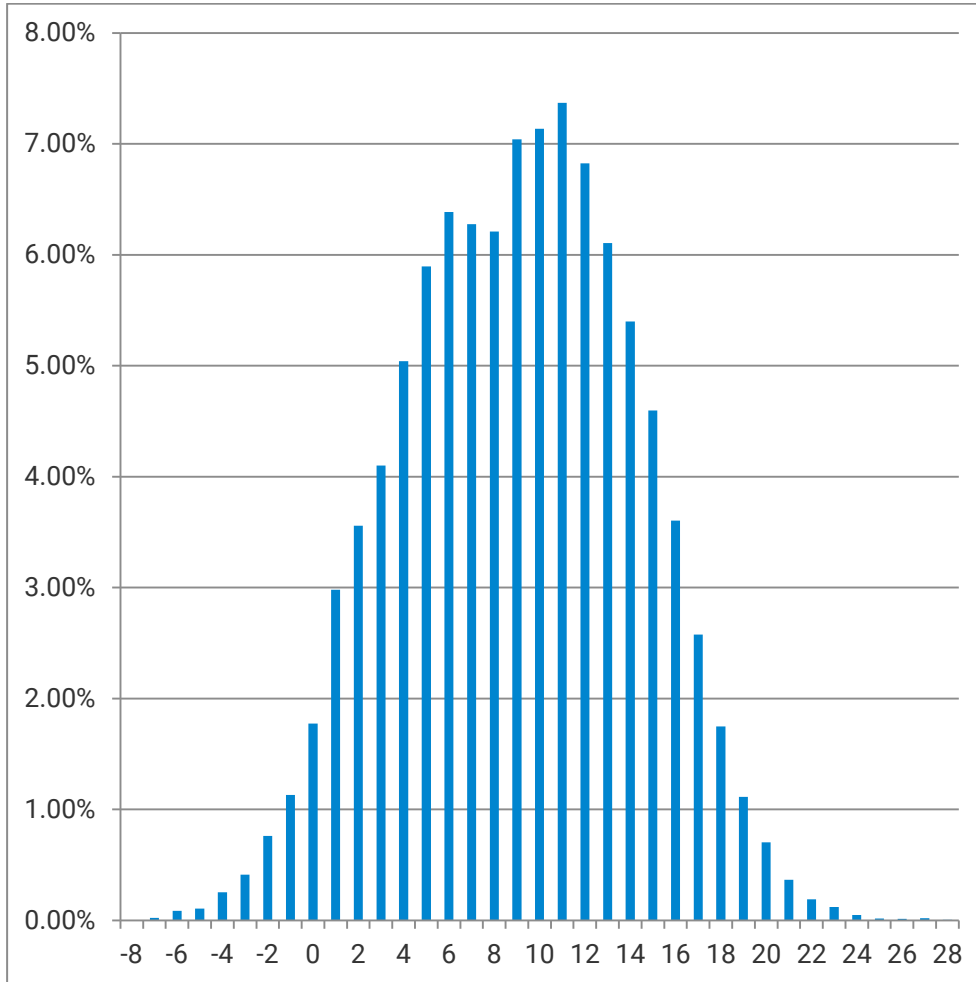
Figure 3: Surface Temperature (°C)

As can be seen from Figure 3, the surface temperature rarely goes below -5°C or above 25°C with an average temperature of 9°C . For the purposes of testing the procedures in the most extreme conditions we have used a minimum temperature of -5°C and a maximum temperature of 25°C . Although the average temperature is 9°C we have used the International Standard Atmosphere (ISA) temperature at mean sea level (MSL) of 15°C for the “base case” scenarios.

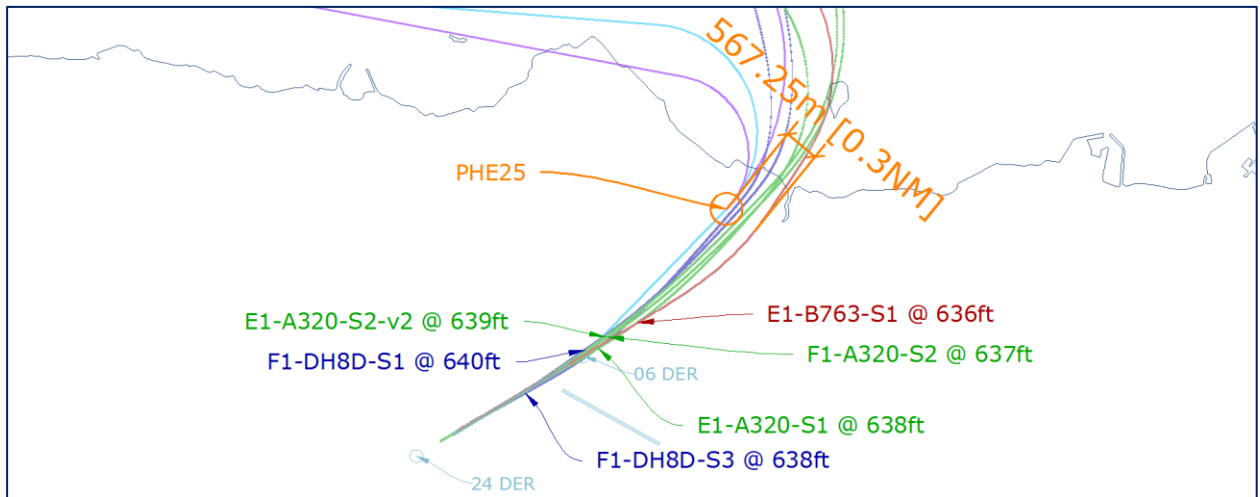
Figure 5: Routes E and F Option 1 Tracks

Figure 5 shows the tracks recorded for the A320, DH8D, and B763 for Route E Option 1 and Route F Option 1. The A320 tracks are in green, the B763 tracks are in red, and the DH8D tracks are in dark blue. The expected average track is in light blue and the expected swathe is in purple. Waypoints and notes are in orange. Figures 6-8 show the screenshots from the B738 runs.

These results show that, while the route is flyable for the B738 and DH8D, waypoint PHE25 is too close to the DER for some aircraft types to achieve, particularly in heavy weight conditions. This option is therefore not being taken forward for inclusion in the ACP.

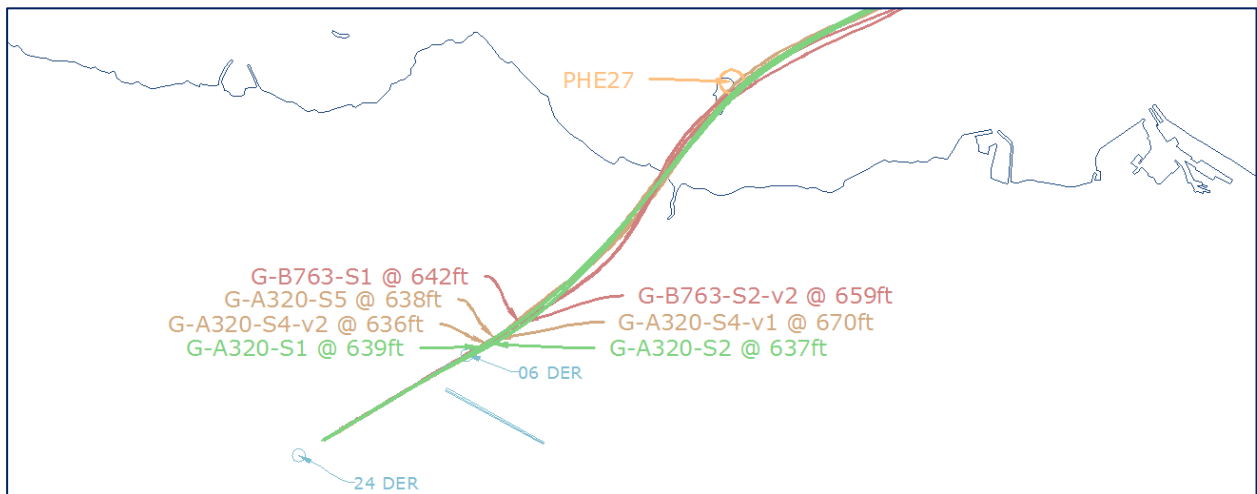
Figure 22: Route G Tracks

Figure 22 shows the tracks recorded for the Initial A320, Supplemental A320, and B763 for Route G. The Initial A320 tracks are in green, the Supplemental A320 tracks are in brown, and the B763 tracks are in red. The desired average track is in light blue and waypoints and notes are in orange.

While this route was found to be flyable, the CAA raised concerns about the possibility of aircraft initiating their first turn before the DER and requested that the initial legs be redesigned to prevent this possibility. Six possible coding options were considered and assessed in sessions 10 and 11. (See sections 6.25 to 6.30.) Of those, “KRAGY 1U” was considered to be the preferred option and was found to be flyable.

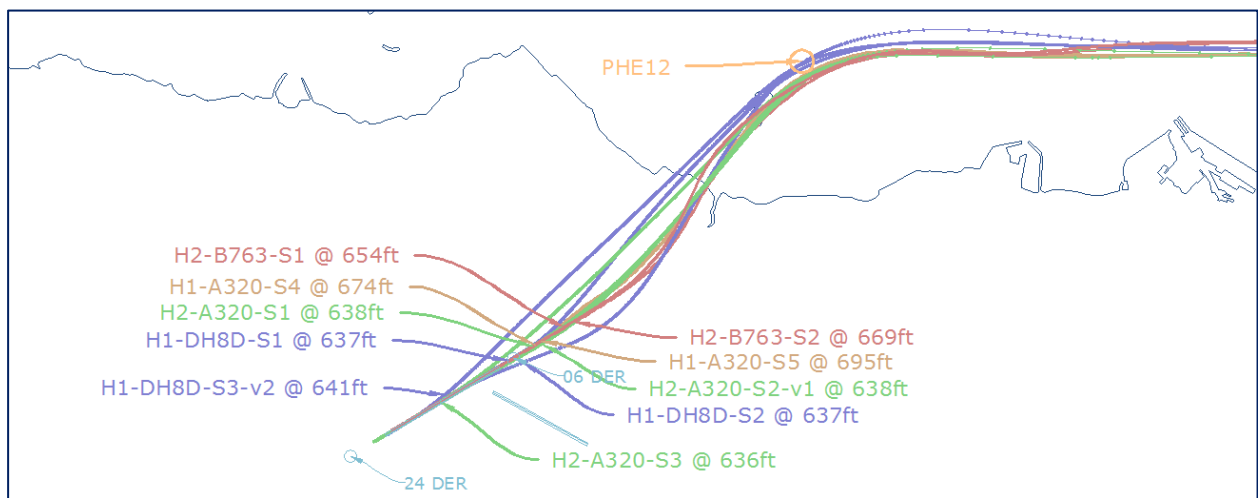
Figure 23: Routes H1 and H2 Tracks

Figure 23 shows the tracks recorded for the Initial A320, Supplemental A320, DH8D, and B763 for Route H1 and Route H2. The Initial A320 tracks are in green, the Supplemental A320 tracks are in brown, the B763 tracks are in red, and the DH8D tracks are in dark blue. The desired average track is in light blue and waypoints and notes are in orange.

While this route was found to be flyable, the CAA raised concerns about the possibility of aircraft initiating their first turn before the DER and requested that the initial legs be redesigned to prevent this possibility. Six possible coding options were considered and assessed in sessions 10 and 11. (See sections 6.25 to 6.30.) Of those, “KRARY 1U” was considered to be the preferred option and was found to be flyable.

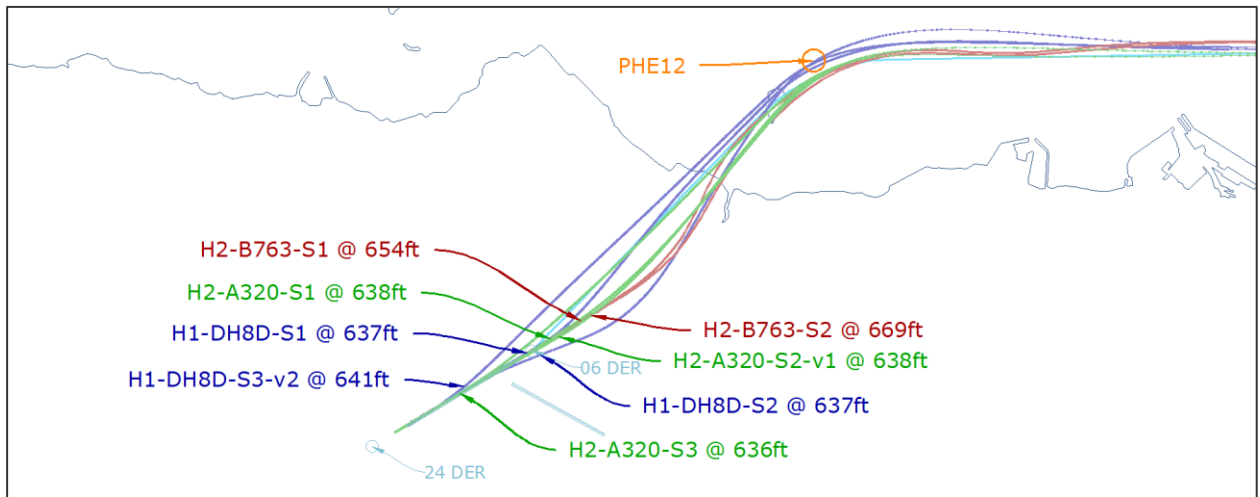
Figure 24: Routes H1 and H2 Tracks

Figure 24 shows the tracks recorded for the A320, DH8D, and B763 for Route H1 and Route H2. The A320 tracks are in green, the B763 tracks are in red, and the DH8D tracks are in dark blue. The desired average track is in light blue and the waypoints and notes are in orange. Figures 25-27 show the screenshots from the B738 runs.

While this route was recorded as “Not Acceptable” by the B763, both run H2-B763-S1 and H2-B763-S2 are noted as being on track (or within 0.1NM of the waypoint) at PHE29. It seems strange that the aircraft was able to fly the route successfully in both maximum weight scenarios but had problems in the minimum weight scenario.

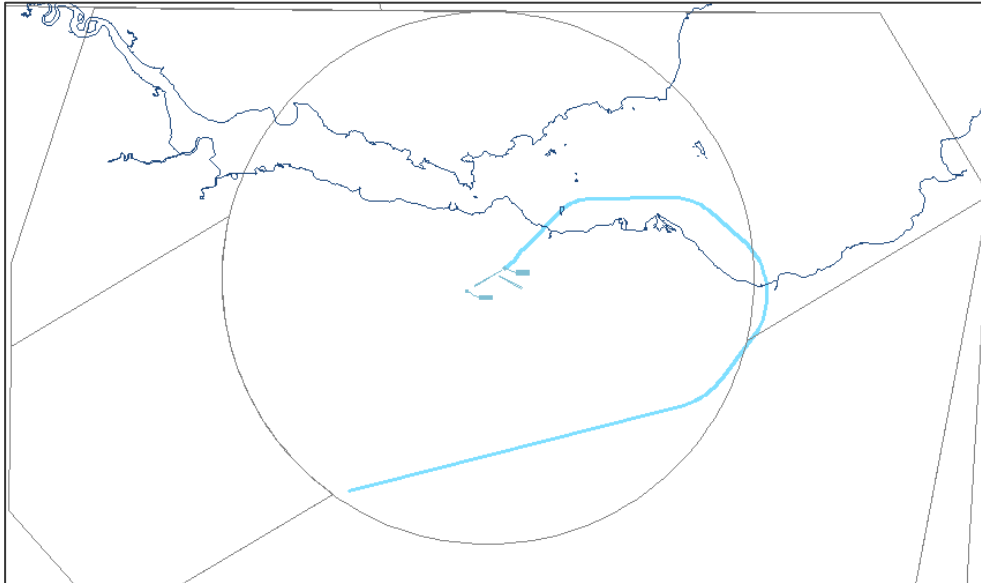
6.27. KRAGY 1W

Description:	Replacement for TALLA 6D SID (Non-Jet Only)	
Purpose:	For departure from runway 06 to the south via TALLA, non-jets from 0600-2259 all aircraft types 2300-0559, using a fly-over waypoint at the DER followed by a 15° offset CF leg	
Aircraft Types:	AT76, D328, DH8D	
	Scenario 7	Scenario 8
Wind Direction:	330°	Still
Wind Speed:	30kts	Still
Surface Temp:	25°C	15°C
Pressure:	980hPa	1013.2hPa
Aircraft Weight:	MTOW	Average
Objective:	Can level restrictions be met in worst case climb conditions	Average conditions
A320 Run ID:	KW-A320-S7	KW-A320-S8
B738 Run ID:	KW-B738-S7	KW-B738-S8
Notes:	• Assume climb clearance to FL240

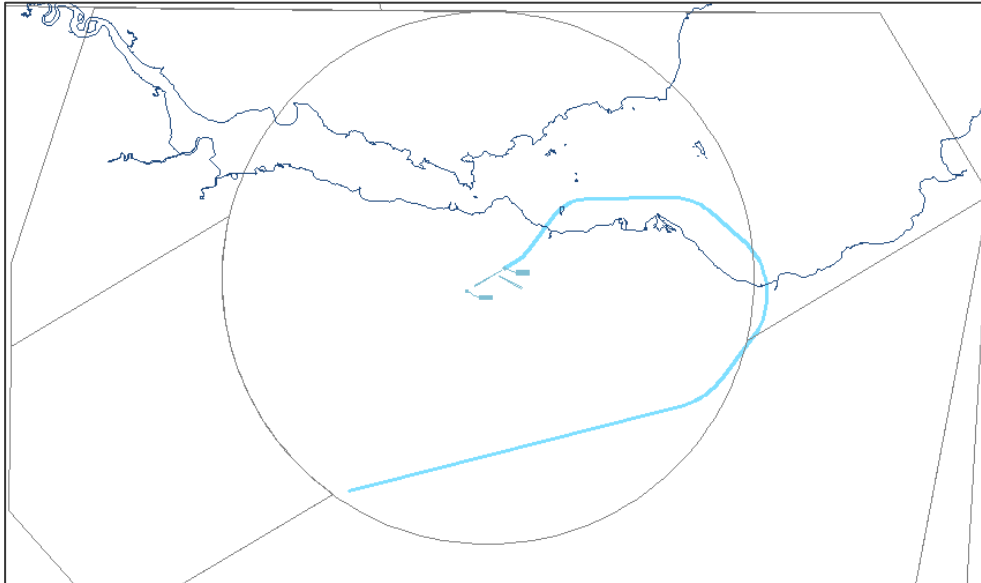
6.28. KRAGY 1X

Description:	Replacement for TALLA 6D SID (Non-Jet Only)	
Purpose:	For departure from runway 06 to the south via TALLA, non-jets from 0600-2259 all aircraft types 2300-0559, using a fly-over waypoint 0.5NM after the DER followed by a DF leg	
Aircraft Types:	AT76, D328, DH8D	
	Scenario 7	Scenario 8
Wind Direction:	330°	Still
Wind Speed:	30kts	Still
Surface Temp:	25°C	15°C
Pressure:	980hPa	1013.2hPa
Aircraft Weight:	MTOW	Average
Objective:	Can level restrictions be met in worst case climb conditions	Average conditions
A320 Run ID:	KX-A320-S7	KX-A320-S8
B738 Run ID:	KX-B738-S7	KX-B738-S8
Notes:	<ul style="list-style-type: none"> Assume climb clearance to FL240

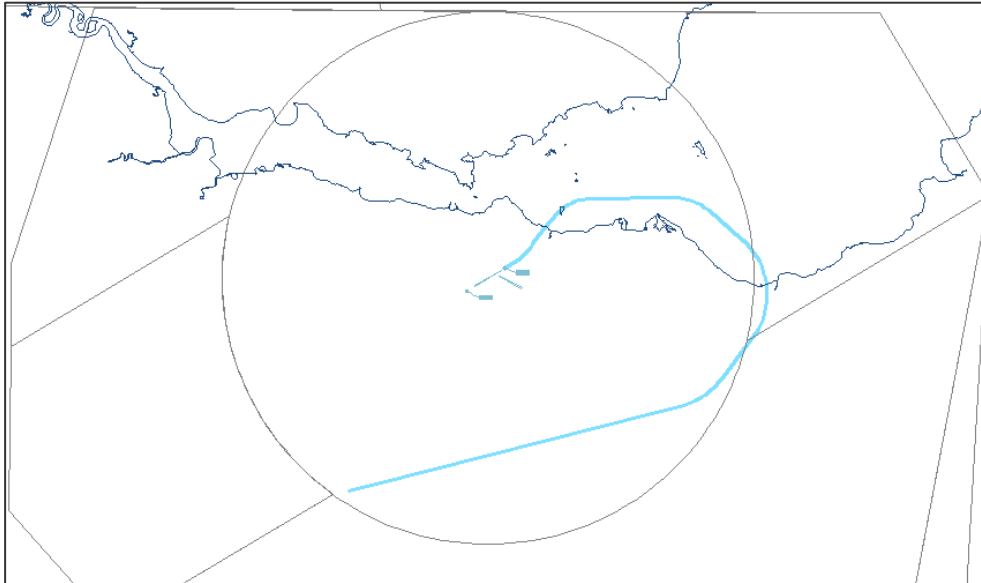
6.29. KRAGY 1Y

Description:	Replacement for TALLA 6D SID (Non-Jet Only)	
Purpose:	For departure from runway 06 to the south via TALLA, non-jets from 0600-2259 all aircraft types 2300-0559, using a fly-over waypoint 0.5NM after the DER followed by an 18° offset CF leg	
Aircraft Types:	AT76, D328, DH8D	
	Scenario 7	Scenario 8
Wind Direction:	330°	Still
Wind Speed:	30kts	Still
Surface Temp:	25°C	15°C
Pressure:	980hPa	1013.2hPa
Aircraft Weight:	MTOW	Average
Objective:	Can level restrictions be met in worst case climb conditions	Average conditions
A320 Run ID:	KY-A320-S7	KY-A320-S8
B738 Run ID:	KY-B738-S7	KY-B738-S8
Notes:	<ul style="list-style-type: none"> Assume climb clearance to FL240

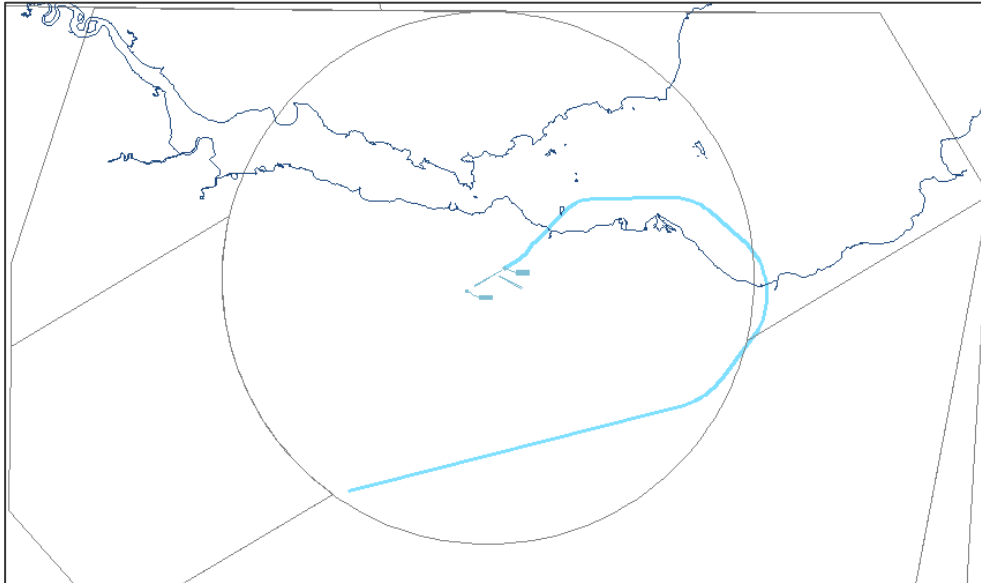
6.30. KRAGY 1Z

Description:	Replacement for TALLA 6D SID (Non-Jet Only)	
Purpose:	For departure from runway 06 to the south via TALLA, non-jets from 0600-2259 all aircraft types 2300-0559, using a fly-over waypoint 0.5NM after the DER followed by a 15° offset CF leg	
Aircraft Types:	AT76, D328, DH8D	
	Scenario 7	Scenario 8
Wind Direction:	330°	Still
Wind Speed:	30kts	Still
Surface Temp:	25°C	15°C
Pressure:	980hPa	1013.2hPa
Aircraft Weight:	MTOW	Average
Objective:	Can level restrictions be met in worst case climb conditions	Average conditions
A320 Run ID:	KZ-A320-S7	KZ-A320-S8
B738 Run ID:	KZ-B738-S7	KZ-B738-S8
Notes:	<ul style="list-style-type: none"> Assume climb clearance to FL240
