Class A HTAWS Warning Annunciation

November 2018

Class A HTAWS

Review of Alerting

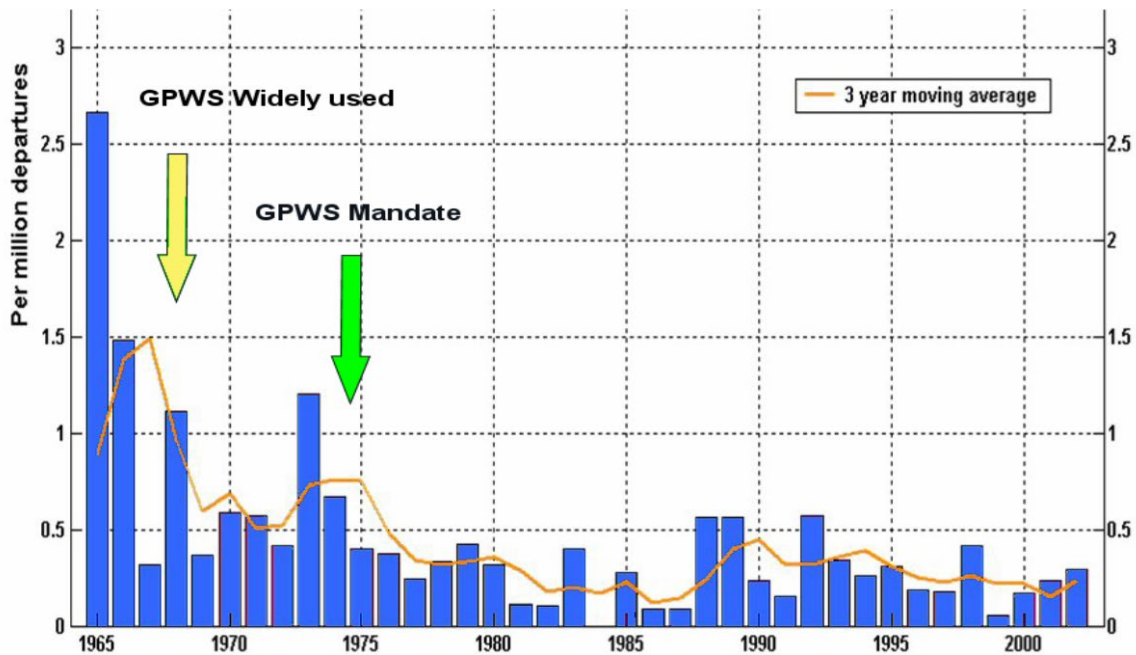
Figure 2.1 – CFIT accident rate for fixed-wing aircraft from 1965-2000 showing GPWS introduction (Gurney, 2006)

TAWS has been required for aeroplanes carrying more than 9 passengers and with a MTOW above 5.7 Tonnes operated in commercial air transport since 2001, while basic GPWS had been required since the 1970s. This equipment has considerably reduced the number of CFIT accidents. Figure 2.1 (Gurney, 2006) shows the CFIT accident rate for fixed wing aircraft from 1965 – 2000 together with the points at which GPWS was adopted and mandated.

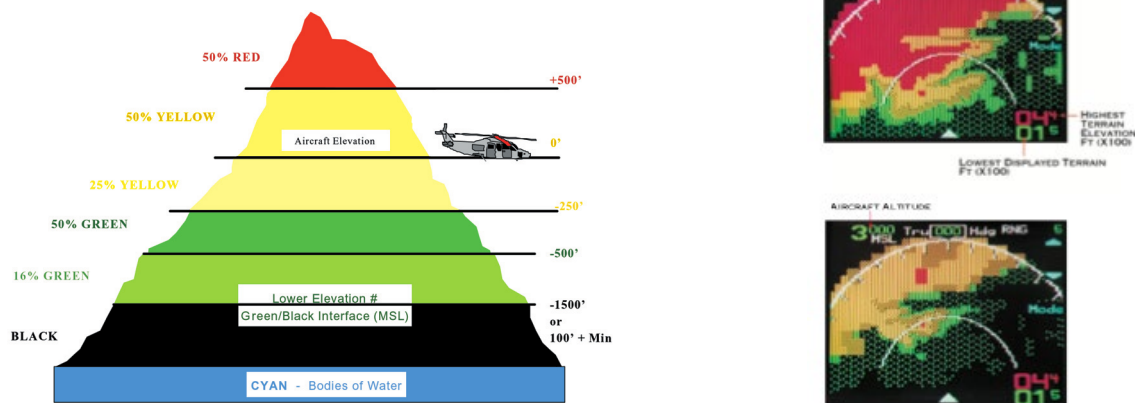
Figure 2.2 – Example of map colouring on Type XXII (Honeywell, 2004)

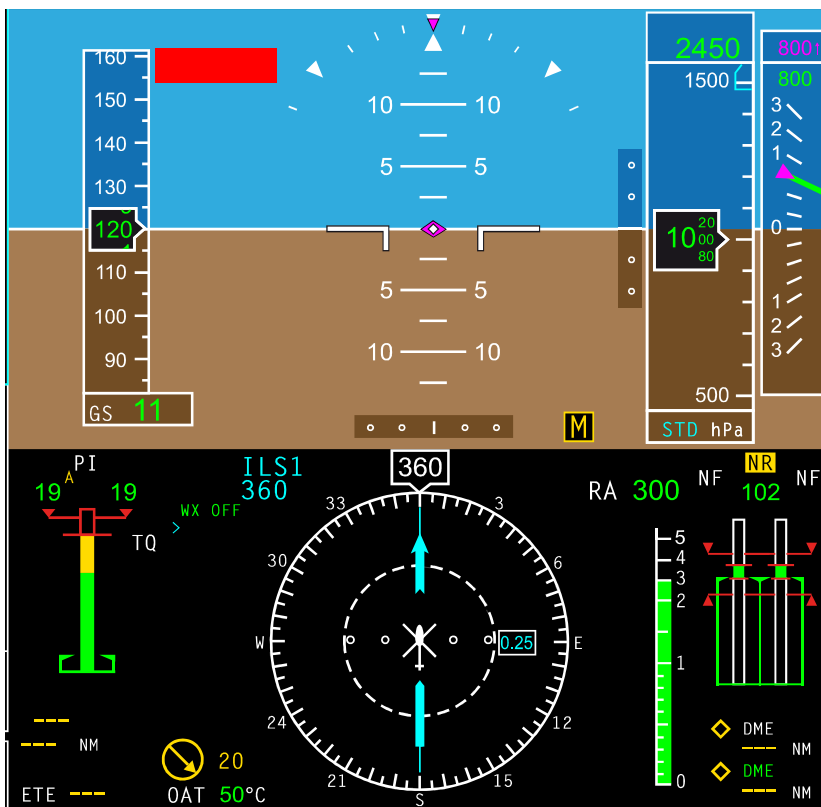
Figure 4.3 – Position and text of red TAWS Warning messages on PFD

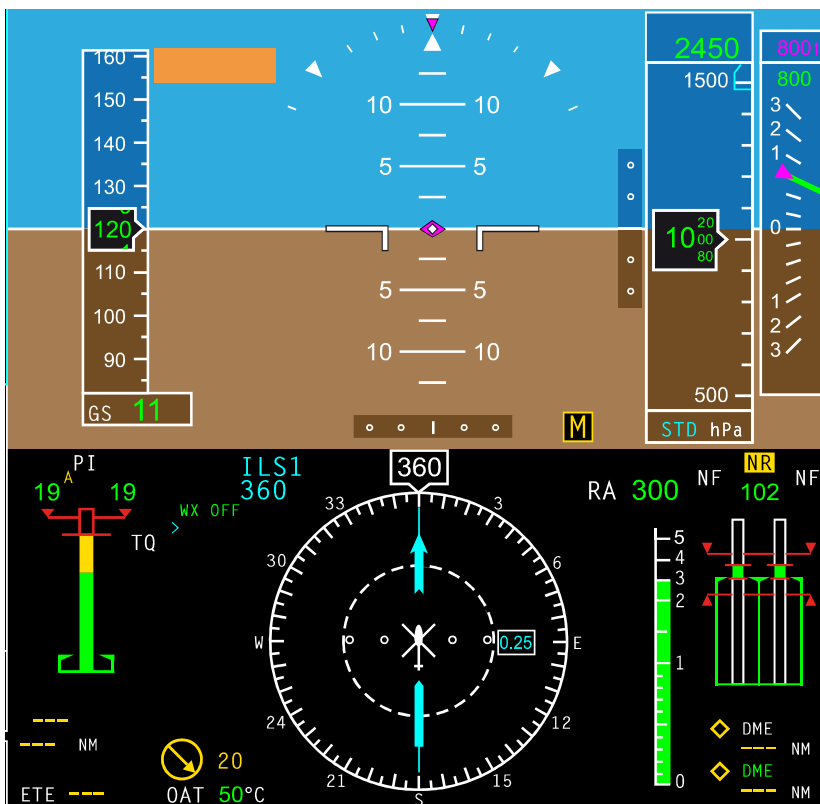
Figure 4.4 – Position and text of amber TAWS Caution messages on PFD

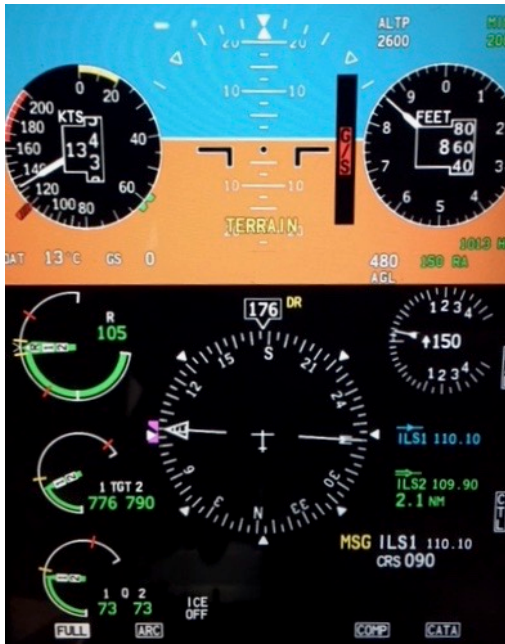
Figure 4.5 Terrain Caution full screen

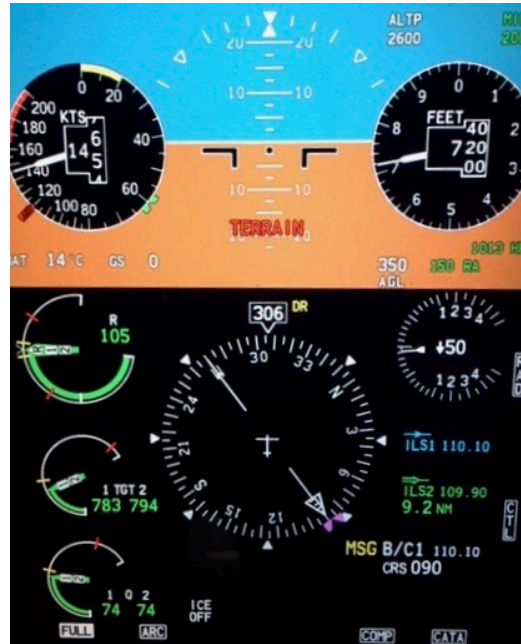
Figure 4.6 Terrain Warning full screen

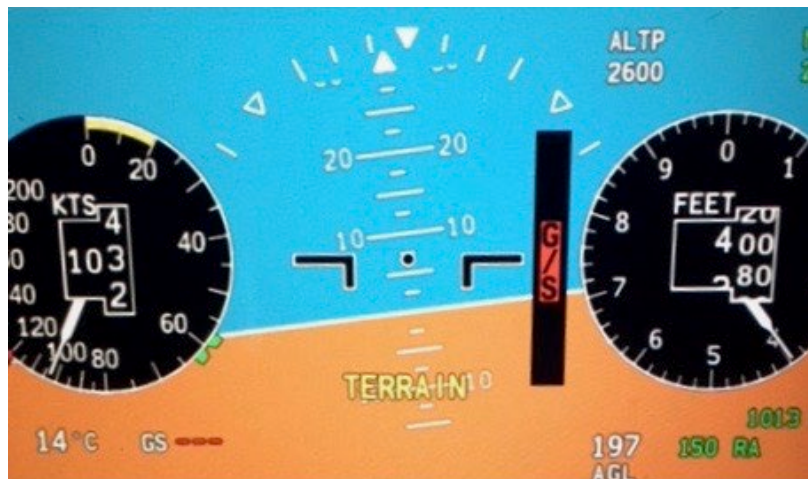
Figure 4.7 – Terrain Caution Expanded

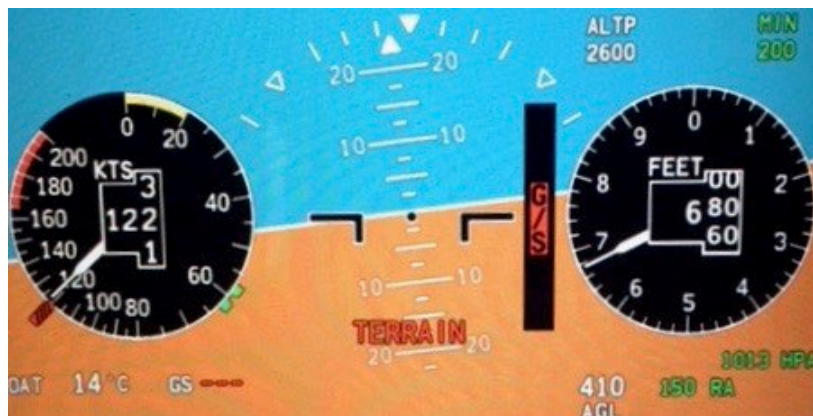
Figure 4.8 Terrain Warning Expanded

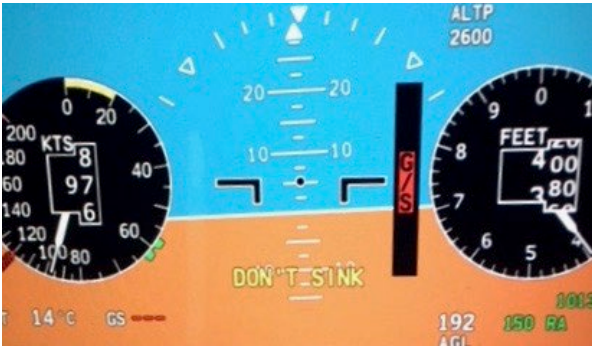
Figure 4.9 Don't Sink Caution

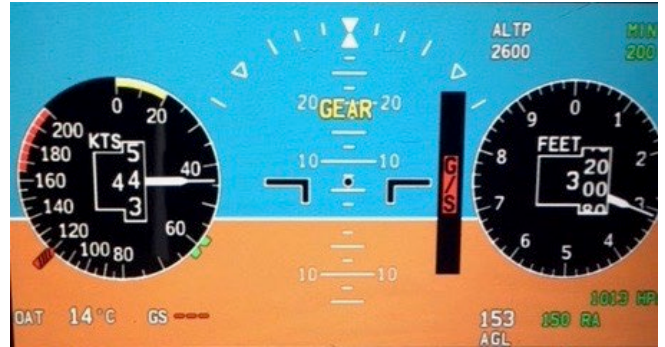
Figure 4.10 Gear Caution

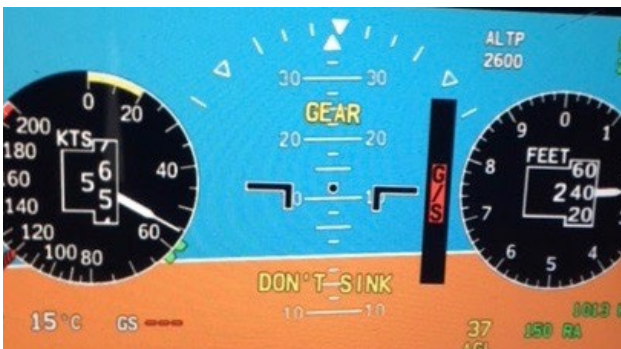
Figure 4.11 Don't Sink and Gear Cautions

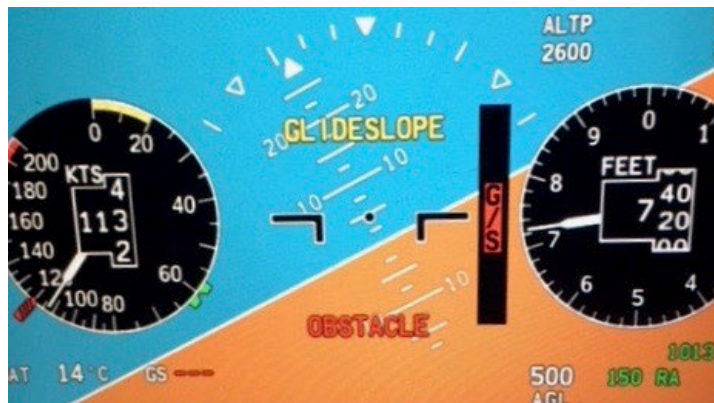
Figure 4.13 Obstacle Warning and Glideslope Caution

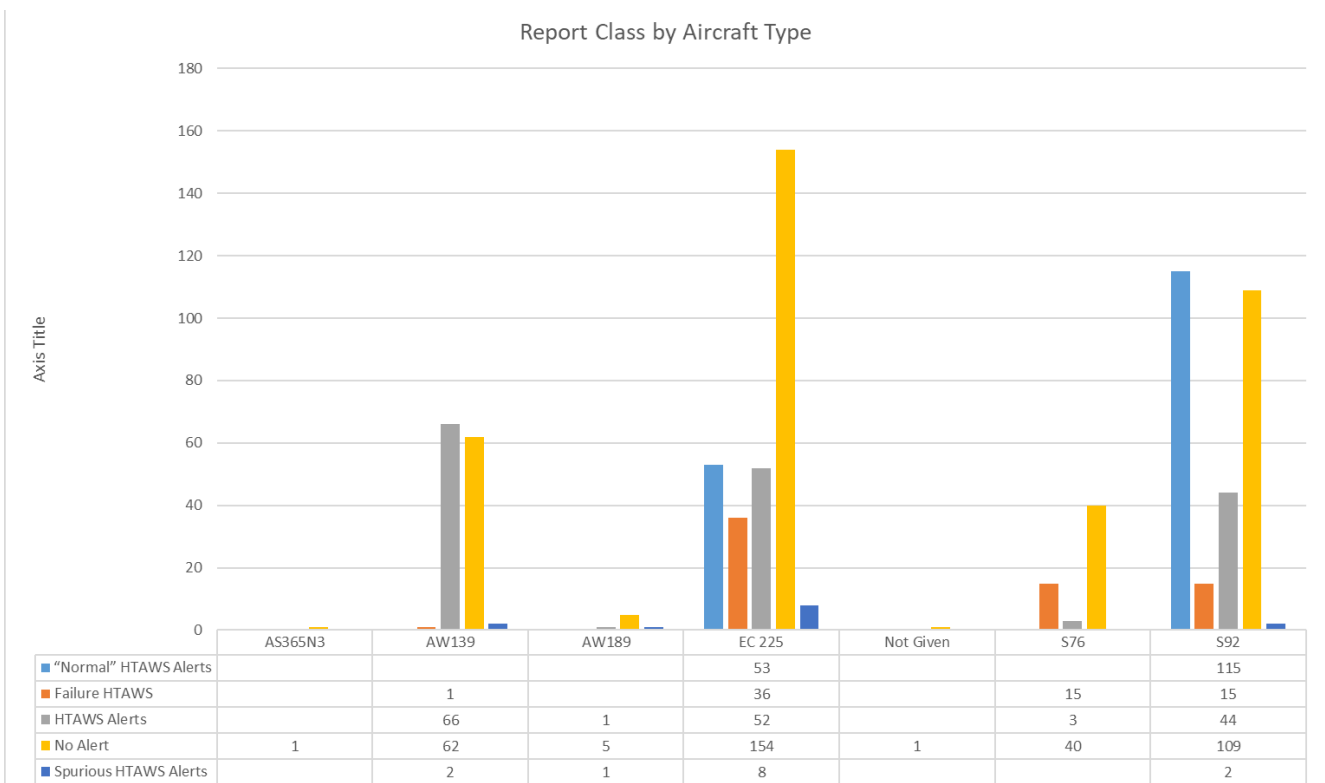
Figure 5.5 – Report categorisation for different aircraft types

Figure 5.5 shows the distribution of the different categories for the different aircraft types.

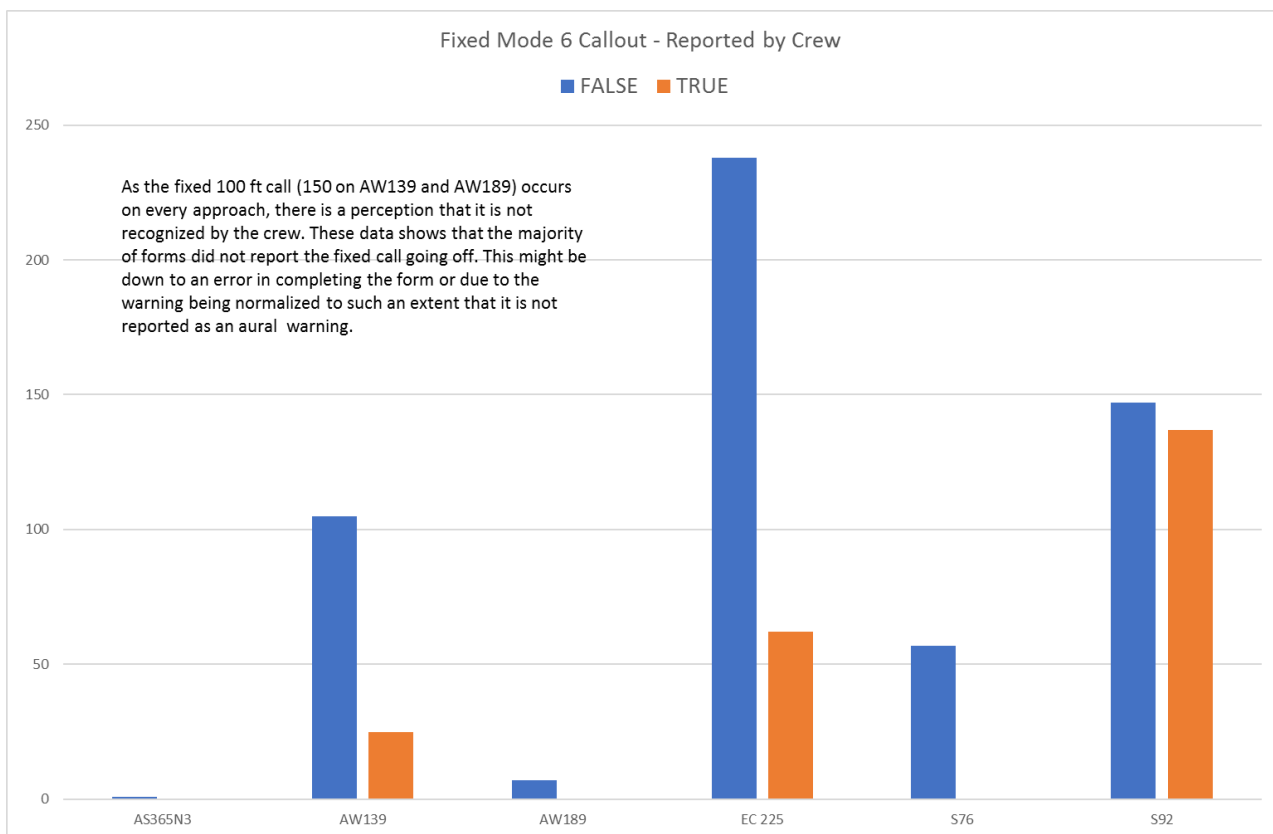
Figure 5.6 – Graph showing whether Mode 6 callouts were reported on form

Figure 5.6 shows whether the Mode 6 callouts were reported by crews or not, against aircraft type.

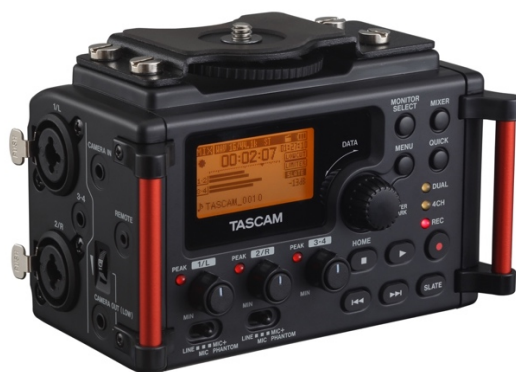
Figure 6.3 – Tascam DR-60D MkII recorder

A TASCAM DR-60D MkII recorder was used. This is a small, lightweight, inexpensive, 4-channel digital recorder. At the recording resolution used, it has a frequency response of +0.5dB / -3dB from 20Hz -40kHz. As with the microphone, it is not classified as measurement-grade equipment.

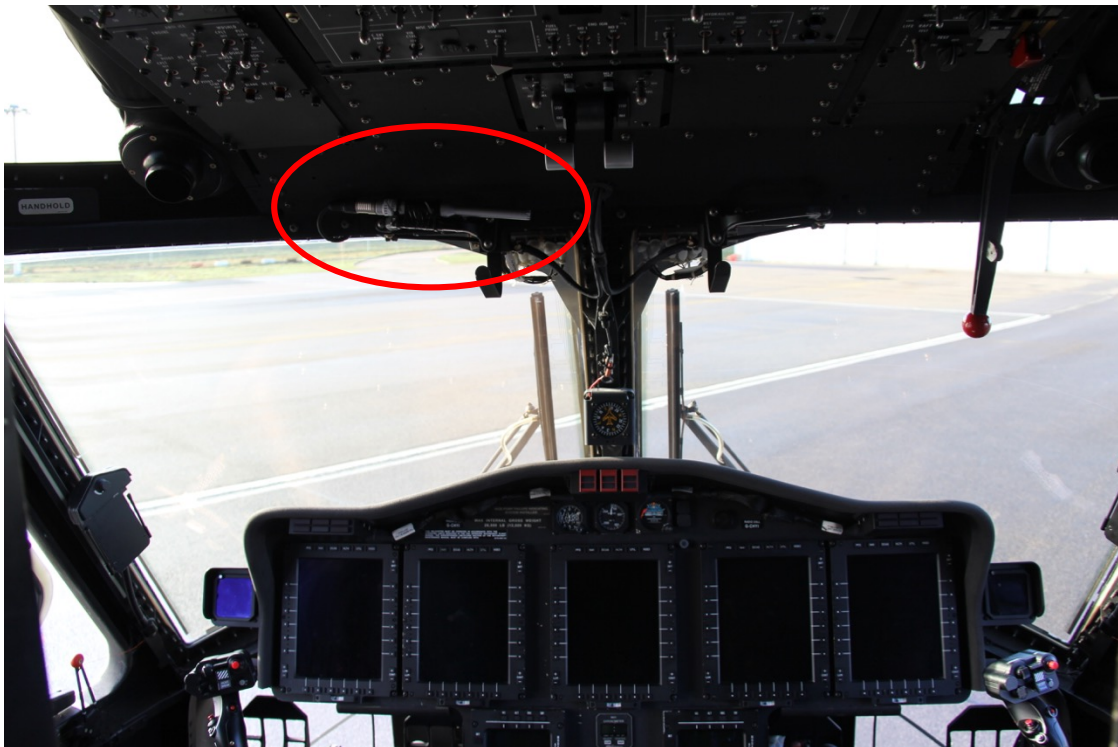
Figure 6.4 – Microphone (circled) location in flight

The microphone was attached to the centre grab handle of the LH seat. This may have introduced vibration noise onto the microphone signal, but complete vibration isolation is difficult to achieve. This position was chosen to give clear entry, egress, security of attachment and safety of operation rather than for any acoustic reasons. The recorder was housed in the 'blue bag' between the seats.

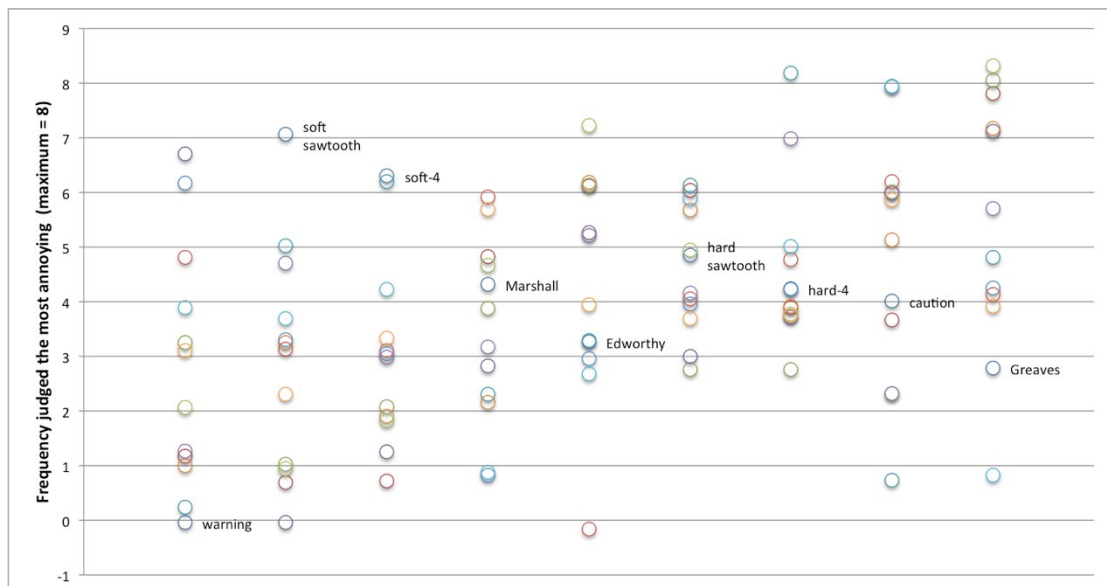
Figure 6.8: Annoyance scores from paired comparison analysis (each point represents the score from a single participant)

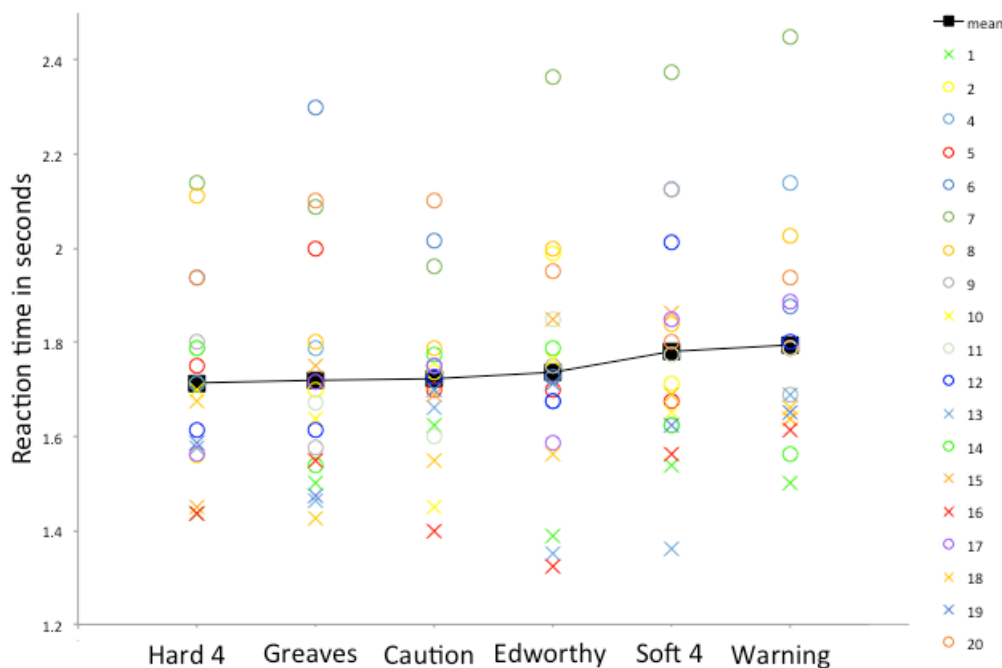
Figure 6.10: Mean reaction times to each alert for each participant (ordered left to right by increasing grand average RT, shown in black)

Reaction times (RTs) were measured in terms of the latency between the onset of the alerting stimulus and the time at which the participant clicked the specified radio button. Mean correct RTs for each alert type were calculated for each participant (see Figure 6.10).

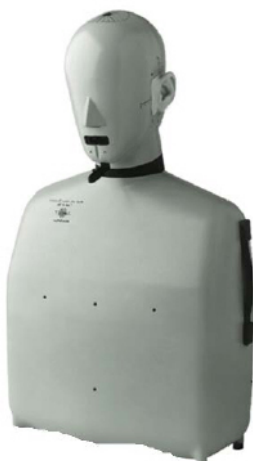
Figure 8.1 – B&K Type 4128-C Head and Torso Simulator (HATS)

A Brüel & Kjær (B&K) 4128-C Head and Torso Simulator (HATS) was used for in-cockpit measurements (see Figure 8.1). The HATS contains an ear simulator, which consists of a removable silicon-rubber pinna (the external part of the ear) joined to an ear canal. The ear canal ends in an occluded ear simulator that simulates the inner part of the ear canal according to the IEC60318-4 standard. The ear simulator contains a ½” microphone and is connected to a microphone preamplifier with an adaptor. The ear simulator complies with ITU-T Rec. P.57 and ANSI S3.25. The microphone was connected through a battery-powered preamp to a B&K Type 2250 battery-powered analyser (see Figure 8.2).

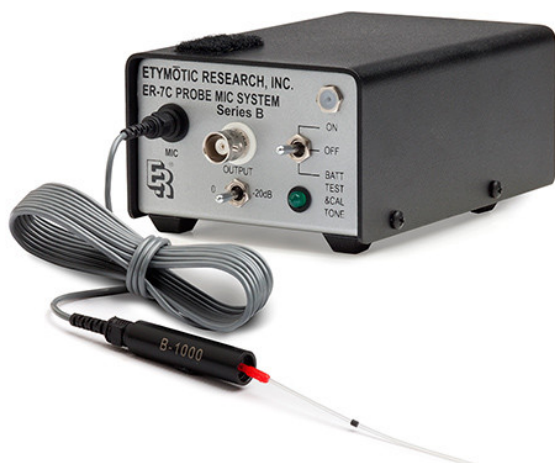
Figure 8.3 – ER-7C measurement probe

In order to capture data in-flight, measurements were made inside the ear cup of the headset using an Etymotic Research ER-7C probe (see Figure 8.3). This microphone has a thin, flexible tube on the end allowing measurements in the ear. However, in this case, rather than being inserted into the ear, it was laid on the foam inside the ear cup of the headset and held with surgical tape (see Figure 8.4). This allowed a measurement to be made of the sound wave being presented to the ear of the flight crew member being monitored. Rolfe (Rolfe, 2016) outlined this protocol and equipment for performing in-ear tests.

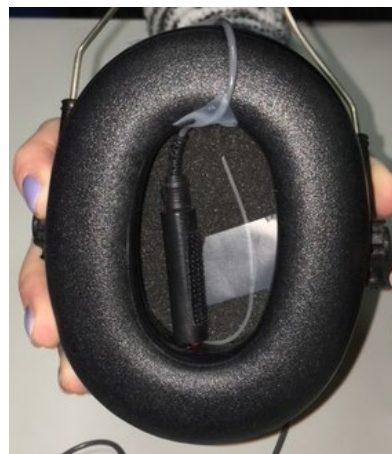
Figure 8.4 – ER-7C in headset

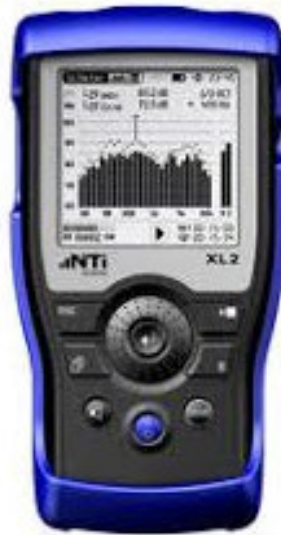
Figure 8.5 – NTi XL2 analyser

All microphones and analysers were calibrated before being installed in the aircraft.

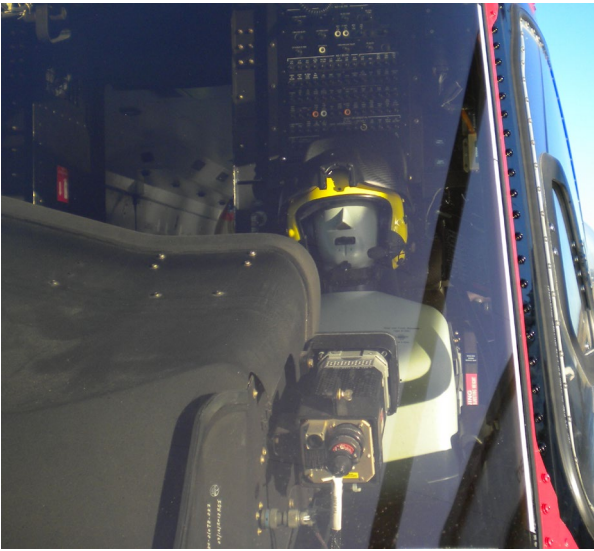
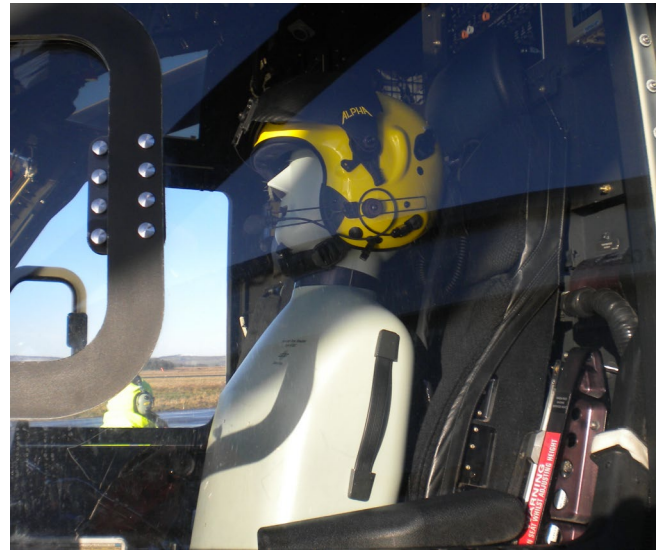
Figures 8.7 and 8.8 – HATS installed in cockpit with ALPHA Eagle helmet

It is possible that the helmet headset was not in the ideal position since the fit around the ears of the head simulator can only be judged visually, with the view of the ear cups being restricted by the helmet structure. The HATS may sit lower in the cockpit than the pilot due to the short torso on the HATS but this is not expected to make a significant difference.

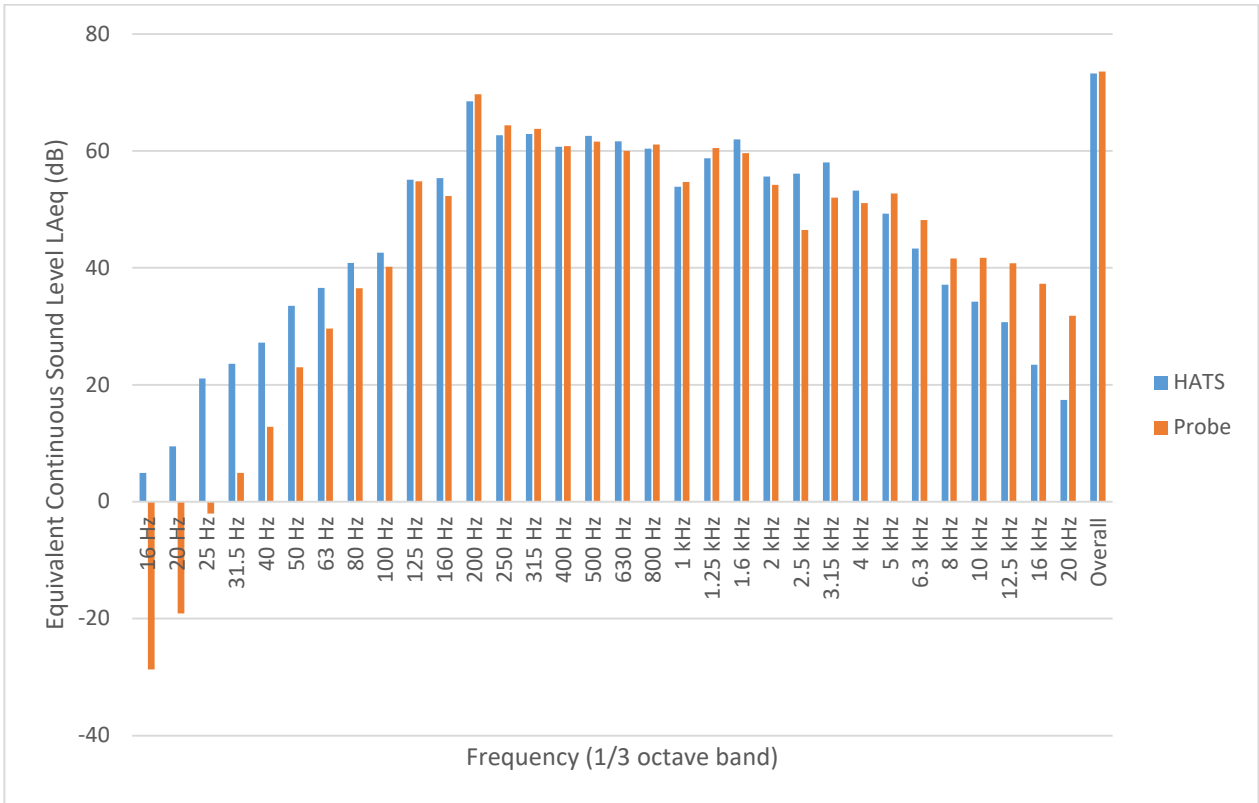
Figure 8.10 – Comparison of HATS and in-ear probe making simultaneous measurement

The similarity of the overall levels (73.2dB versus 73.6dB) is explained by spectrum; the bulk of the energy is contained in the 125Hz to 4kHz region where the readings show good agreement. The effect of large measurements differences at frequencies where there is much less energy will be small. However, it is important to bear this in mind when using the probe measurements.

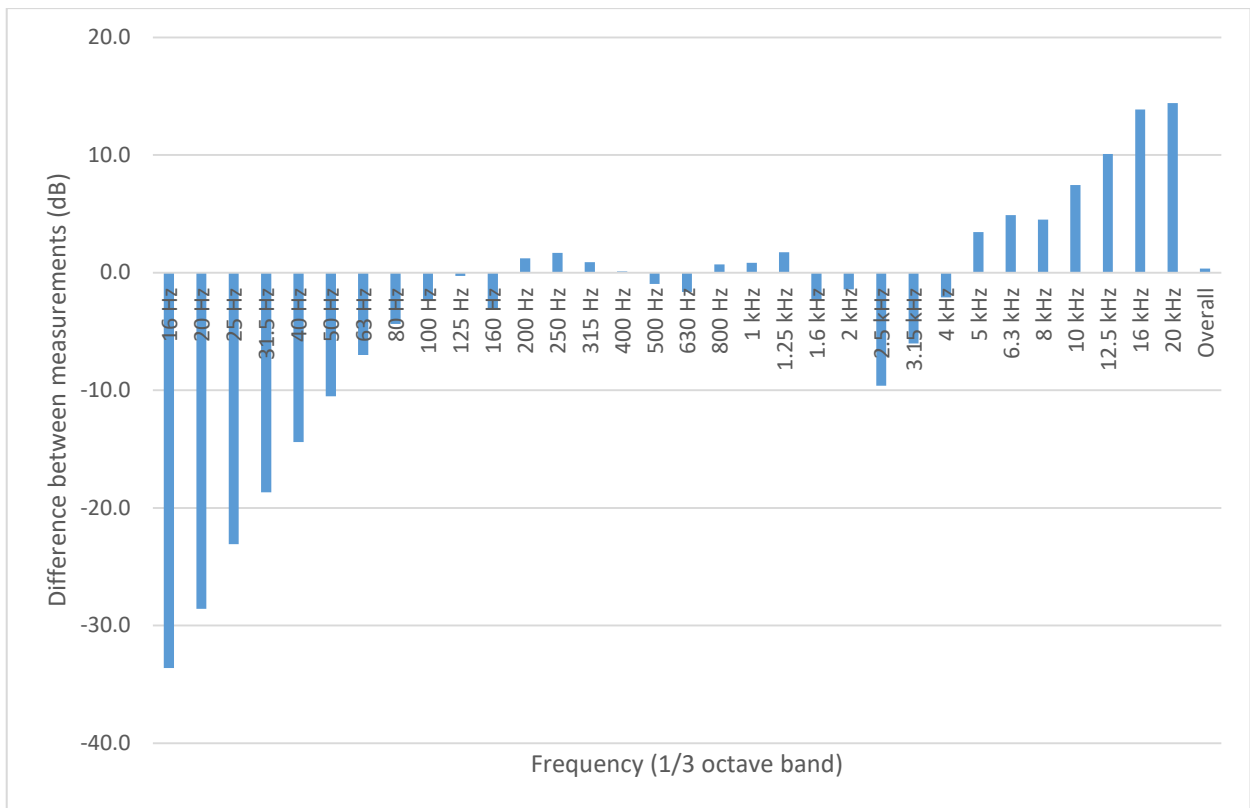
Figure 8.11 – Difference between the two measurements shown in Figure 8.10 (i.e. the difference between the HATS and in-cup probe measurement)

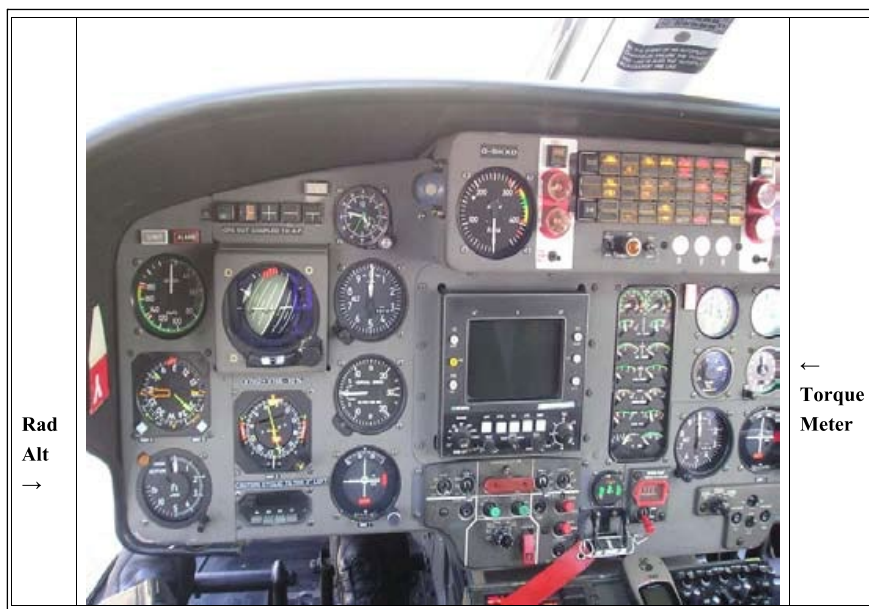
Figure A2.2 – RADALT position from (Air Accidents Investigation Branch, 2008)

This conflicts directly with the recommendation made regarding RADALT position stemming from the accident to G-BEON. This is not to imply that either observation is incorrect, but rather to highlight the complex and competing demands that helicopter operations impose. In some conditions, flight with reference to the outside environment supplemented by instruments is appropriate whereas, at other times, predominantly instrument flying with some visual reference is more appropriate. Alternatively, a clear division of 'head-up' and 'head-down' flying between the flight crew may be preferred. Designing a cockpit which is ideal for all situations is extremely challenging, as the contradiction between these recommendations implies, or may even not be possible.

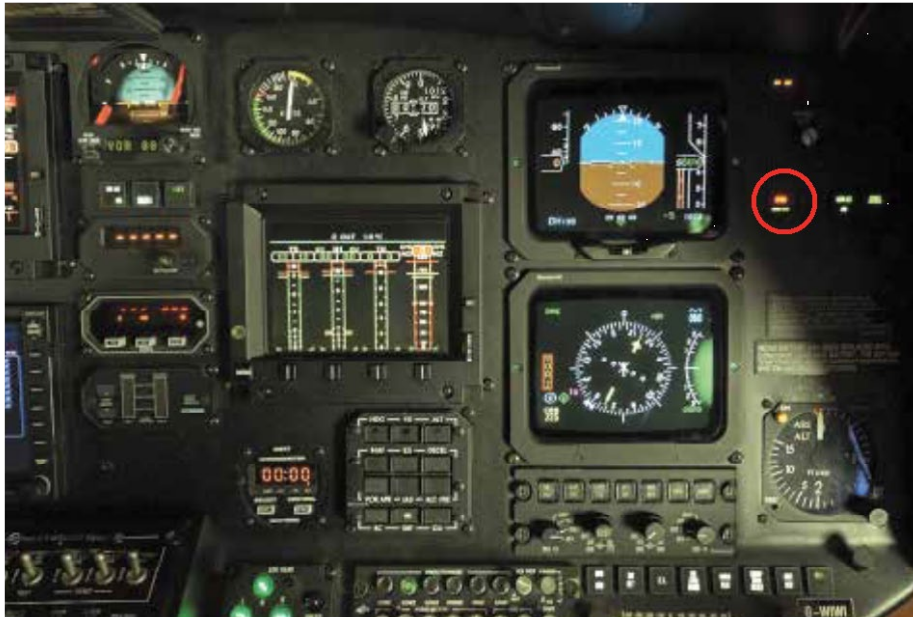
Figure A2.3 – RH instrument panel of G-WIWI showing GPWS visual alert (amber – circled red) from (Air Accidents Investigation Branch, 2014a)

“EGPWS visual cues appeared not to be especially attention-getting being small and presented only as illuminated script in small lit push-buttons”

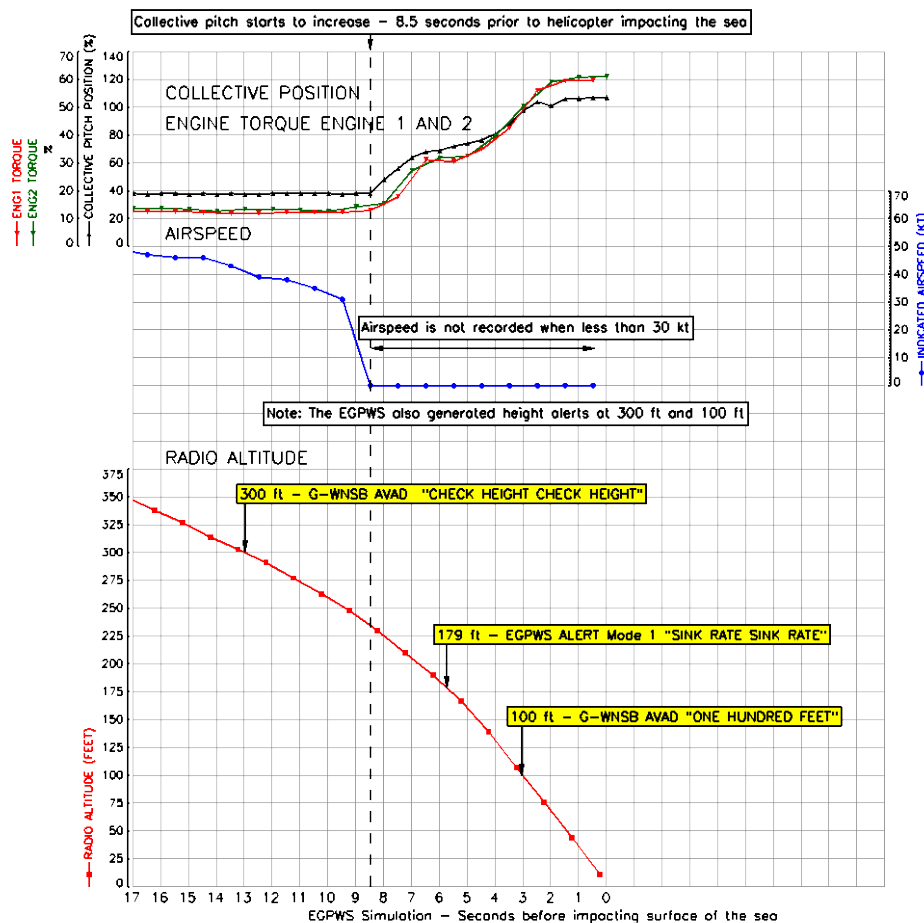
Figure A2.6 – EGPWS Simulation

G-WNSB was not equipped with a TAWS, nor was there any requirement for it to be fitted. A laboratory simulation was performed by Honeywell to establish if a TAWS alert would have been generated. Figure A2.6 below, taken from the report, where the alerts would have sounded had a TAWS been fitted. The report concluded that “at a height of 179 ft, about 5.7 seconds before G-WNSB struck the surface of the sea, a Mode 1 ‘sink rate sink rate’ audio alert would have been generated”.
