CAA PAPER 2001/1

**REPORT ON FUSELAGE
BURNTHROUGH RESEARCH
ADDRESSING INSTALLATION
ASPECTS**

D C Dodd

REPORT PREPARED BY DARCHEM FLARE, STILLINGTON, STOCKTON-ON-TEES,
AND PUBLISHED BY
CIVIL AVIATION AUTHORITY, LONDON, AUGUST 2001

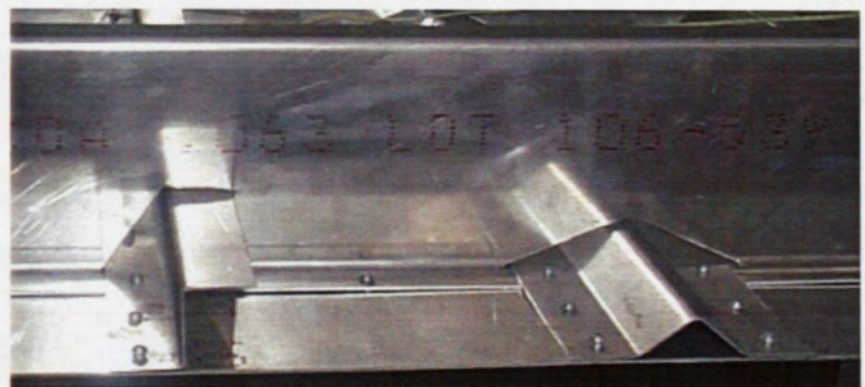
Figure 9 Frame and Stringer Arrangement for Stylised Fuselage Panel

From studies of aircraft fuselages and as a result of discussions with the CAA and airframe manufacturers a stylised fuselage panel was constructed as shown in Figure 6, Figure 7, Figure 8 and Figure 9. Riveted onto a plain aluminium panel are a number of structural features typical of those employed in fuselage construction. These features comprise three frame members and a number of z section and top hat stringers running perpendicular to the frames. The size and positioning of these features are intended to be typical of those used on an aircraft.

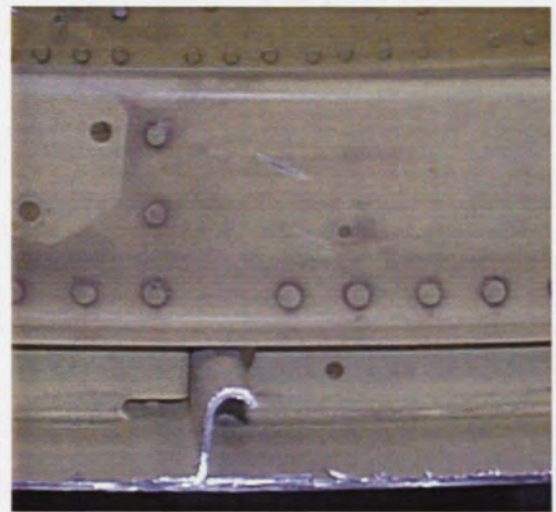
Figure 11 Frame and Stringer Details on Actual Aircraft panel

The aircraft panels used for the burnthrough tests were taken from cut-outs from an in-service aircraft that had undergone conversion to a freight aircraft. In an attempt to ensure consistency for each test all of the panels used were thoroughly cleaned before use and where possible the panels were chosen so that the configurations of frames and stringers were similar to the configuration of the stylised panel and each other. A typical aircraft panel is shown in Figure 10 and Figure 11.

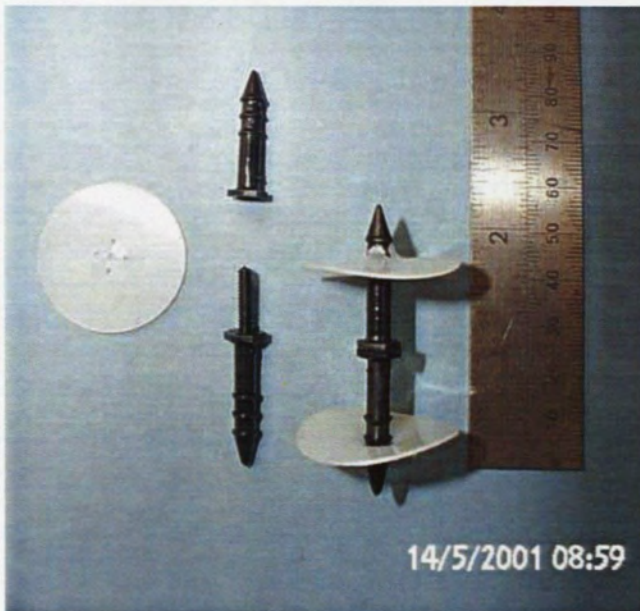
Figure 13 Plastic Through Frame Fixing Component and Washer

Through frame fixing pins are an insulation system attachment method by which a single or two-piece metallic or plastic component is located through the aircraft fuselage frame. The insulation system is pushed on to the pin and held in place using a washer. This method of installation results in the insulation material being pierced in the region of the pin. Typical through frame fixing pins are shown in Figure 13 and Figure 14.

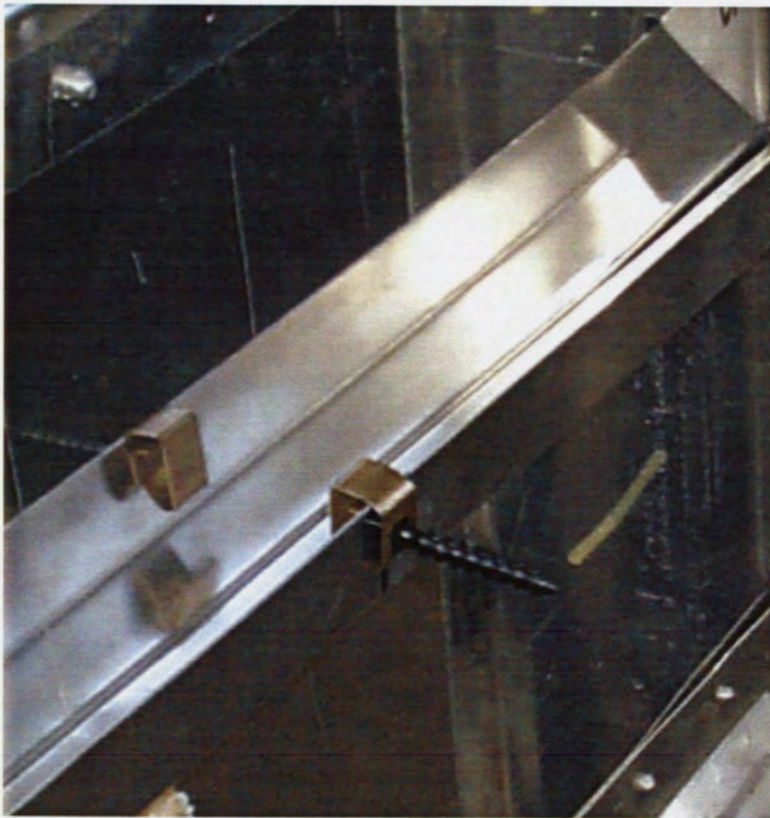
Figure 16 Stringer Pin/Clip Attachments to Stringer

A typical stringer pin as located on the fuselage stringer, and with insulation installed, is shown in Figure 16 and Figure 17.

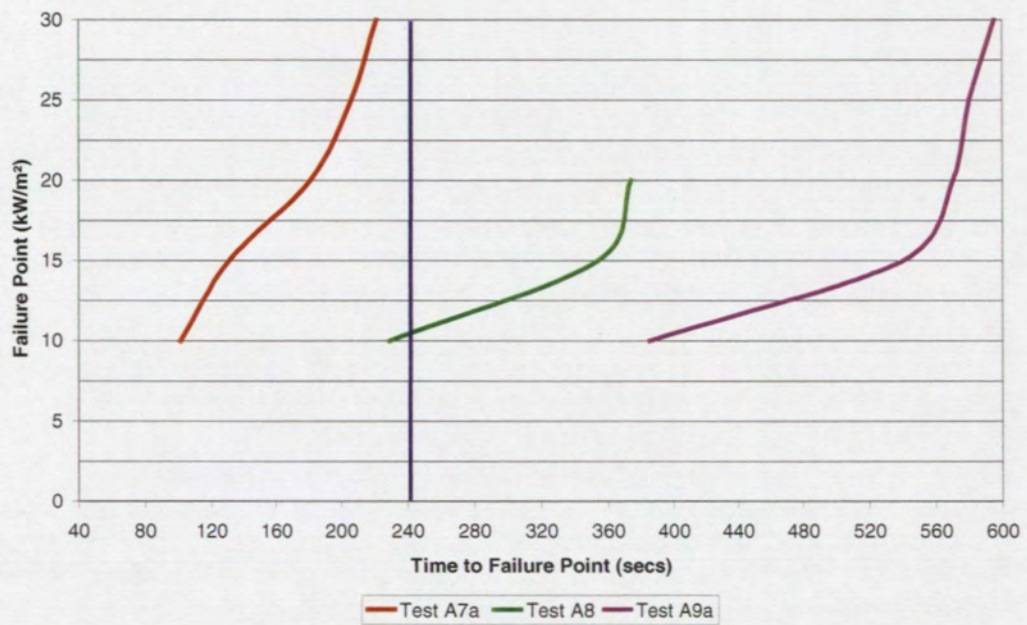
Figure 18 Phase 1 Failure Point Analysis

- (ii) Figure 18 and Figure 19 illustrate the heat flux histories for seven tests. The target burnthrough time of at least 240 seconds is shown on both figures. It may be seen that tests A7a, B3, B4 and B8 did not meet the target burnthrough times (irrespective of the heat flux failure criterion). Tests A8, A9a and B9 were considered to have met the 240-second target burnthrough time for the insulation material. It may be seen that for all three of these successful tests, that the heat flux readings tend to rise rapidly in the range 15 to 20 kW/m². The choice of 20 kW/m² as the failure criterion therefore has the advantage that small variations in the heat flux reading produce small changes in the derived burnthrough time. At lower heat flux levels small variations in the recorded values could result in larger variations in the derived burnthrough time.

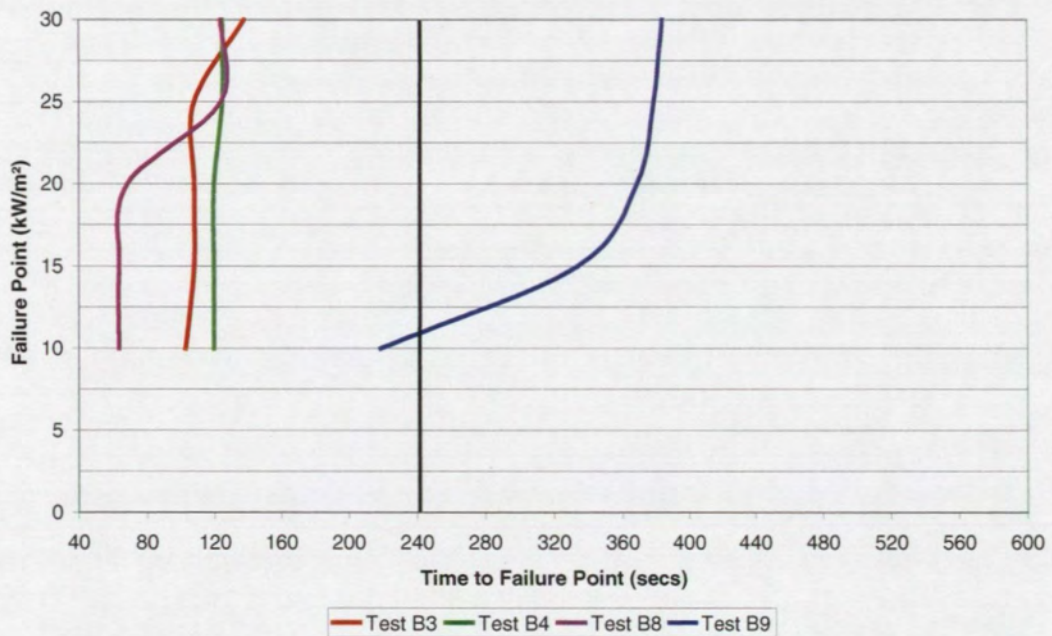
Figure 19 Phase 2 Failure Point Analysis

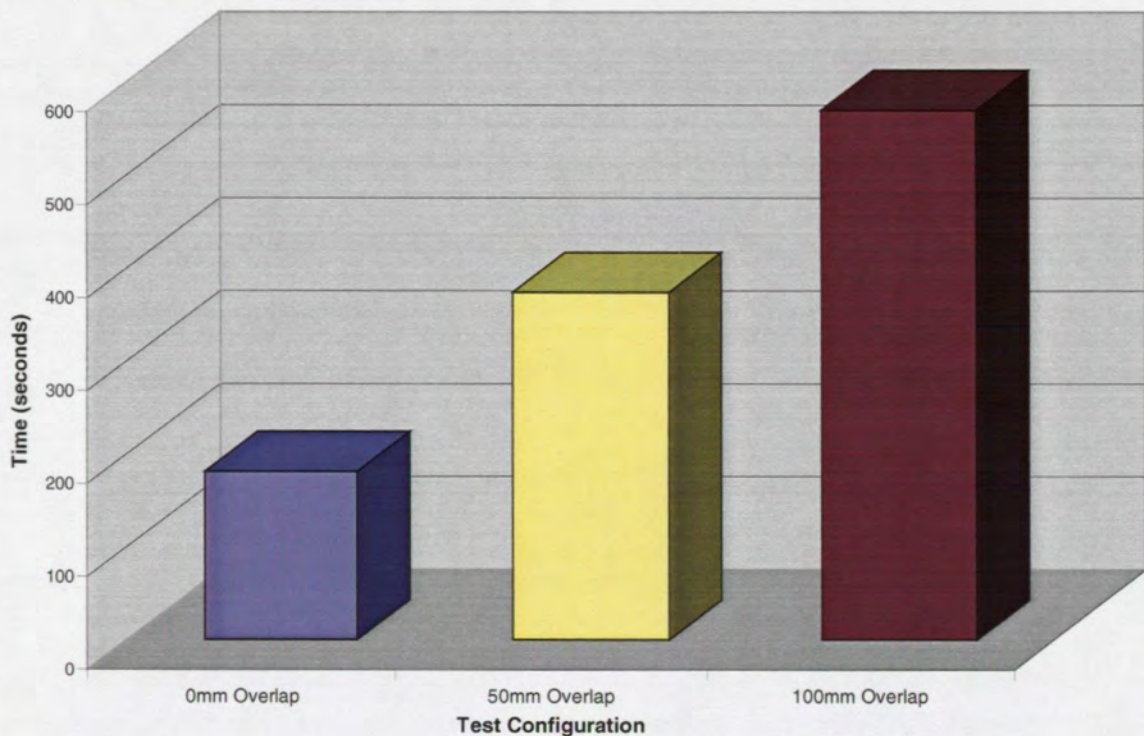
Figure 20 Burnthrough Times with varying Frame Overlap

Tests A7a, A8 and A9a illustrate the pronounced effect that bag overlap can have on burnthrough times. All three tests were carried out using the stylised fuselage panel. The insulation system used was Orcobloc encapsulated in Orcofilm KN-80 and was attached to the frame using steel fixing pins and washers.

The results from these three tests are shown in Figure 20. Each value shown on the graph represents the time taken to reach a heat flux level of 20 kW/m².

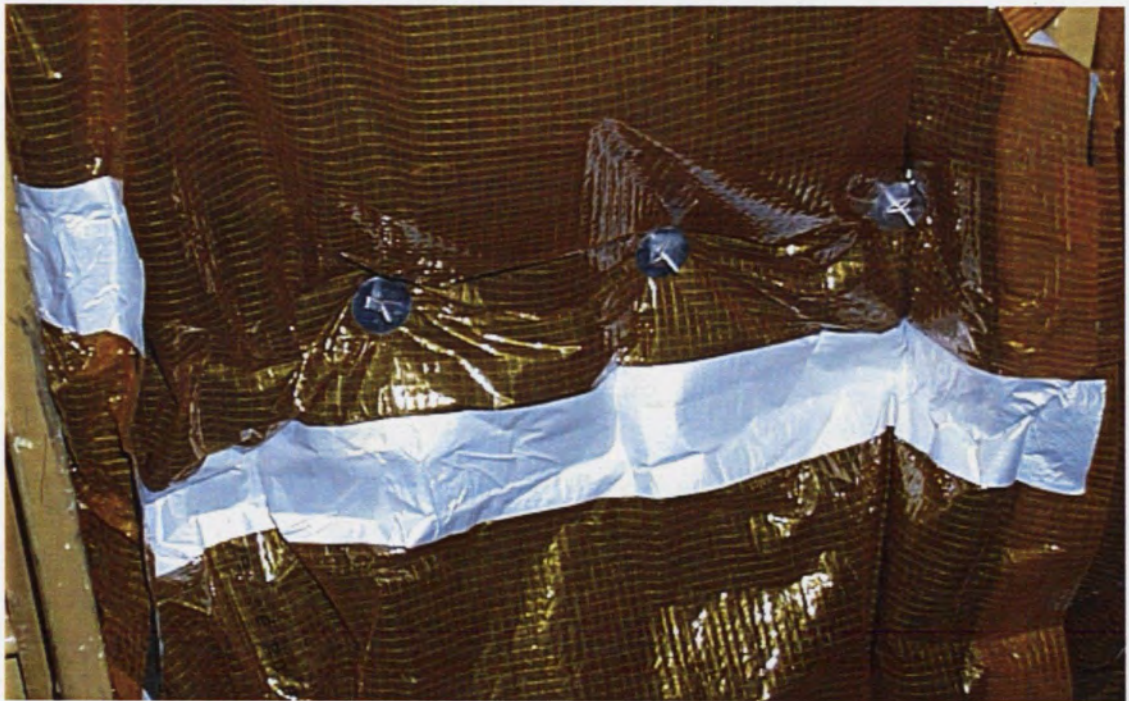
Figure 21 Details of Insulation Bag Overlap Showing PVF Tape and Stringer Pins

Testing was normally carried out with the blankets between the two main frame bays being made of a single insulation blanket. However, for this test two blankets were used to investigate the integrity of the bag overlap. The insulation blankets were overlapped by 150 mm and were fastened together using double-sided adhesive tape across the entire width of the area of overlap. In addition PVF tape was used beyond the area of overlap to attach the blankets together as shown in Figure 21 and Figure 22. Fire resistant stringers pins were also attached to the aircraft panel in the region of the bag overlap at a spacing of 150 mm apart. The insulation blankets were then pushed onto these stringer pins and held in position using fire resistant washers as shown in Figure 21. The areas of bag overlap for the two frame bays were offset as shown in Figure 23 in an attempt to improve the integrity of the insulation system to fire penetration.

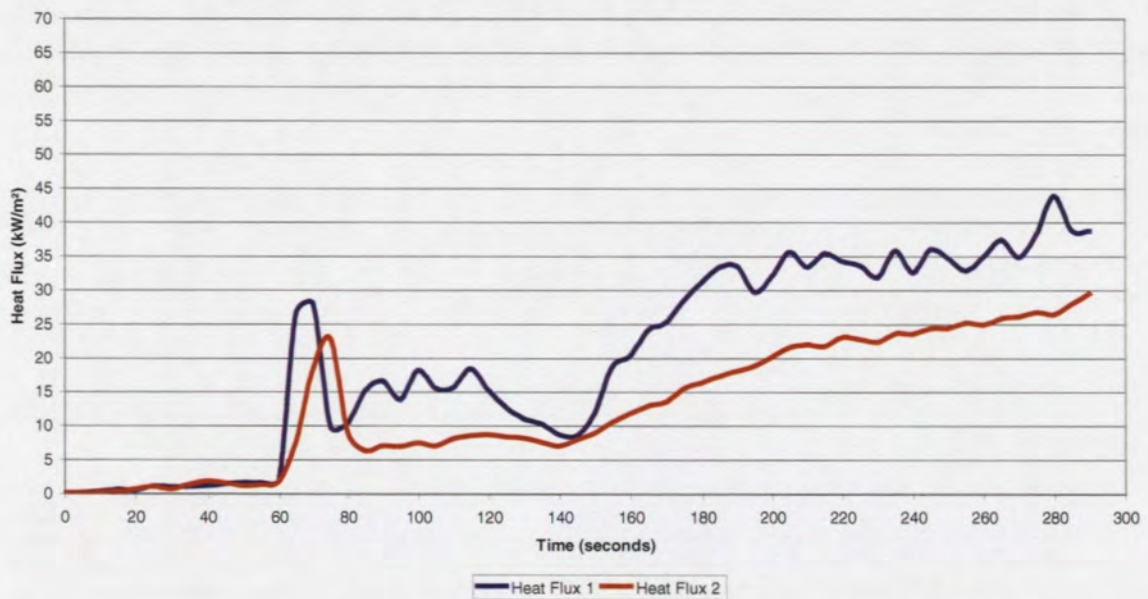
Figure 25 Heat Flux Profile for Test D6-4

This test was carried out using an actual aircraft panel that had been treated with corrosion inhibitors. The insulation bags were attached to the frame using aluminium through frame pins positioned at 50 mm up the frame and at a pitch of 350 mm. The insulation blankets extended up the frame a distance of 50 mm. The test resulted in rapid burnthrough with the 20 kW/m² level of heat flux being achieved in approximately 65 seconds from the start of the test.

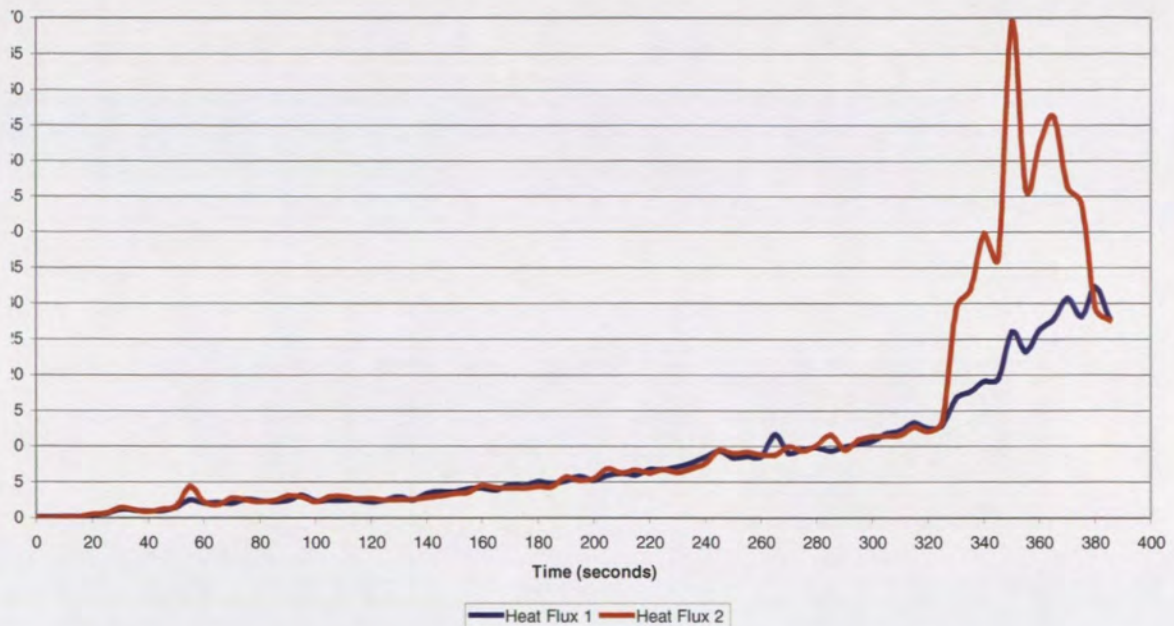
Figure 26 Heat Flux Profile for Test D6-5

A similarly configured test was then carried out with the addition of capping strips, test D6-5. The capping strips were made of fibreglass batting encapsulated in a PVF based bagging film. As with test D6-4 the insulation bags were attached to the frame using aluminium through frame pins positioned at 50 mm up the frame and at a pitch of 350 mm. The overlap at the frame was 100 mm. The heat flux profile for test D6-5 is shown in Figure 26.

The test resulted in a heat flux level of 20 kW/m² being achieved after approximately 330 seconds from the start of the test.

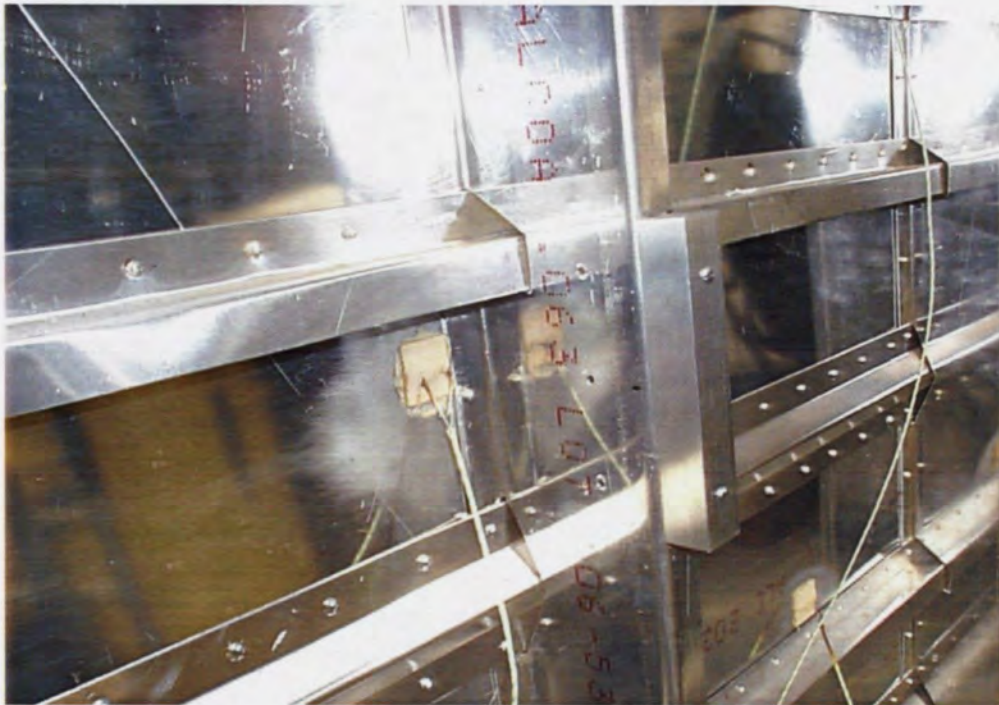
Figure 27 Simulated Clamp Block on Fuselage Frame

The configuration used in Test D3-1 was intended to simulate a hydraulic pipe clamp block attached to an aircraft panel in order to assess the effects of such a feature on burnthrough resistance. A 150mm long by 25mm square mm long block of aluminium was attached to the centre of the central frame on a stylised panel. In order to accommodate the clamp block a cut out was made in the capping strip.

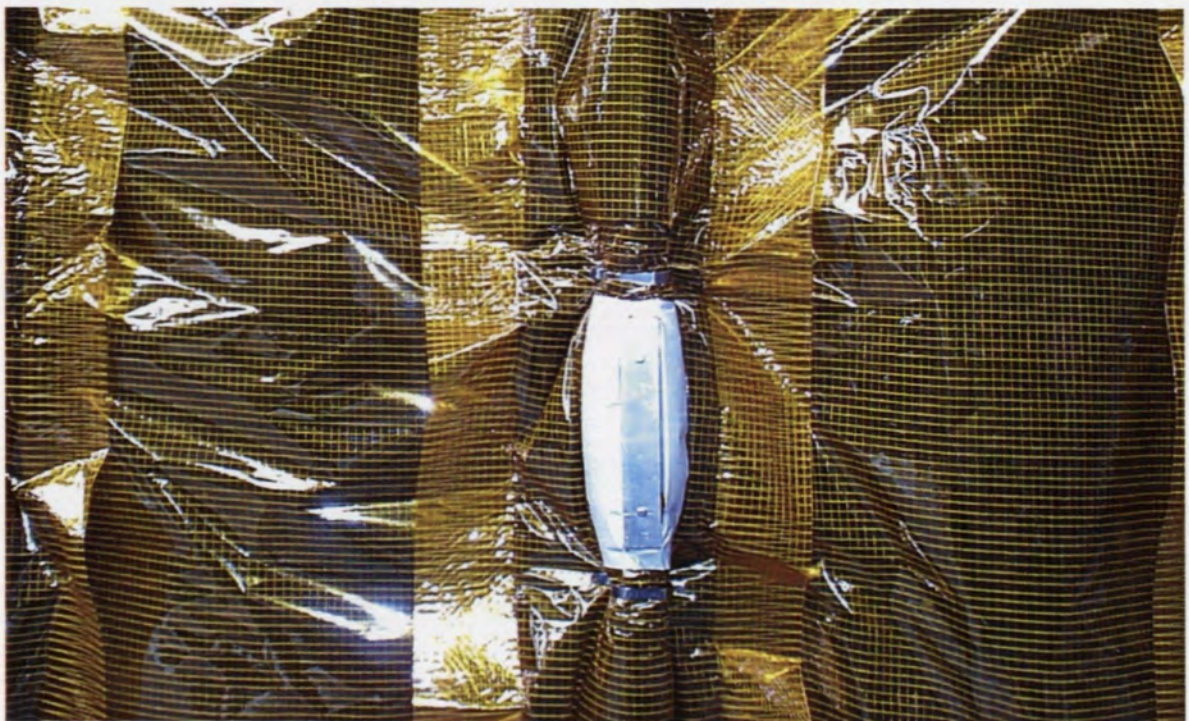
Figure 28 Simulated Clamp Block with Insulation Installed

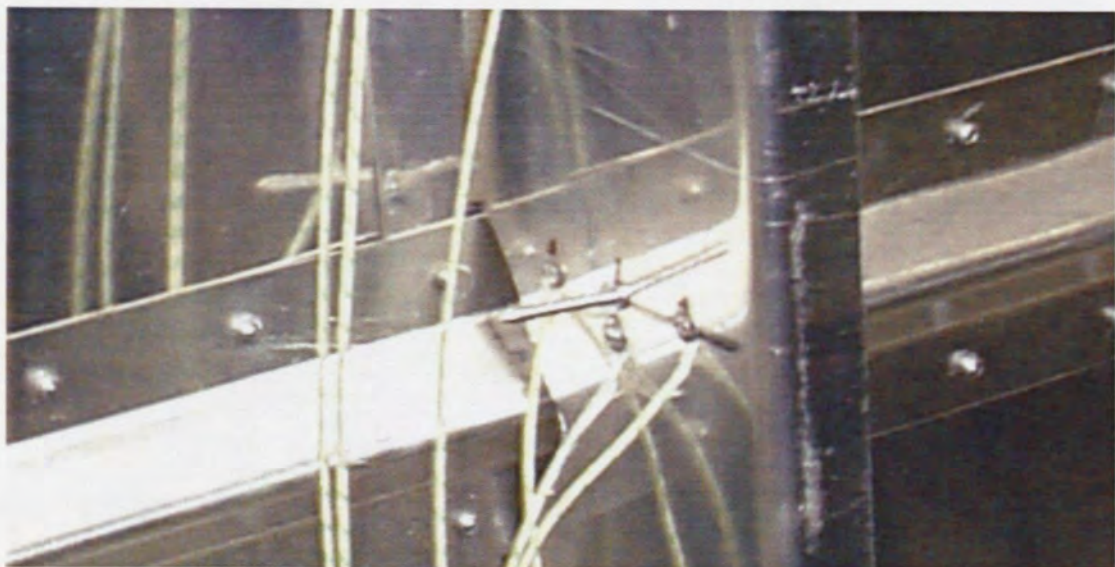
Figure 30 Aluminium Through Frame Pin positioned 50 mm up the Frame

The insulation system used for the tests was again Orcobloc insulation encapsulated in Orcofilm KN-80 bagging film. In Section 4.3 the importance of frame overlap was discussed. For the tests described in this Section of the report 100 mm of frame overlap was used since this resulted in improved burnthrough results in comparison with smaller overlaps. A number of steel and aluminium through frame fixings were used for these tests with pitches along the frame of approximately 170 mm, 260 mm, and 350 mm. The vertical location of the through frame fixings in relation to the skin of the panel was also varied with values of 25 mm and 50 mm being selected. Figure 30 shows one of the through frame fixings as located on the test panel.

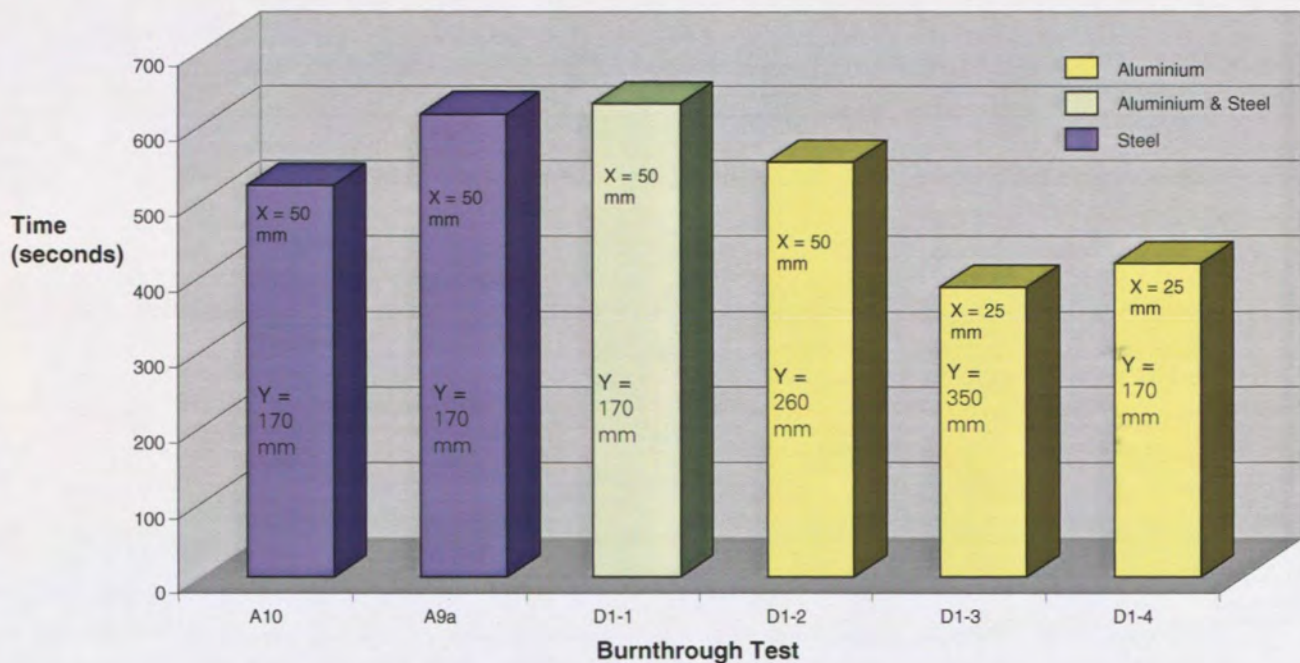
Figure 31 Time to Reach Failure Point of 20 kW/m² for Tests using Through Frame Fixing Pins & Washers

NB: Y = Pitch of through frame fixing along the frame
X = Vertical location of through frame fixing in relation to the skin of the panel

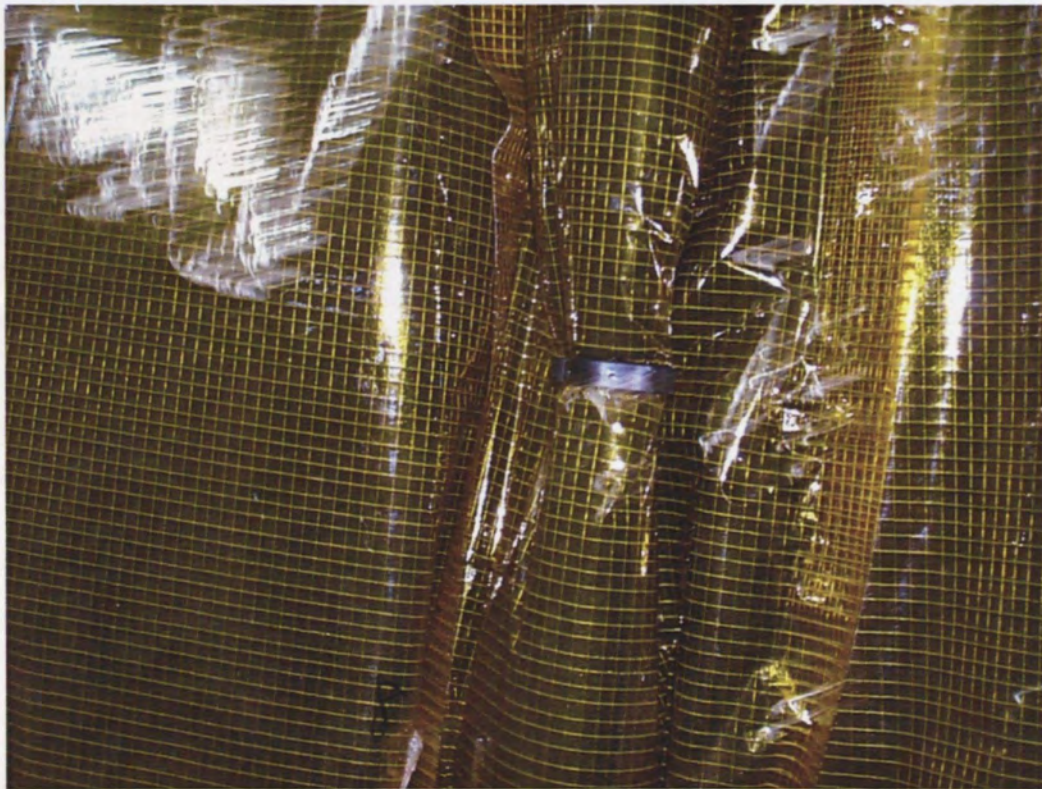
Figure 33 Test D2-1 Close up of Plastic Clip

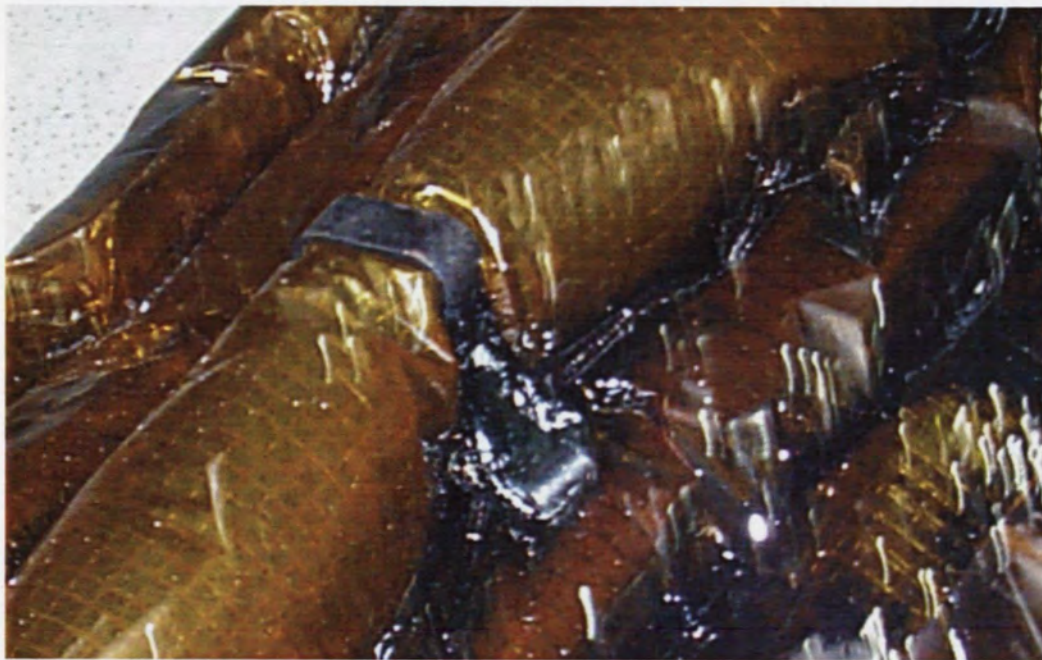
Figure 34 Test D2-3 Close up of Plastic Over Frame Clips after Testing

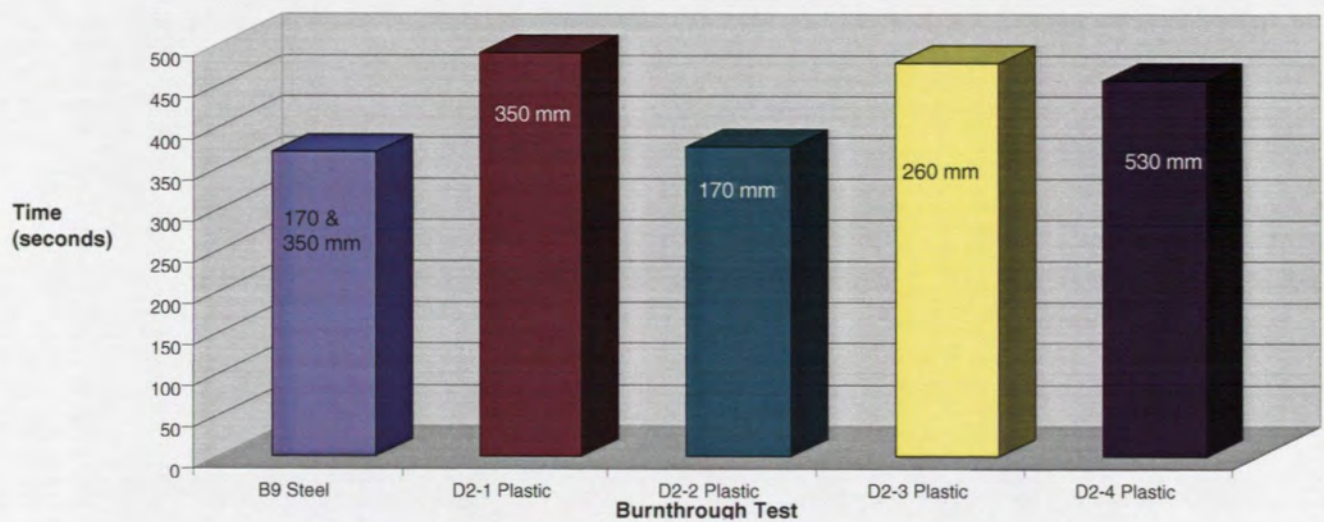
Figure 35 Time to Reach Failure Point of 20 kW/m² for tests involving over frame clips

NB: The values at the top of each column indicate the pitch of the fixings along the frame

In Section 4.3 the importance of frame overlap was discussed and for each of these tests the frame overlap was 100 mm. Steel and plastic clips were used and pitches of approximately 170 mm, 260 mm, 350 mm and 530 mm. Details of the typical construction of these samples are shown in Figure 32 and Figure 33. The condition of one of the plastic over frame fixings after a test is also shown in Figure 34. A summary of the results of these tests is shown in Figure 35.

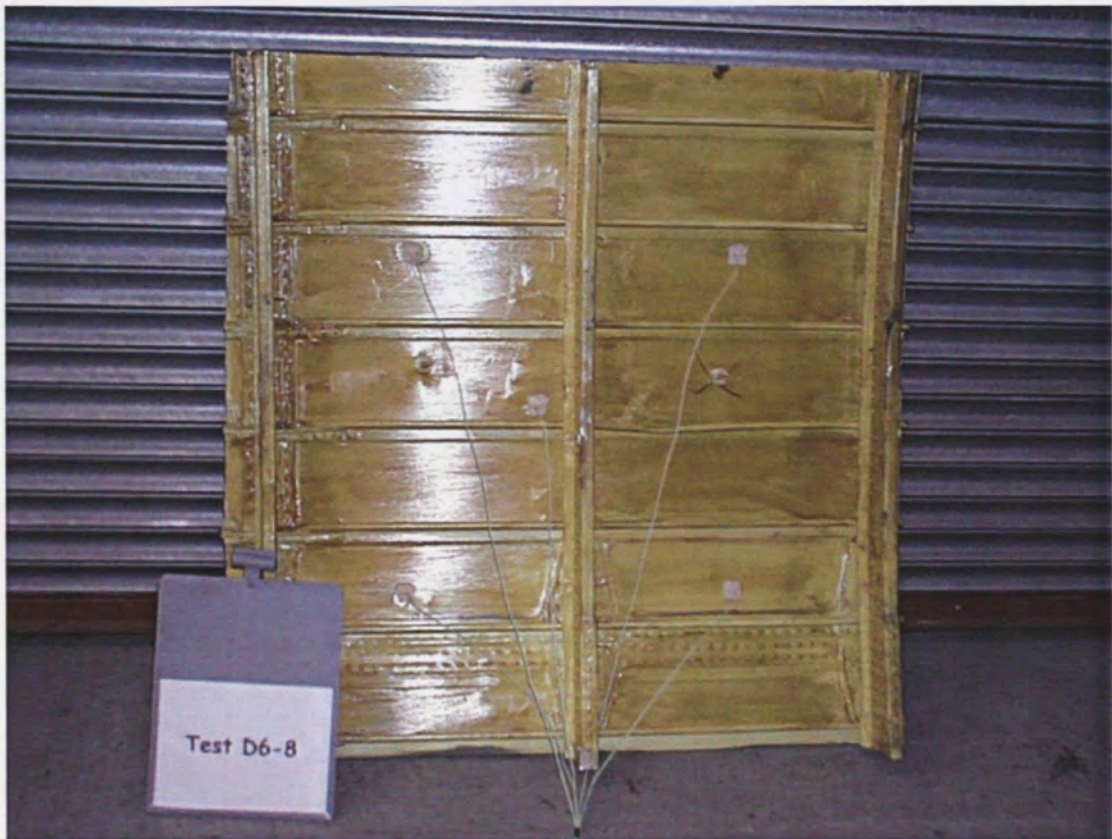
Figure 36 Test D6-8 Fuselage Panel Coated with Corrosion Inhibitors

Using the stylised panel a minimum acceptable standard of installation characteristics could be derived. However, it was considered expedient to verify this minimum acceptable standard on an actual aircraft panel. Section 4.2 discussed the effect that corrosion inhibitors, and the protective coatings applied to aircraft structures, may have on burnthrough time of a fuselage and insulation system. Therefore two tests, D6-7 and D6-8, were conducted on an actual aircraft panel using over frame fixings as the method of insulation system attachment. For test D6-8 corrosion inhibiting compounds were also applied to the actual aircraft panel as indicated in Figure 36.

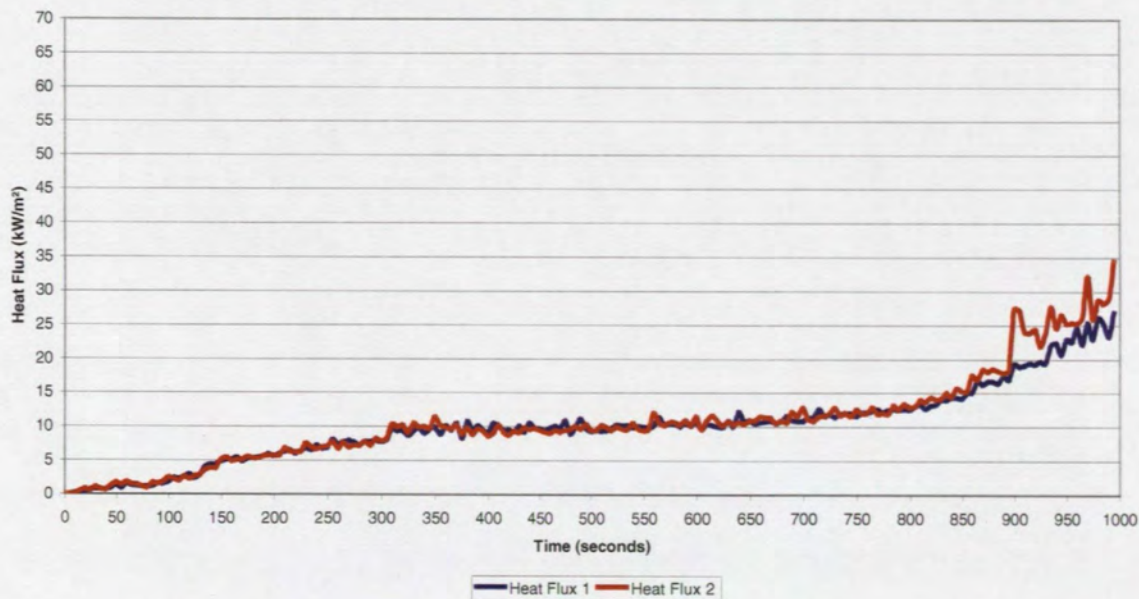
Figure 38 Heat Flux Profile for Test D6-8

Test D6-5 was carried out using capping strips made of fibreglass batting encapsulated in a PVF based bagging film. Tests D6-7 and D6-8, which are described later in this document, were carried out using capping strips made of Orcobloc encapsulated in Orcofilm KN-80, which has previously shown to display superior levels of burnthrough resistance. (see Figure 37 and Figure 38)

The two tests were conducted using Orcobloc insulation batting encapsulated in Orcofilm KN-80 bagging film and the overlap of insulation at the frame with the capping strip was 100 mm. The heat flux profiles are shown in Figure 37 and Figure 38.

For both tests the burnthrough time of the system was again well in excess of the failure criterion of 300 seconds. Test D6-8 did not fail until approximately 900 seconds. The burnthrough times for the actual fuselage panel tests are higher than those for the equivalent tests using the stylised fuselage panel.

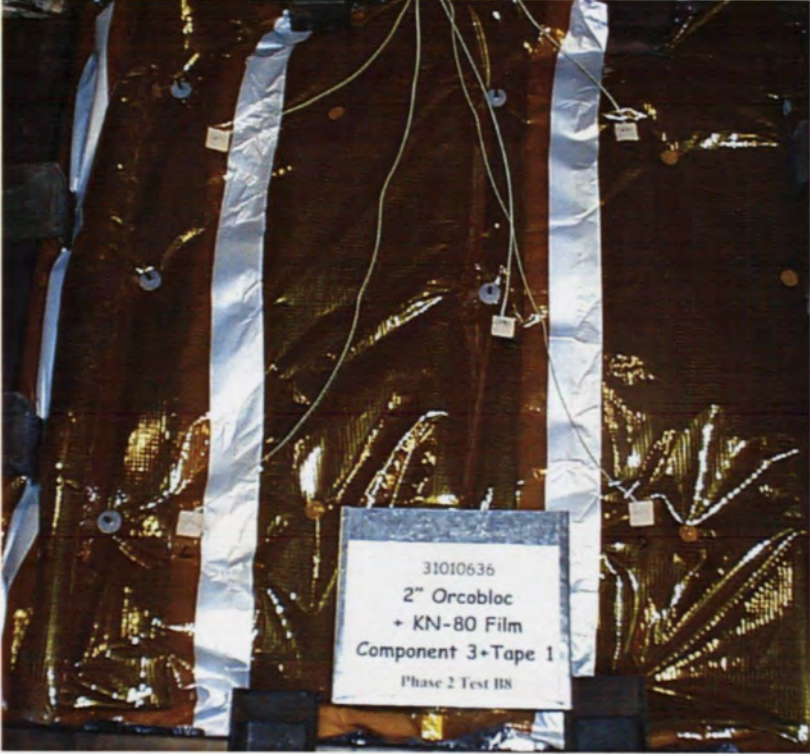
Figure 40 Test B8 Pre-Test

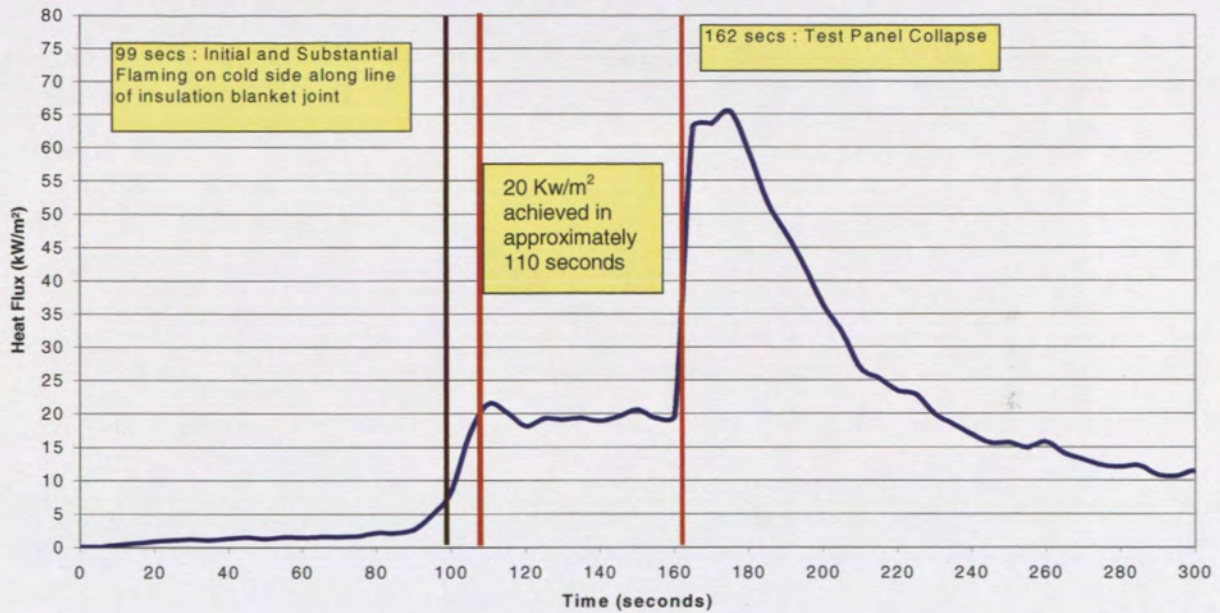
Figure 42 Heat Flux Profile for Test B8

This test resulted in a rapid burnthrough with the 20 kW/m² level of heat flux being achieved in approximately 110 seconds as shown in Figure 42. This result indicated that this method of attaching an insulation system to the aircraft fuselage was not capable of providing significant burnthrough protection even by using insulation materials that have been shown to be burnthrough resistant.

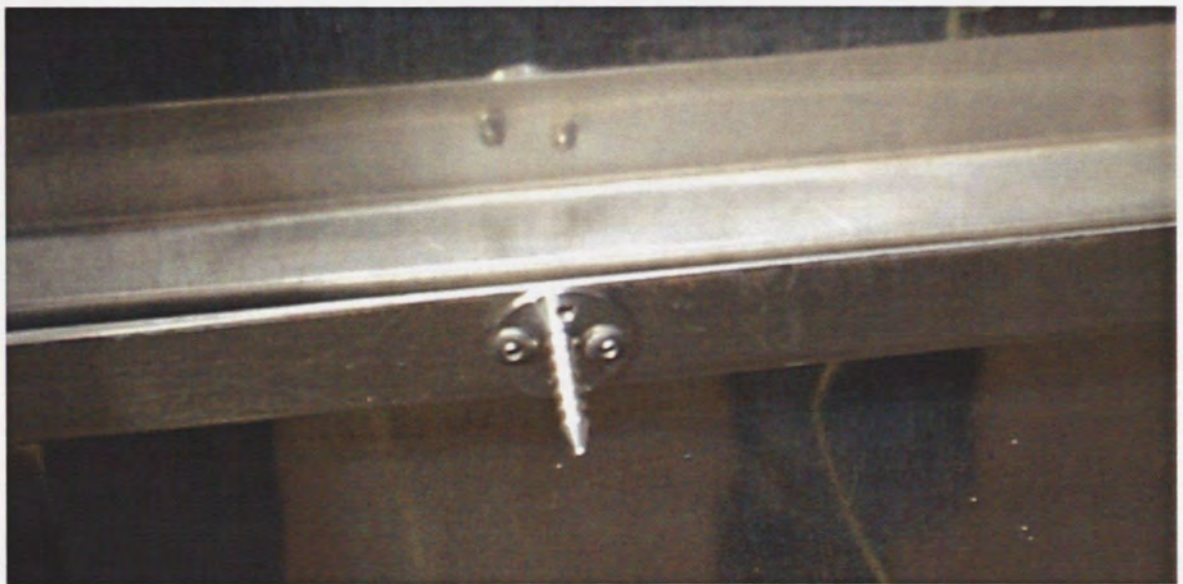
Figure 43 Test D5-1 Close Up of Aluminium Stringer Pin attached to Stringer

In test B8 the combination of plastic stringer fixing pins and PVF tape was found to be unacceptable. Test D5-1 was conducted using a stylised fuselage panel and the Orcobloc insulation material and Orcofilm KN-80 bagging film combination. The insulation bags were attached to the frame using steel over frame clips, positioned over the frame at a pitch of approximately 250 mm. The frame blanket extended a distance of 100 mm up the frame. In one of the frame bays a number of aluminium stringer pins were riveted on to the stringer sections as shown in Figure 43. The insulation was pushed onto these stringer pins and then held in place using aluminium washers as shown in Figure 44.
