Accident
on 25 December 2003
at Cotonou Cadjèhoun
aerodrome (Benin)
to the Boeing 727-223
registered 3X-GDO
operated by UTA
(Union des Transports Africains)

REPORT TRANSLATION
3x-o031225a

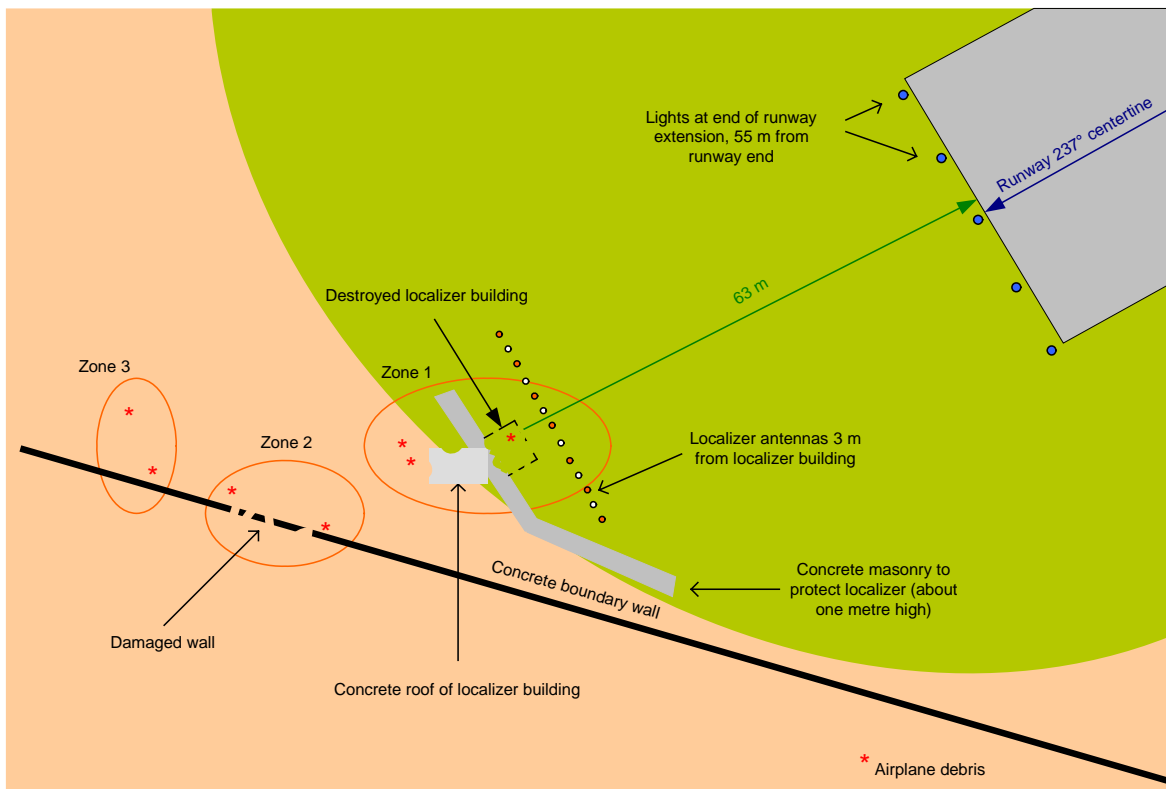
Site 1

The illustration of site 1 (below) shows the distribution of the airplane debris in three distinct zones, with a total area of about 1,550 m².

The airplane damaged the localizer antennas, which were about a hundred and fifteen meters from the end of the runway, then destroyed the reinforced concrete building housing the electronic equipment bays.

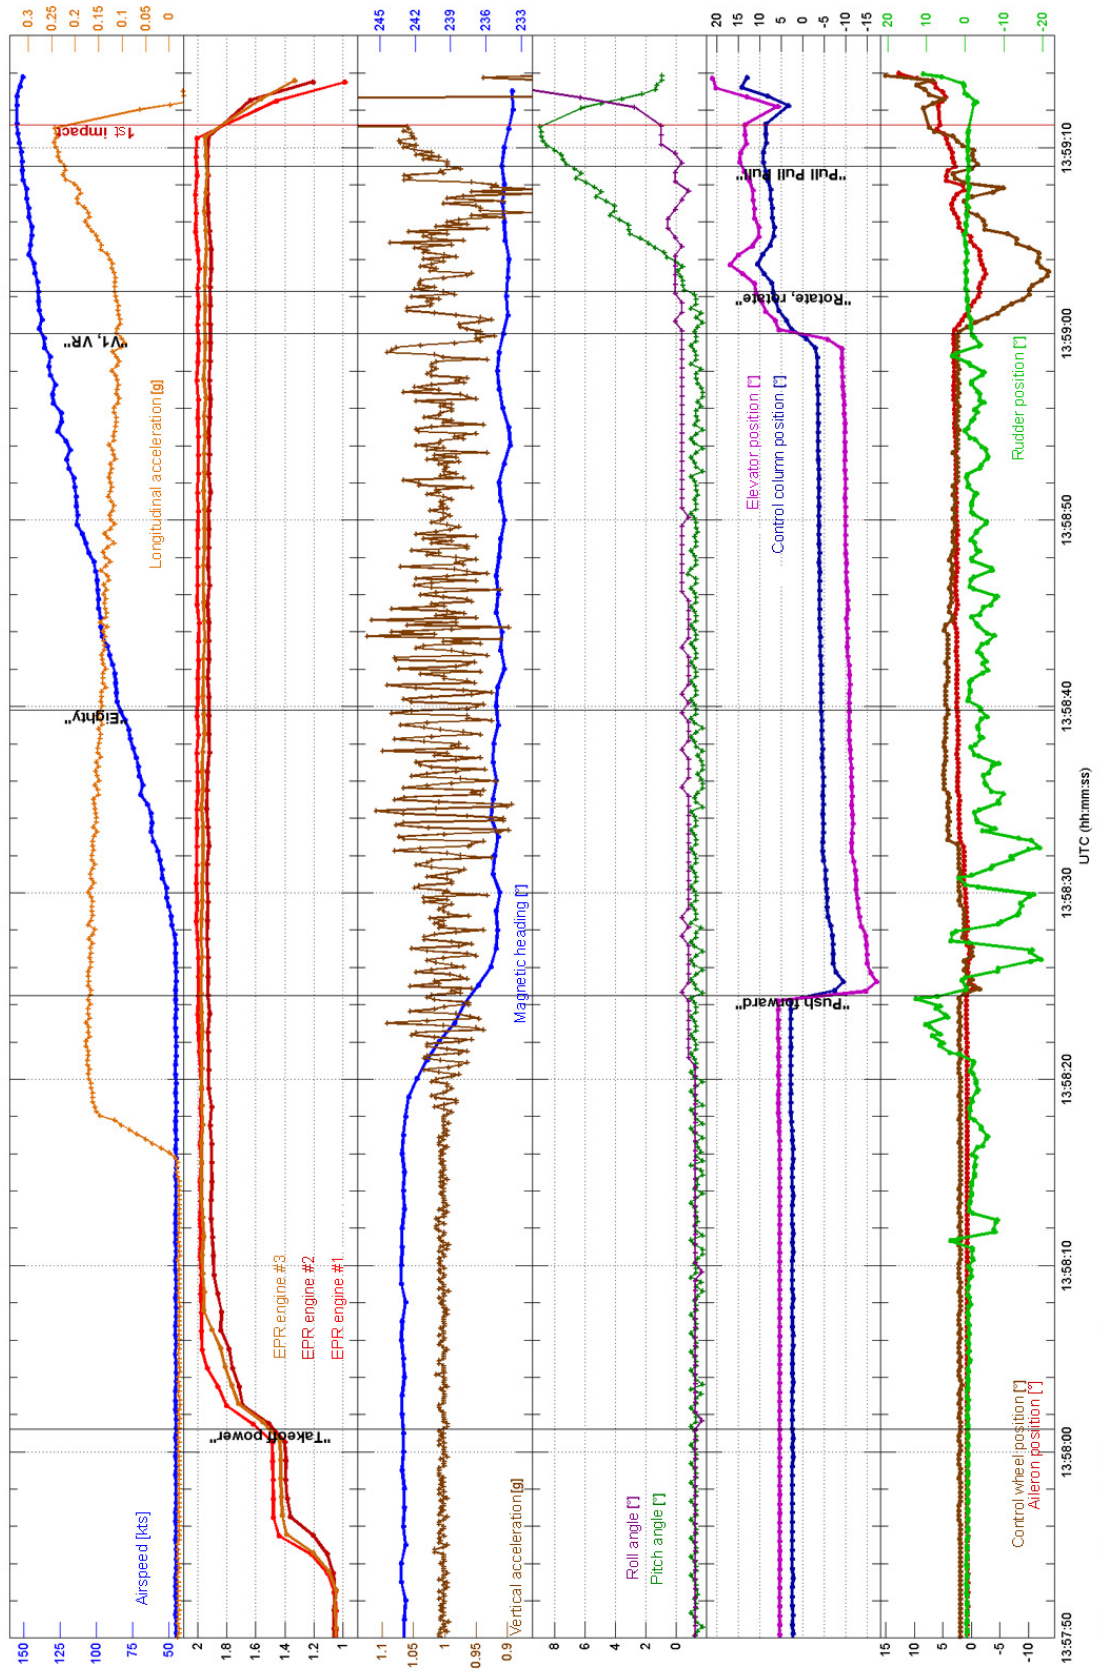
Takeoff in Cotonou, flight of the accident

The graphs obtained from the recorded parameters (see appendix) show that, when the stick was pulled back, the elevator was immediately set in pitch-up position, but that the airplane's response time was very slow compared to the usual time, the nose lifting off late while the acceleration was continuing. Such a situation at the beginning of the climb-out indicates either a limitation in the elevator's operation or an airplane with a center of gravity that is too far forward.
