CAA PAPER 98002

**FRICITION CHARACTERISTICS
OF HELIDECKS ON OFFSHORE
FIXED-MANNED INSTALLATIONS**

I Beaty, Cranfield University

REPORT PREPARED BY COLLEGE OF AERONAUTICS
FLIGHT SYSTEMS AND MEASUREMENT LABORATORIES,
AIRCRAFT GROUND OPERATIONS GROUP
AND PUBLISHED BY
CIVIL AVIATION AUTHORITY, LONDON, MARCH 1998

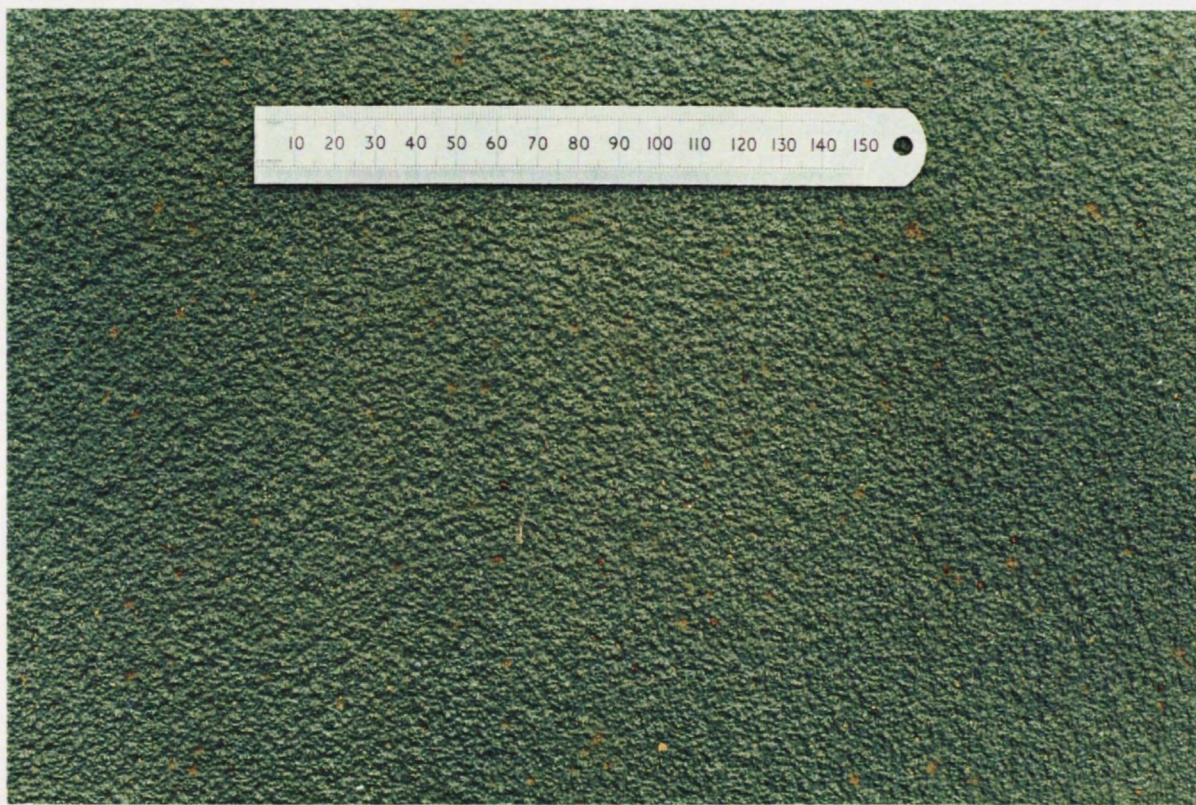
Figure 2 Sealcoat Green Deck Surface

- 2.3.2 The experimental epoxy surfaces were manufactured and laid by Safeway Traffic Products Ltd. The overall surface finish on the helideck was 'Sealcoat Green' (Figure 2) whilst the markings were also of the same epoxy finish, but with an added pigment to give 'Safeflor Yellow' (Figure 3) on the aiming circle and 'Safeflor White' on the 'H' and the platform name. The yellow and white pigmented areas contain retro-reflective materials for improved visibility at night.

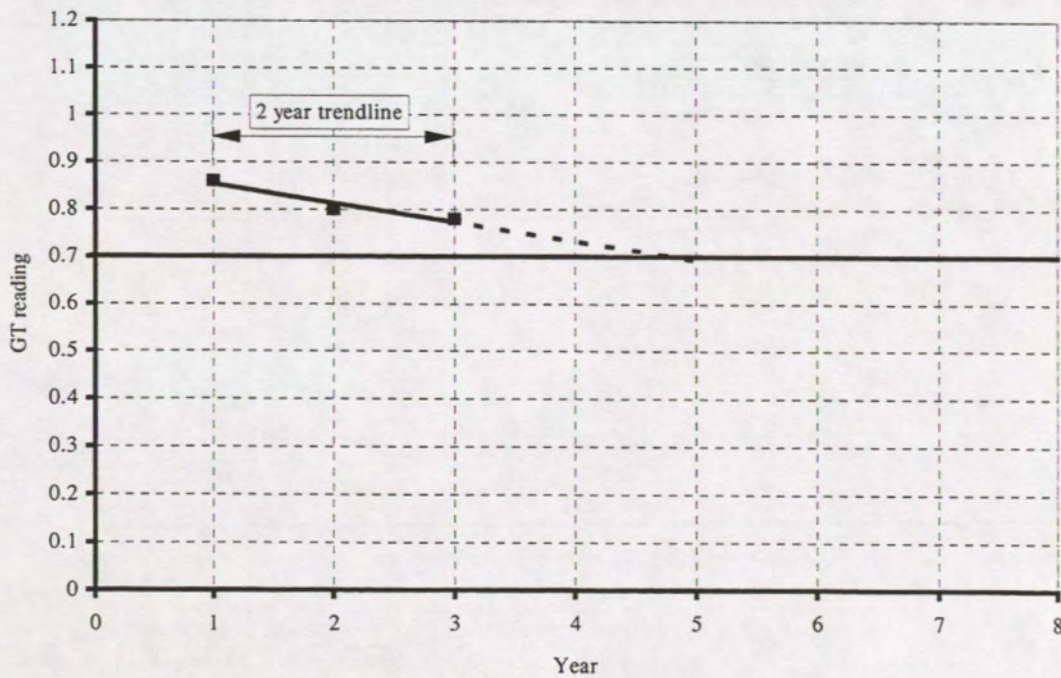
Figure 12 Unacceptable 2yr Trendline

The extension of the 2 year (3 point) trendline falls below 0.7 within 2 years.

3.3.2.1 A flow diagram for the following process is shown in Figure 10. If all three areas of a helideck have demonstrated a friction value of 0.70 or more over the previous three annual friction measurements it is proposed that the period between tests can be increased to 2 years provided that an extension of the 3 point trendline* does not indicate a transgression below 0.70 μ -value within these two years (Figure 11). If the trendline falls below 0.70 μ -value before the two year period expires (as shown in Figure 12) then testing must remain at a one year or 6 month interval as appropriate.

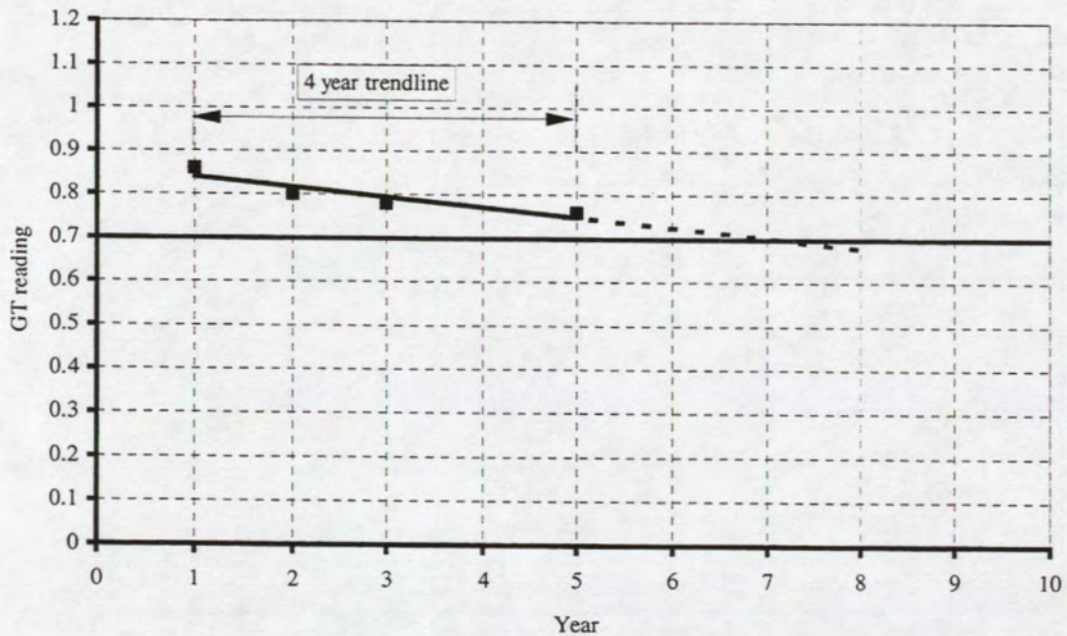
Figure 14 Unacceptable 4yr Trendline

The extension of the 4 year (4 point) trendline falls below 0.7 within three years.

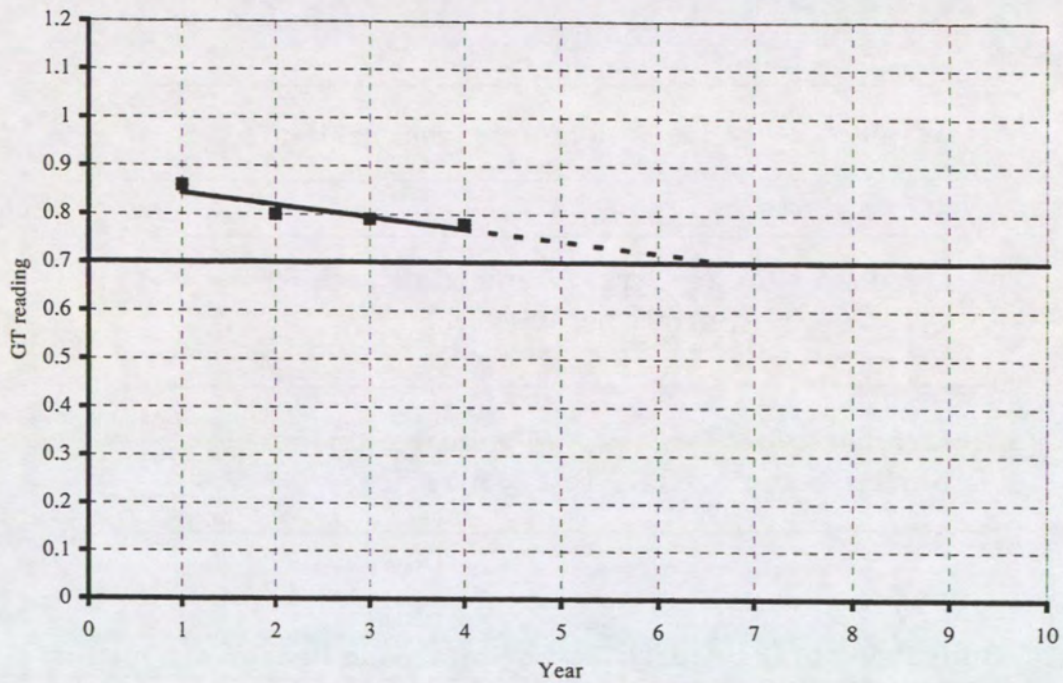
Figure 18 Conditionally Acceptable 3yr (4 point) Trendline

The extension of the 3 year (4 point) trendline crosses 0.7 within 3 years: Retest required in this case after 2 years
