**CAP 661**

**Mandatory Permit Directives**

**For Aircraft Operating on a Permit to Fly**

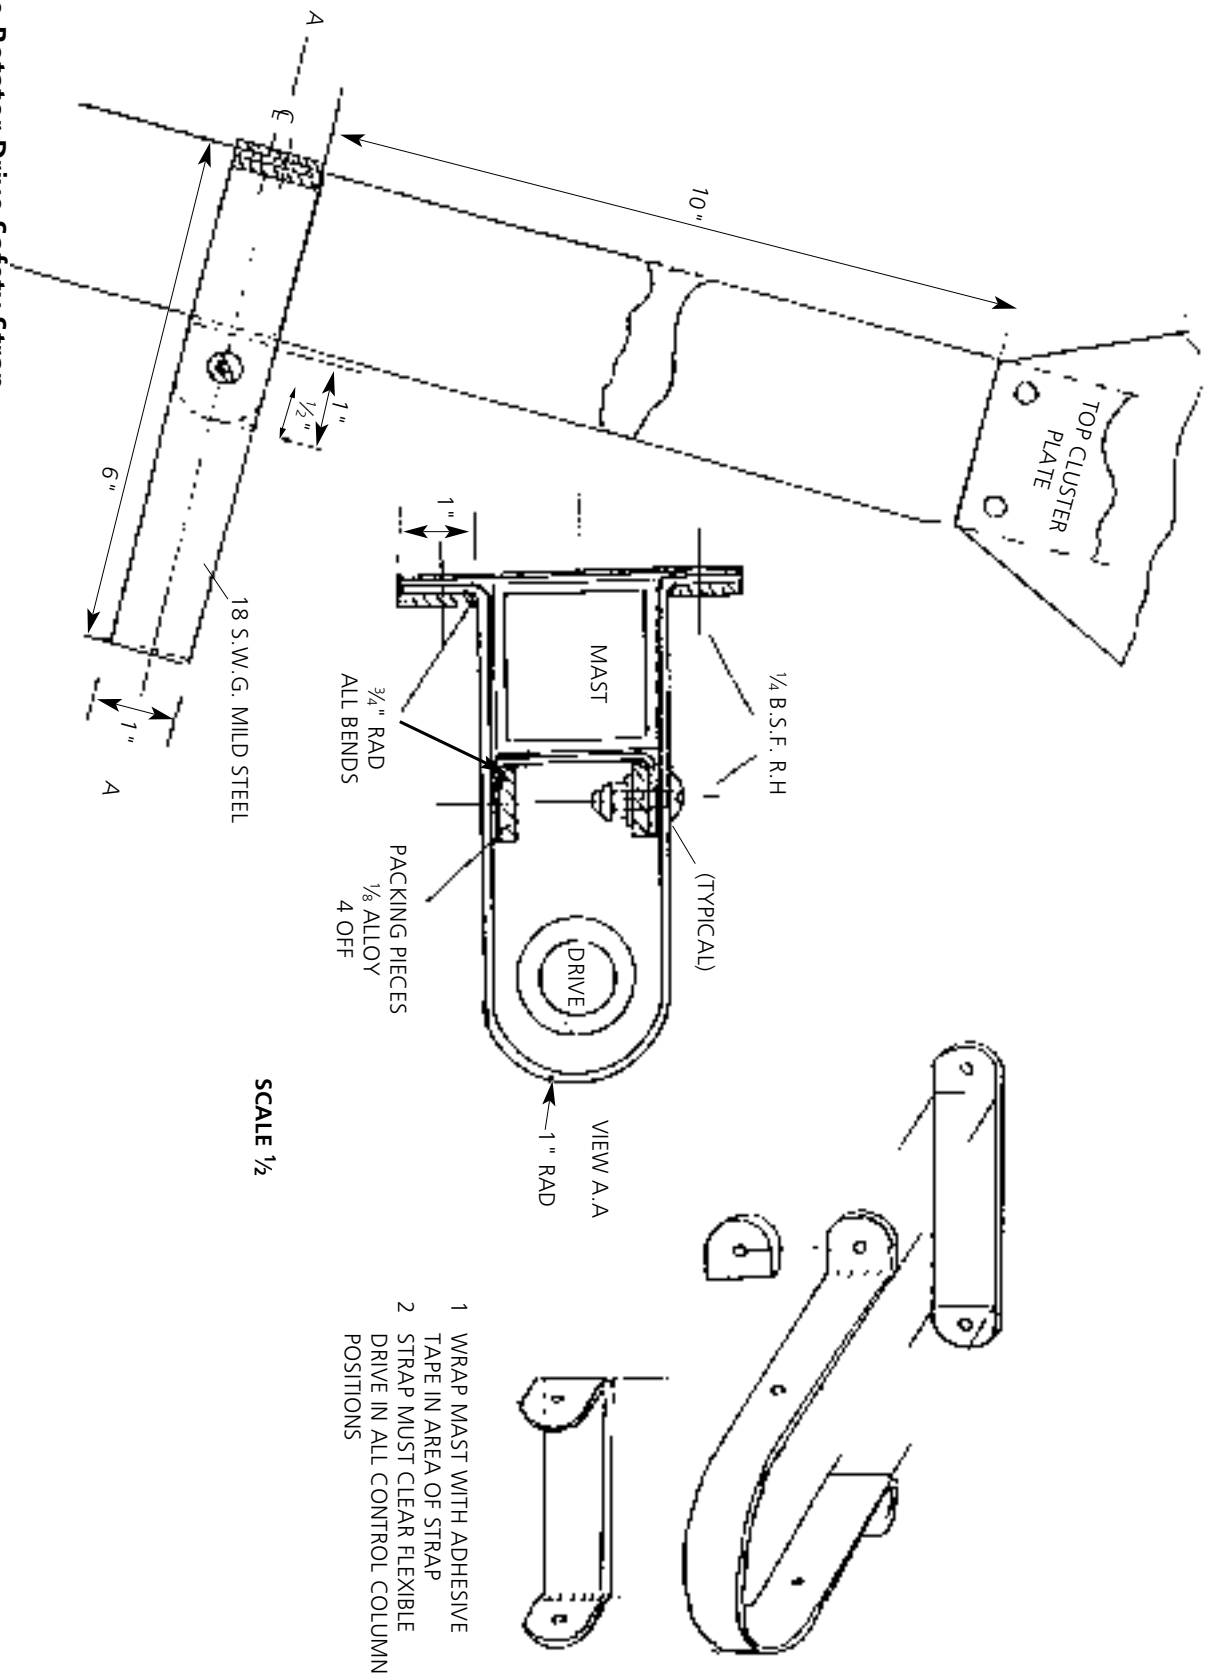
Figure 3

- 2 Check that the flexible drive shaft is correctly restrained in position on the aircraft by a safety collar mounted on the rotor pylon positioned approximately 10" below the rotor head cluster plates. (See Figure 3). This safety collar is a loose fit around the shaft which must be able to move freely up and down as the flying controls are moved. (See Figure 4).

Figure 4 Pre-Rotator Drive Safety Strap

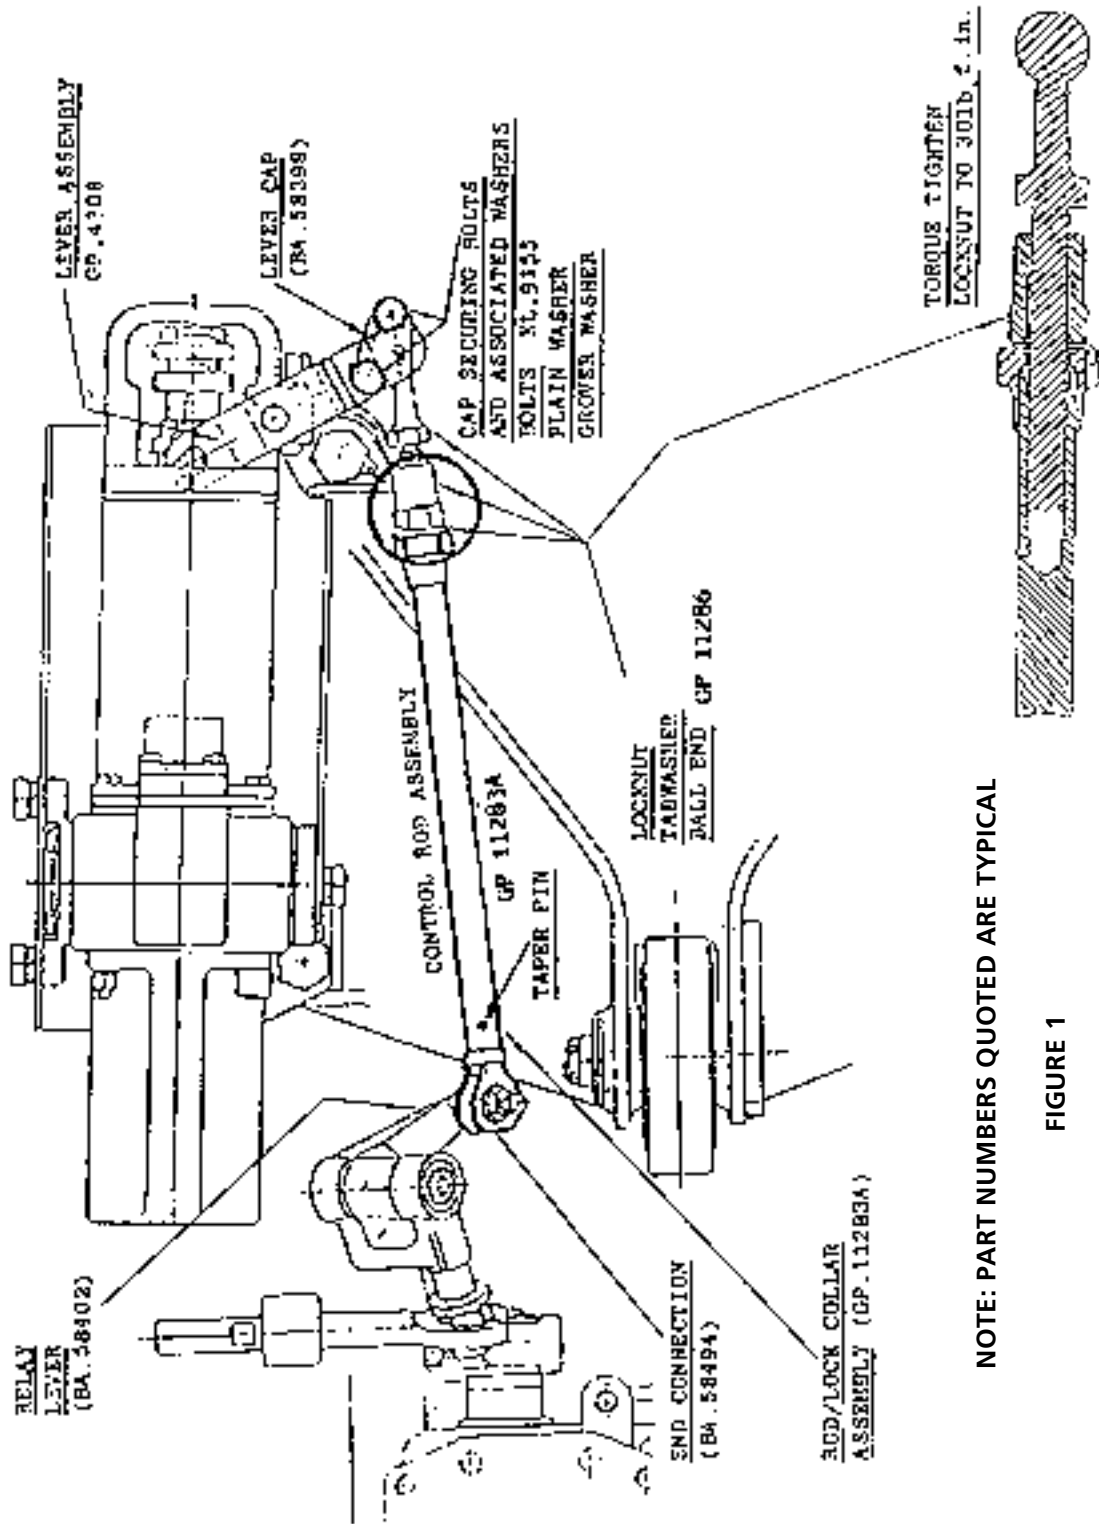
FIGURE 1

TOP TEMPERATURE CONTROL LINKAGE

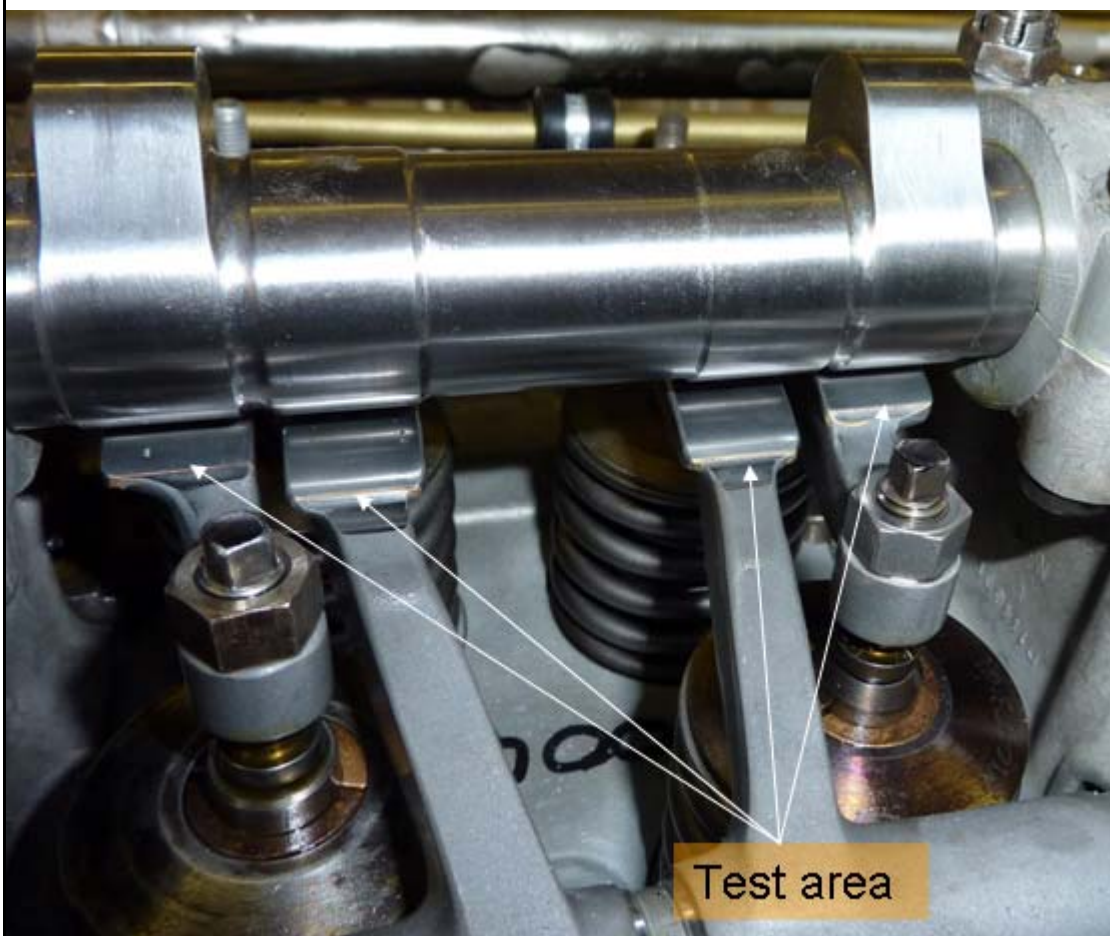
Figure 1.

Any instances of arms rejected from service and details of operating time should be reported to the CAA Aircraft Certification Department.
