Civil Aviation Authority
SAFETY NOTICE
Number: SN-2021/015

Issued: 8 July 2021

Engine Valve Springs
Rolls-Royce and Packard Merlin (All Marks)

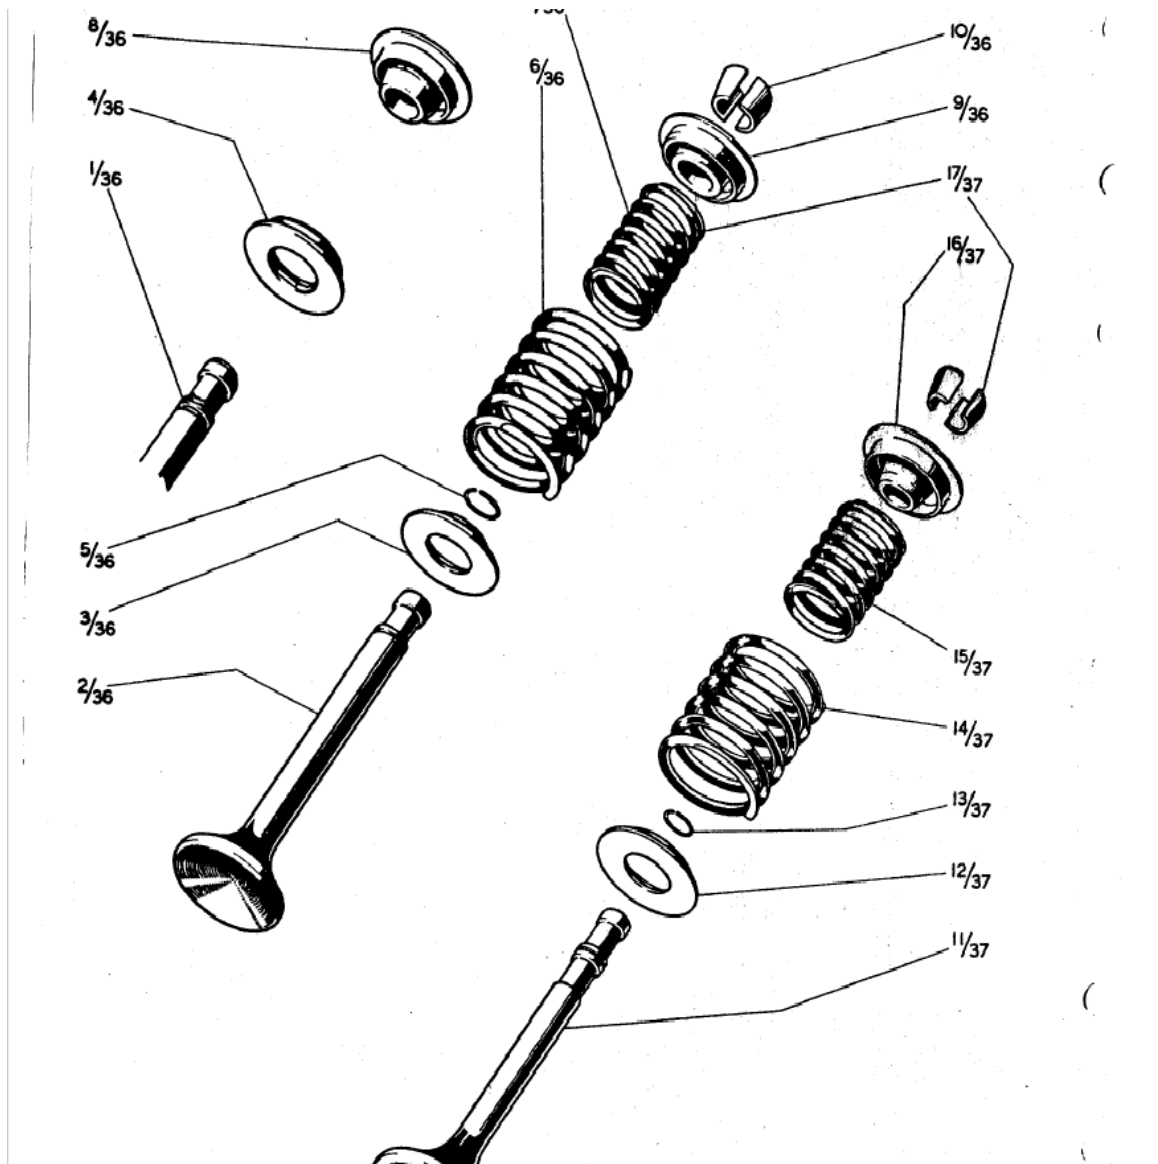
Rolls Royce Merlin Valve Spring Components

- 1.2 Several instances of inlet and exhaust valve spring failures have been discovered during routine engine maintenance on Rolls Royce Merlin series engines, including the discovery of a broken inlet valve spring on examination of engine wreckage from a Supermarine Spitfire accident in 2015. The subsequent investigation concluded that an inlet valve spring failure may have led to cylinder valve complications and subsequent engine loss of power. More recent instances of spring failure have been detected during routine engine maintenance, where the removal of cylinder head rocker covers is required for servicing. Broken springs and/or debris have been found, which can potentially lead to engine damage and loss of power.

- 1.3 An examination and study of a recently found failed inlet valve spring and retaining collet determined that the likely cause was a spring and retaining collet failure due to a high cycle fatigue mechanism propagating from an area of corrosion pitting. The associated collet also subsequently failed due to a high-cycle fatigue mechanism propagating from a corrosion pit or gouge.

- 2) Visually inspect valve springs and collars for signs of gouging, scoring, surface pitting, corrosion or fractures to the springs and retaining collets.

- 3) Check for evidence of missing surface protection on the valve springs and retaining collars. This is evidenced by bright bare metal shiny areas due to rubbing or fatigue, and subsequent loss of surface treatment protection. Such areas should be carefully examined for the onset of corrosion or surface pitting.

- 4) If evidence of gouging, surface pitting or corrosion are found, it is recommended that the component and/or collet should be removed and replaced prior to further flight.

- 5) If any valve spring or retaining collets are found to be broken or incomplete, and the missing fragments or debris cannot be located, accounted for and removed, it is recommended that the engine is taken out of service for further examination.

- 6) Subsequent scheduled maintenance tasks involving valve rocker cover removal should include inspection of valve springs and collets for damage and deterioration.
