OCCURRENCES

Cracking job

Sorting a problem doesn't have to be an issue

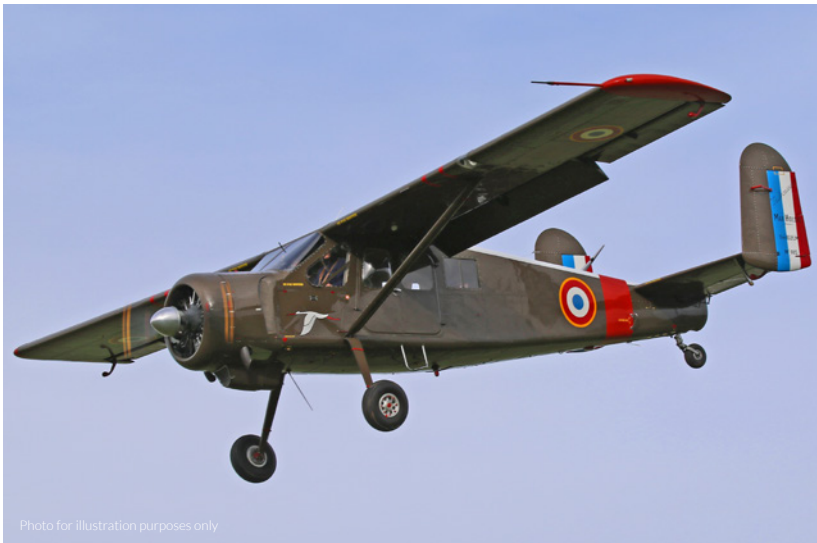
Photo for illustration purposes only

During an annual maintenance inspection on an Avions Max Holst MH 1521 'Broussard' in 2021, longitudinal cracks were found in an undercarriage bracket.

Based upon the collaboration between the CAMO and the CAA, and following a brief consultation period, a Safety Notice was published providing a detailed description of the issue and recommendations for operators of this specific aircraft type regarding the inspection process in relation to the affected part(s).
