**CAA PAPER 2002/04**

**A Benefit Analysis for Cabin Water Spray  
Systems and Enhanced Fuselage Burnthrough  
Protection**

**FAA Reference: DOT/FAA/AR-02/49**

**Report prepared by R G W Cherry & Associates Limited**

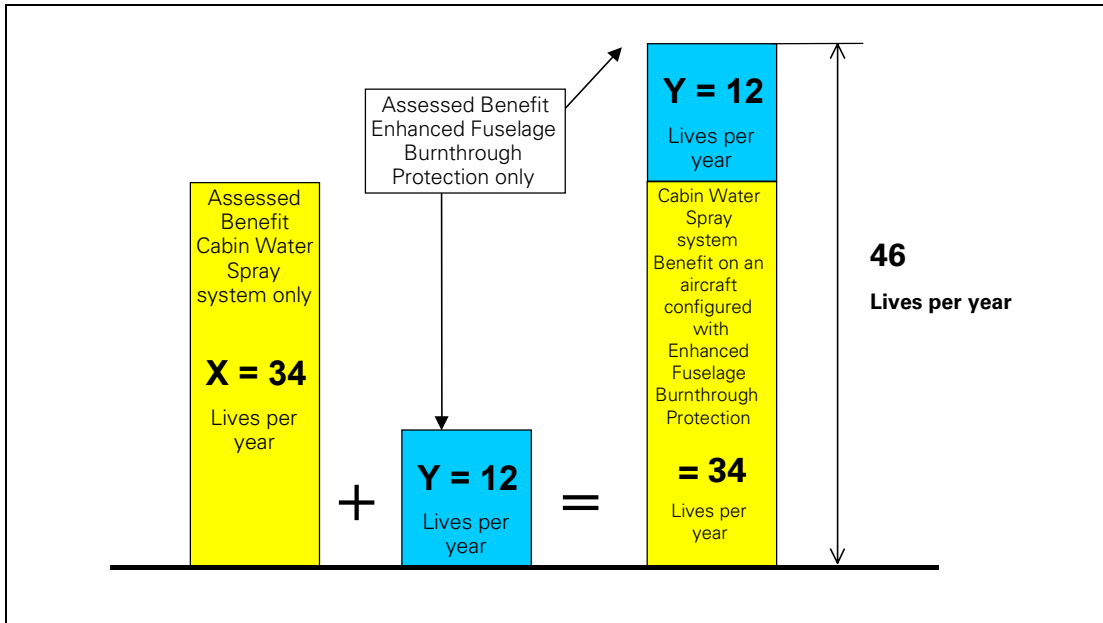
- Figure 3 and Figure 4 illustrate the resultant benefit in terms of number of lives saved per year by a Modular and Singular Cabin Water Spray system respectively. It may be seen that for a Modular System the assessed Benefit provided by a Cabin Water Spray system fitted to an aircraft configured without enhanced Fuselage Burnthrough Protection is 34 lives per year. The assessed Benefit for an aircraft configured with enhanced Fuselage Burnthrough Protection is also 34. The Benefit from the Cabin Water Spray system is reduced, to some extent, by the lives having been saved by enhanced Fuselage Burnthrough Protection. However, this is compensated for by the two improvements providing sufficient protection in combination than the sum of the two individually. This situation does not appear to be the same for the Singular Cabin Water Spray system in that the two improvements combined result in less Benefit than the sum of the two individually. However, it is considered that the levels of accuracy of the predictions of Benefit

**Figure 3** Illustration of Benefit combination for enhanced Fuselage Burnthrough Protection and a Modular Cabin Water Spray system

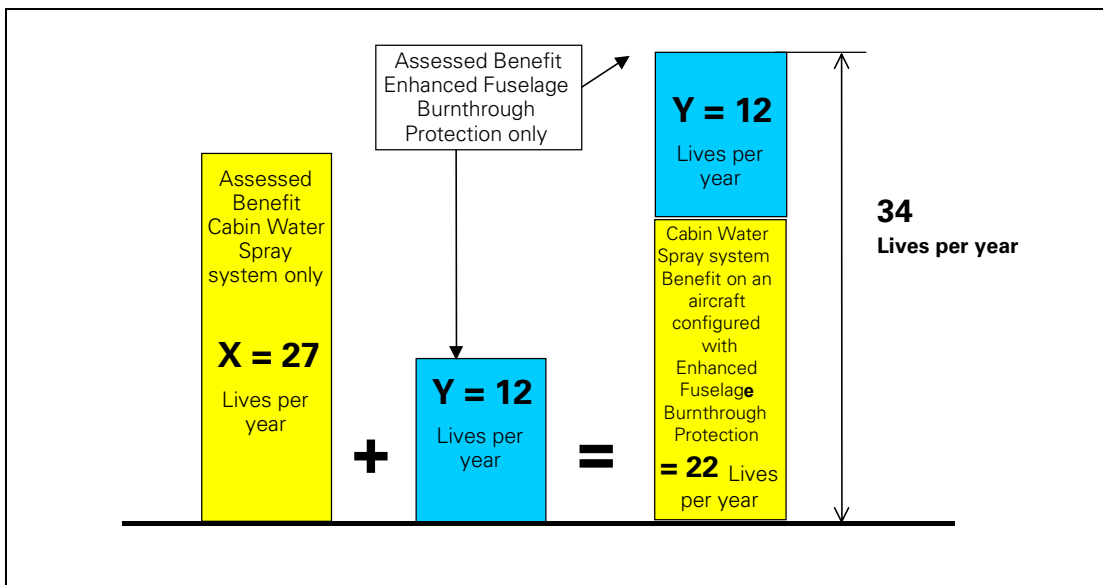
**Figure 4** Illustration of Benefit combination for enhanced Fuselage Burnthrough Protection and a Singular Cabin Water Spray system
