# CAP 762

The Effectiveness of Image Recorder  
Systems in Accident Investigations

Issue 1, 10 November 2006

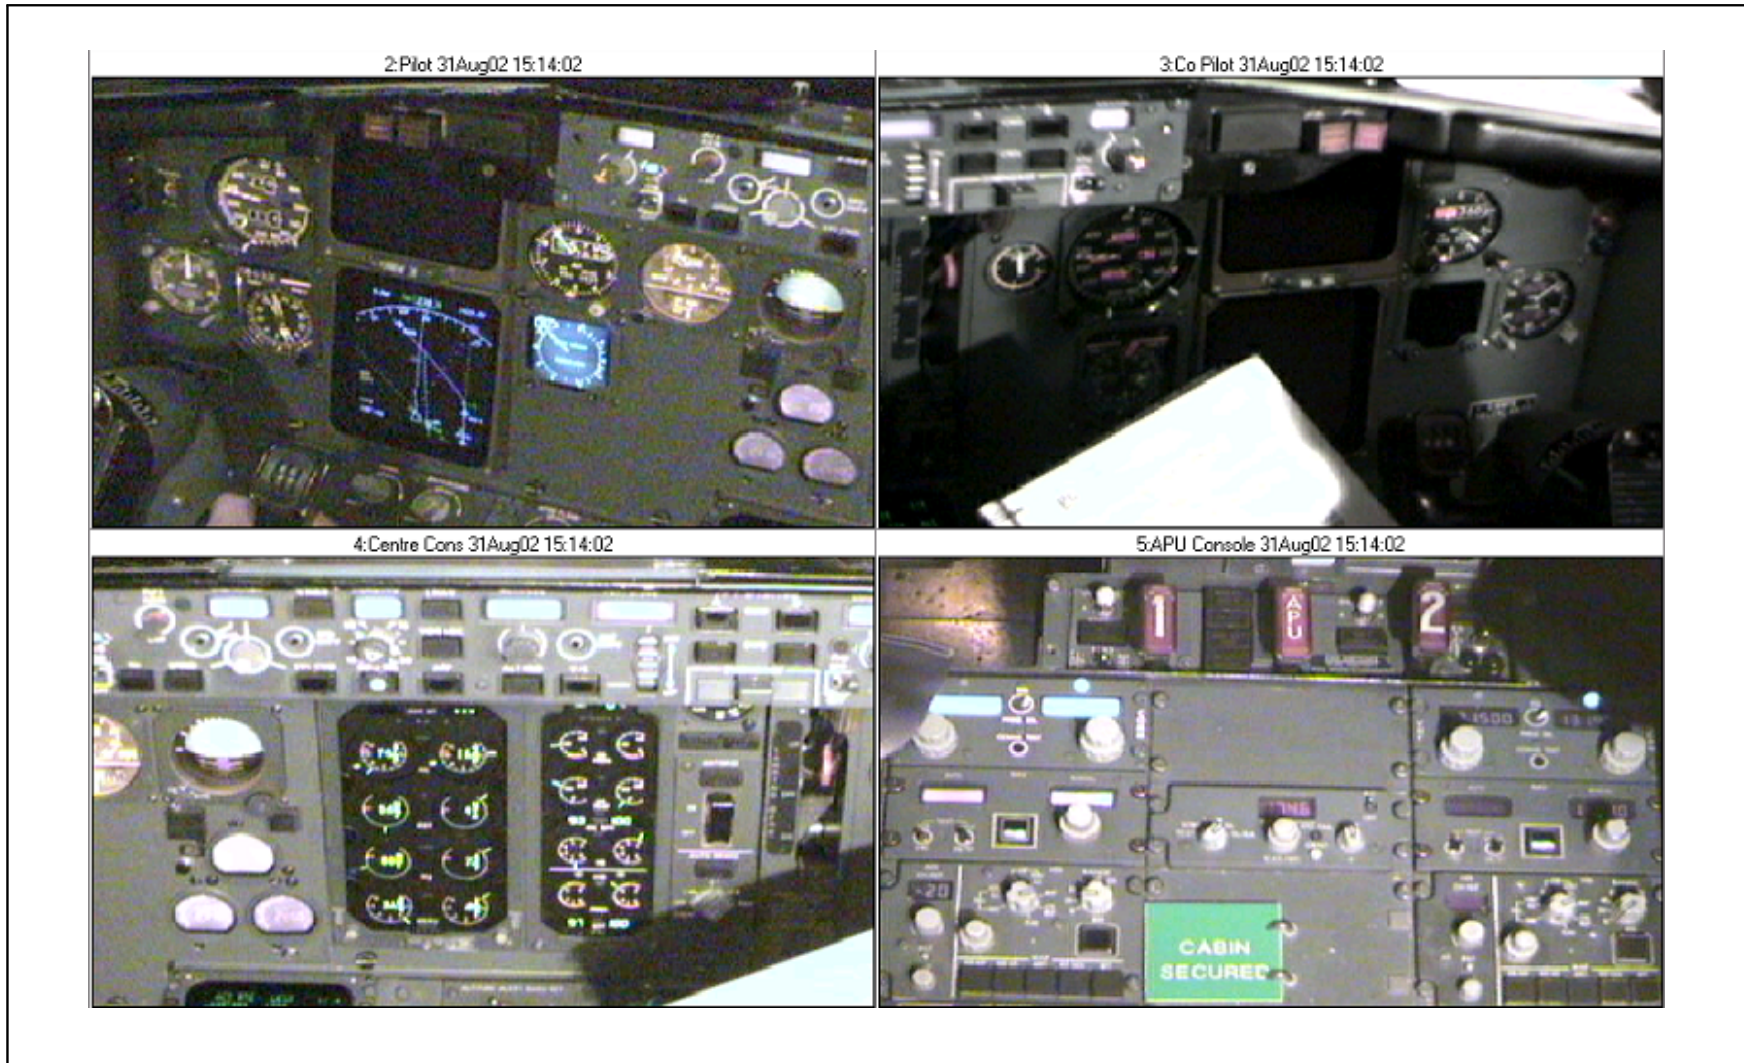
**Figure 2** Images Supplied by Camera Views

The selected camera angles/locations resulted in the following types of image:

After reviewing the images presented it was agreed that they provided sufficient coverage of the flight deck instruments to allow the investigators to attempt an analysis of the accident scenarios. As previously stated, the camera installation did include one "typical" general area view which the investigators were instructed to use **only if they could not gain the information in any other way** as this camera did allow flight crew to be identified.
