CAA PAPER 2009/06

**Hazard Analysis of the Use of GPS in Offshore
Helicopter Operations**

February 2010

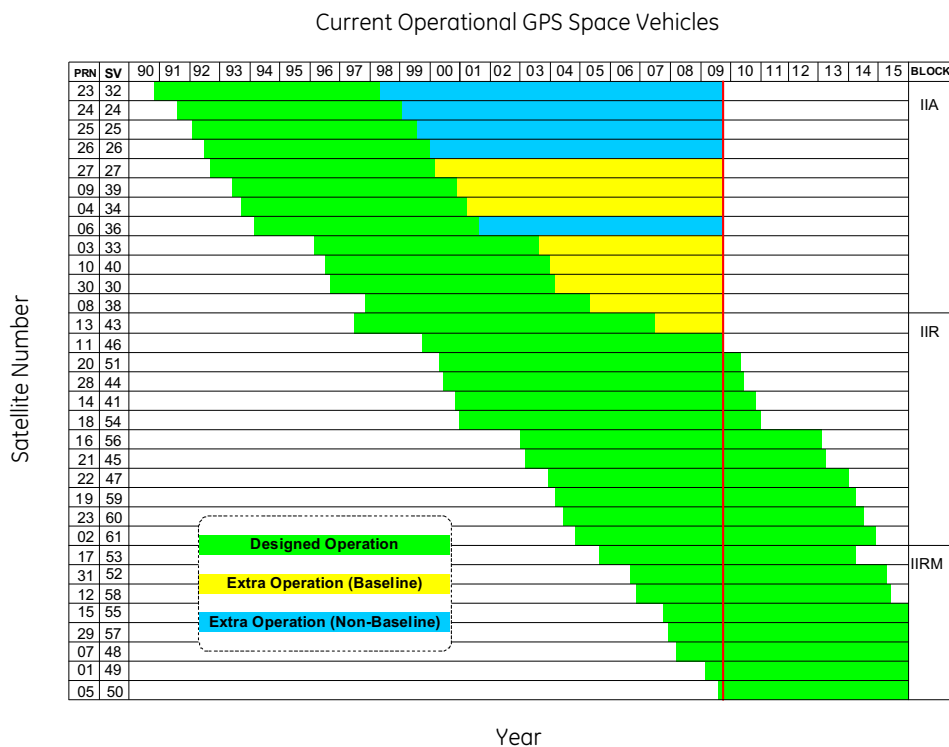
Figure 2-1: Status of GPS Constellation as at 30 September 2009 (Design vs Actual Life)

The limited overall effect of the loss of satellite signals 'seen' during the offshore approach trials was due to the redundancy in the GPS space segment, i.e. an aircraft can usually 'see' more satellites than it actually needs to generate a position solution. It is a fact, however, that many of the satellites in the GPS constellation are operating well beyond their design lives and some are only one failure away from complete collapse – see Figure 2-1.

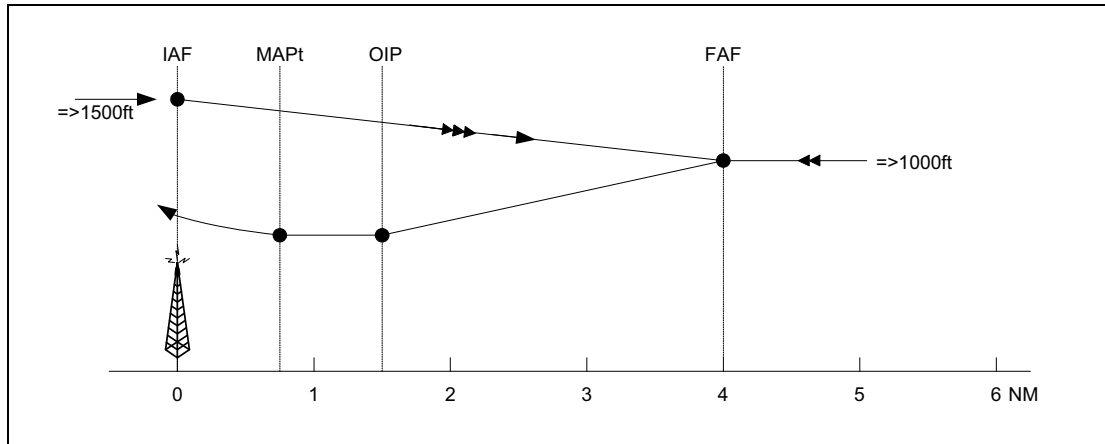
Figure 4 ARA approach procedures (vertical profile) (Bristow)

- 2.5.1 The intermediate segment commences at the IF.
- 2.5.2 It ends at the Final Approach Fix (FAF) and should be no less than 2 NM in length.
- 2.5.3 Bristow alteration: The Bristow procedure does not include an intermediate segment (see Figure 3 and Figure 4).
- 2.5.4 The purpose of this segment is to align and prepare the helicopter for the final approach.
- 2.5.5 The destination should be identified on the weather radar, and the final approach and missed approach areas should be identified and verified to be clear of radar returns.
- 2.5.6 MOC is at 500ft.
- 2.5.7 Prior to descent, the radar altimeter and barometric altimeter are cross-checked.

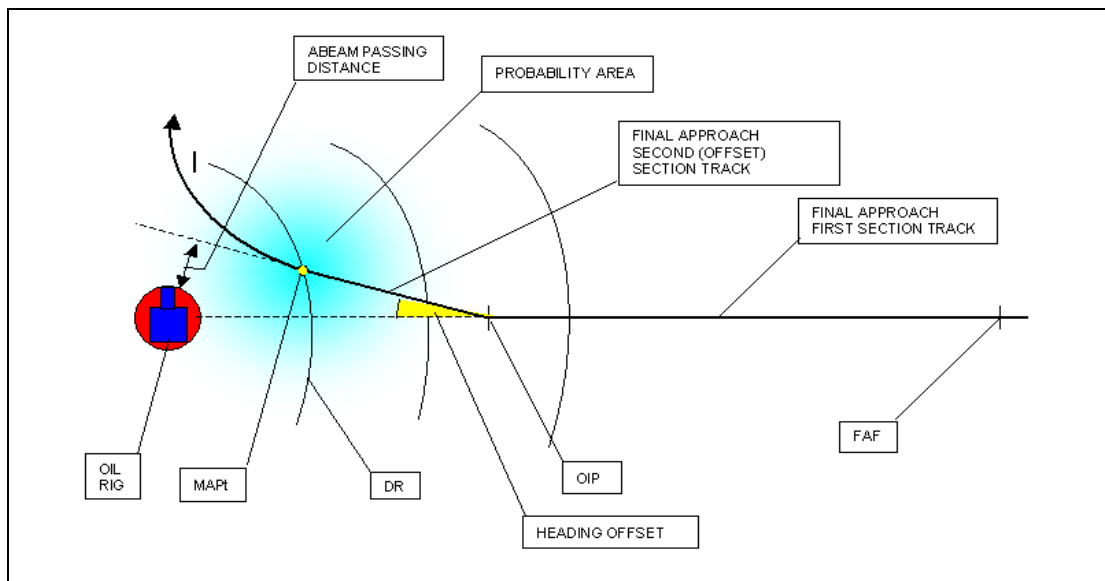
FINAL APPROACH TRACK & OFFSET INITIATION POINT

The final approach segment has two sections. The first section lies between the final approach fix (FAF) and the offset initiation point (OIP). During this phase of the flight at a 'given' airspeed (input parameter), the flight crew will carry out what is essentially a sampling process, with repeated assessment and adjustment of the aircraft heading taking place, so that by the time the OIP is reached, the drift will have been compensated and a relatively precise heading will have been determined. This will define a track that, if maintained, would take the helicopter to the centre of the oil installation. However, it is inevitable that there will be a tracking error present (input parameter - see below), taking the form of a Normal Distribution in which the mean track so identified would most often lead to the central area of the oil installation. Fewer tracks can be expected to intersect with the edges of the oil installation and a very few might miss the oil installation altogether.

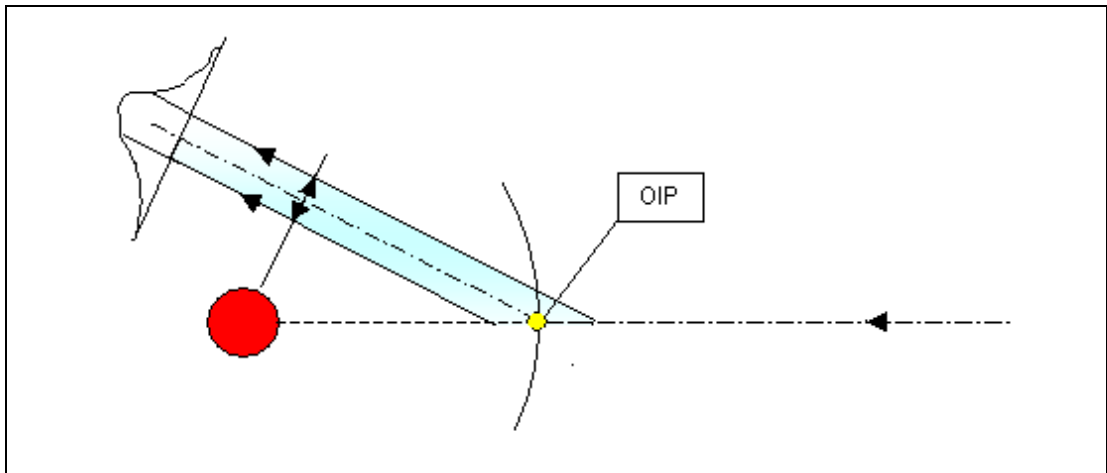
RANGE DERIVED ERROR

- I.3.7 The OIP is defined as a radar range (input parameter), and this is considered to be subject to a mean radar ranging error (input parameter) and to a random radar ranging error (input parameter) with a Normal Distribution.

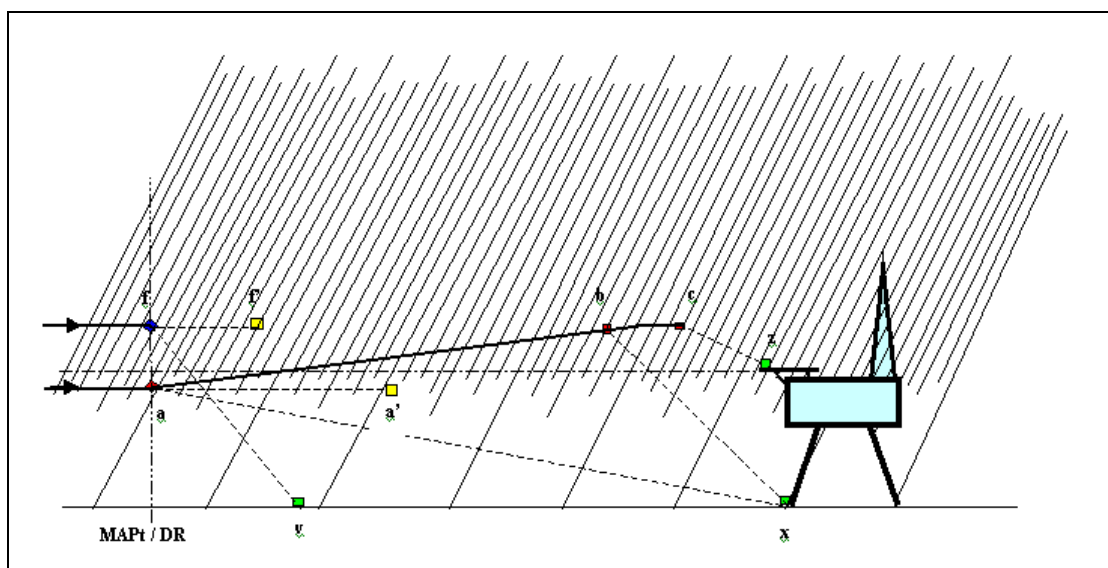
MDH v VISIBILITY (SECOND CASE)

- I.3.20 Consider now, the case where the cloud and visibility are denser than in the previous example.
- I.3.21 The pilot of a helicopter at point (f) flying at an MDH 50 ft to 100 ft above helideck elevation will not see the oil platform. The forward limit of horizontal visibility will be point (f') and the furthest point that can be seen on the surface will be (v). This aircraft will, therefore, execute a go-around.

- I.3.22 The pilot of a helicopter at (a) will have a limit to his horizontal visibility at (a'), but will be able to see the base of the oil platform at (x). However, as he climbs to above helideck elevation he will lose contact with the oil platform and may not regain contact with it until he is dangerously close at point (b). Nor will he make visual contact with the helideck until he closes to point (c). This is clearly unsatisfactory and indicates why the MDH/A should not be lower than 50 ft above the helideck.

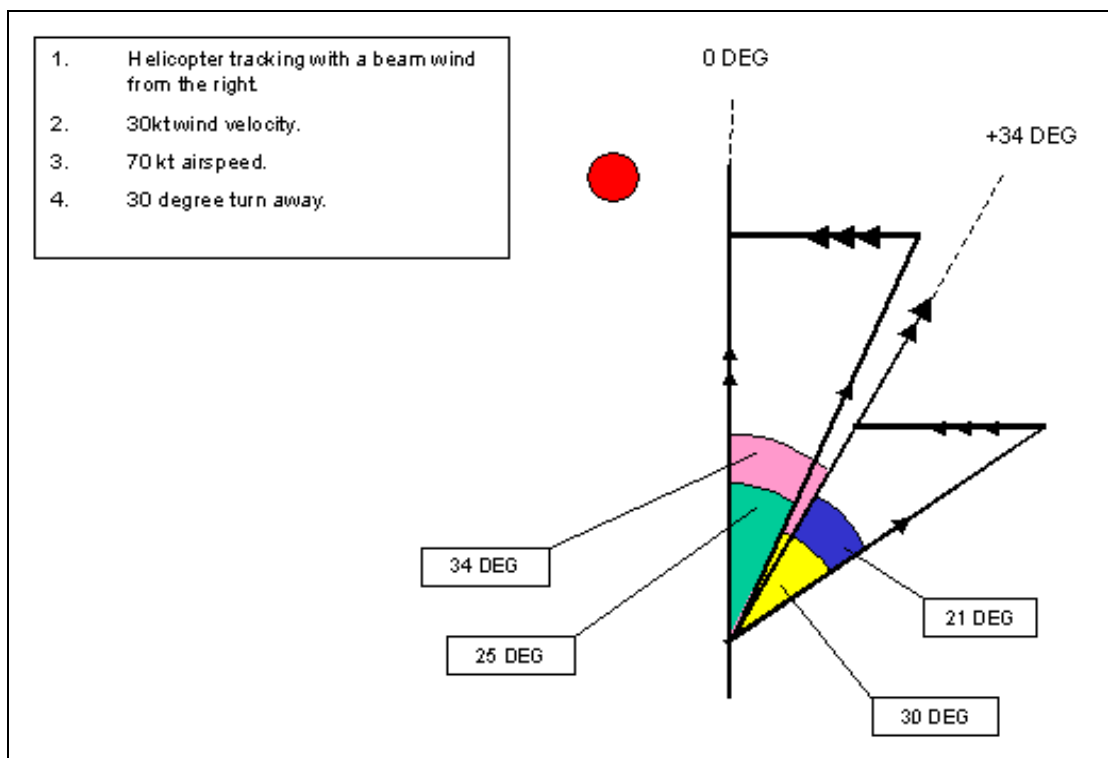
I.4.3 In the final example shown above, the helicopter is maintaining the desired final approach track with a 30 kt beam wind from the right with 25 degrees of left drift. In this case a turn-away of 30 degrees to the right has resulted in a change in track of 34 degrees to the right.

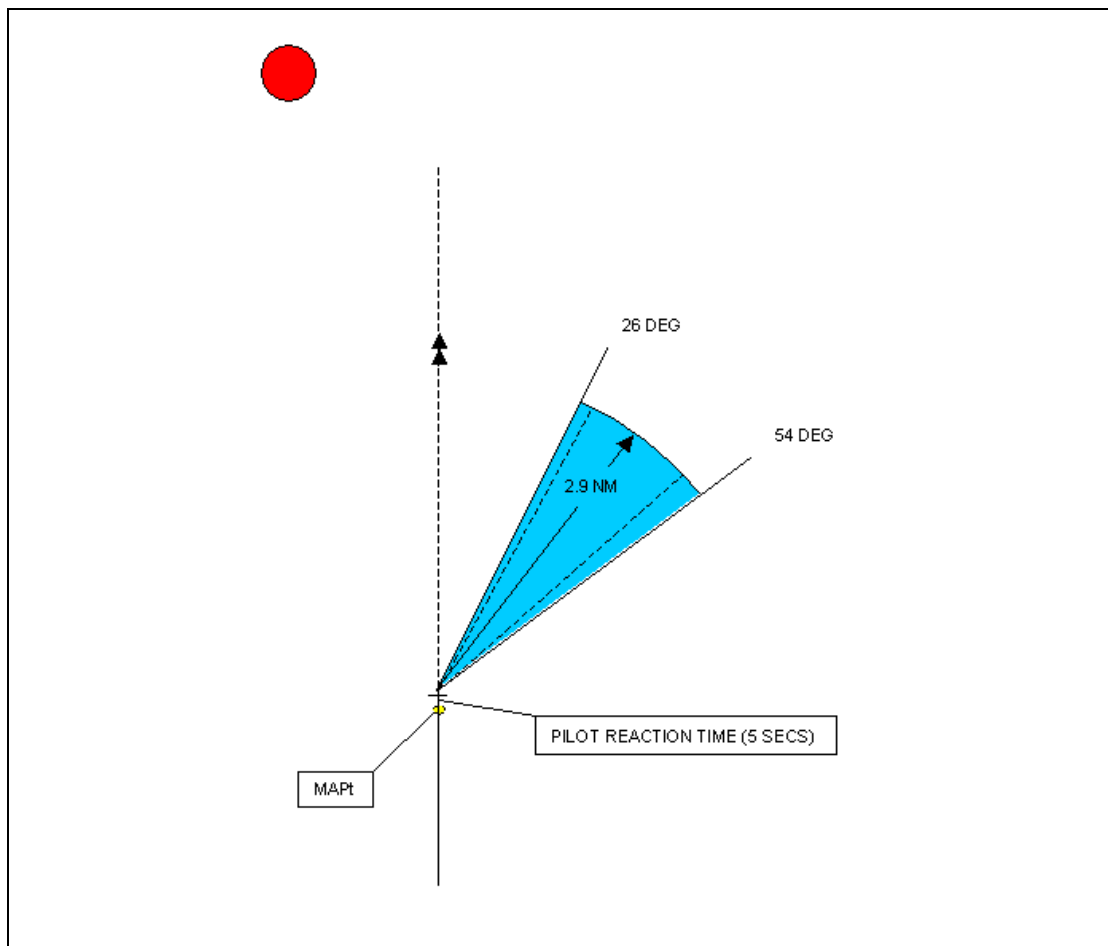
- Turn-away 30 deg
- Pilot Reaction 180 mtrs (5 secs)
- Flight Technical Error - 2 / + 5 deg
- W/V (Head & Beam) 0 - 30 kts
- TAS 70 kts
- Rate of Turn Rate 1
- Gradient of Climb 2.5%
- MOC 132 ft
- Obstacles 500 ft (assumed)
- Height Gain 432 ft
- Horizontal Distance 2.9 nm

- I.5.2 The missed approach segment commences on go-around from the final approach. It normally begins at the MAPt, but in the event of an early go-around may start from anywhere within the final approach area. It ends when the helicopter reaches minimum en-route altitude. The manoeuvre is a "turning missed approach" which, to be compatible with the decision range of 0.75 nm, must be not less than 30 degrees. However, it should not, normally, be greater than 45 degrees. A turn away of more than 45 degrees does not reduce the collision risk factor any further, nor would it permit a closer decision range (DR). However, turns of more than 45 degrees may increase the risk of pilot disorientation and, by inhibiting the rate of climb (especially in the case of a one engine inoperative (OEI) go-around), may keep the helicopter at an extremely low level for longer than is desirable.

I.4.4 With this information it is now possible to construct a turning missed approach template (footprint) as follows shown below.

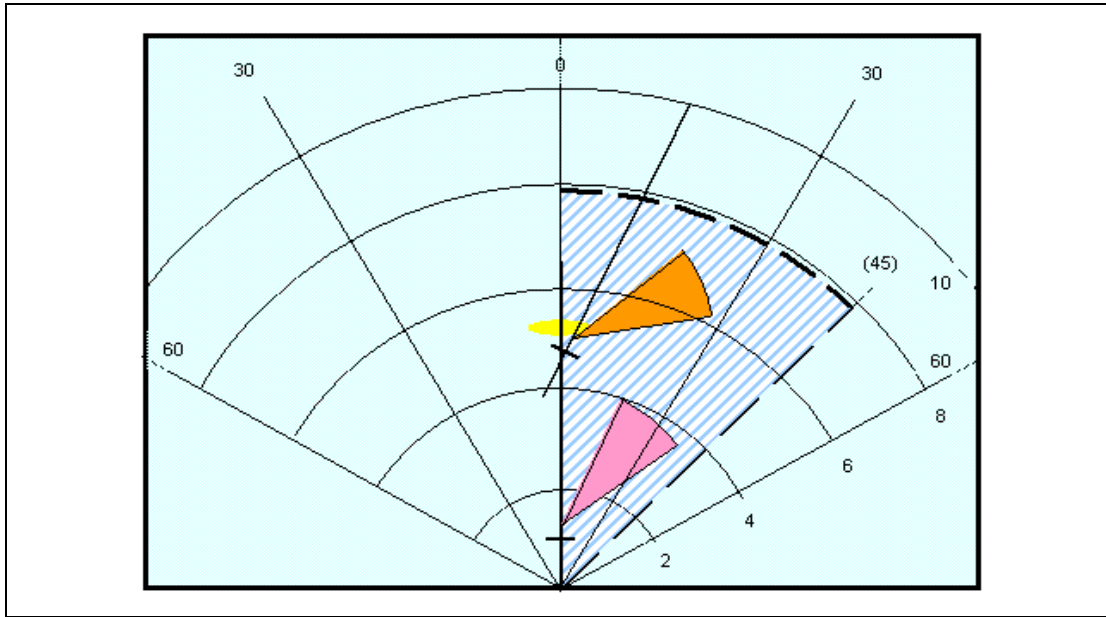
- I.5.7 However, this area may be refined and reduced in size if the associated complication of the procedure during the intermediate and final approach segments can be tolerated as follows:

1.5.8 In the case of a procedure which specifies a turning missed approach of 30 degrees, the missed approach area which must be clear of all radar returns, may be reduced to a 30 degree sector originating at the 5 nm point and orientated 0 to - 30 degrees or 0 to + 30 degrees, left or right of the final approach track. However, in order to protect the aircraft in the circumstance of an early go-around, the missed approach procedure must specify a climb straight ahead until within 3 nm of the radar return for the destination before the turn-away is commenced.

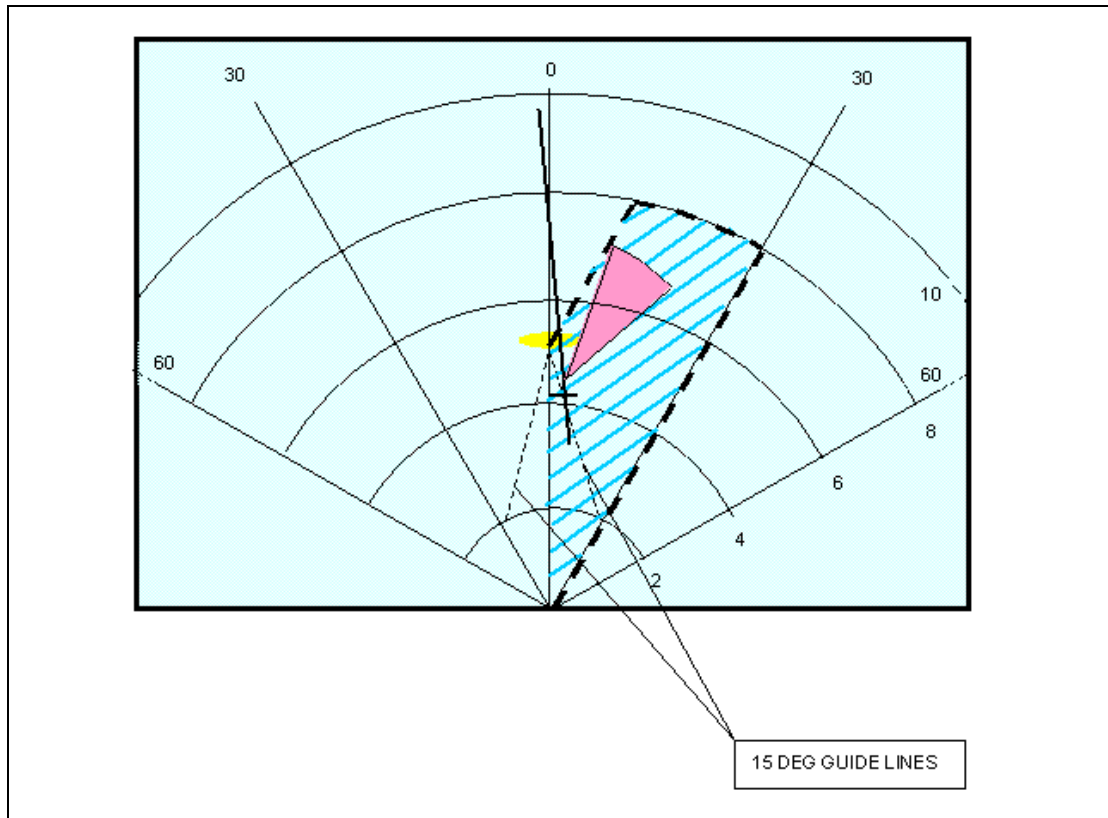
- I.5.9 The sectors which originate at the destination and lie within ± 30 degrees of the extended final approach track beyond the radar return of the destination, may also be deleted from the required missed approach area, but only if the final approach prior to the OIP is constrained within ± 15 degrees of the initial heading identified at the final approach fix. A change in heading during this segment of more than ± 15 degrees will indicate that the approach has not been stabilised and, consequently, the standard missed approach must be executed.
