**Paper 2013/03**

**Reliability of Damage Detection in Advanced  
Composite Aircraft Structures**

**Prepared for CAA by:**    **L Cook**  
                                  **A Boulic**  
                                  **D Harris**  
                                  **P Bellamy**  
                                  **P E Irving**  
                                  **Cranfield University**

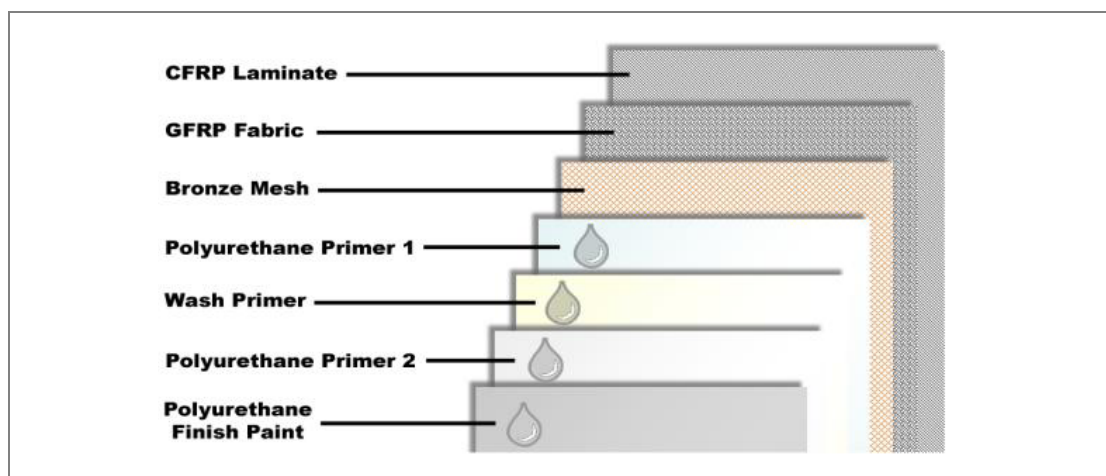
CFRP aircraft structures include metal mesh lightning strike protection and are normally externally painted [2-4]. A typical section through a horizontal stabiliser skin material is shown in Figure 3 [2]. CFRP plies are the innermost layer.

**Figure 3** Material Lay-Up and Paint Coats applied to Horizontal Stabiliser Skin

A thin layer of GFRP fabric separates the bronze mesh and the CFRP to avoid galvanic corrosion between the carbon fibres and the metal mesh.

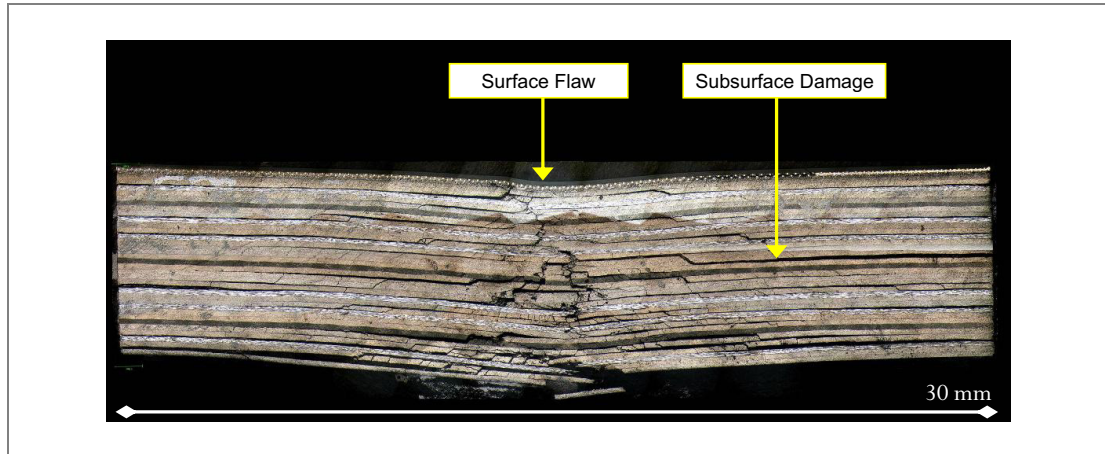
**Figure 4** Cross section through impact damage to a 33 ply, bronze mesh incorporated, painted, CFRP laminate [9]

The subsurface delamination and cracking will be invisible on visual inspection, only the surface flaw being visible. As seen in figure 4, the visible surface flaw due to impact damage can often be significantly smaller in width than the subsurface delamination.

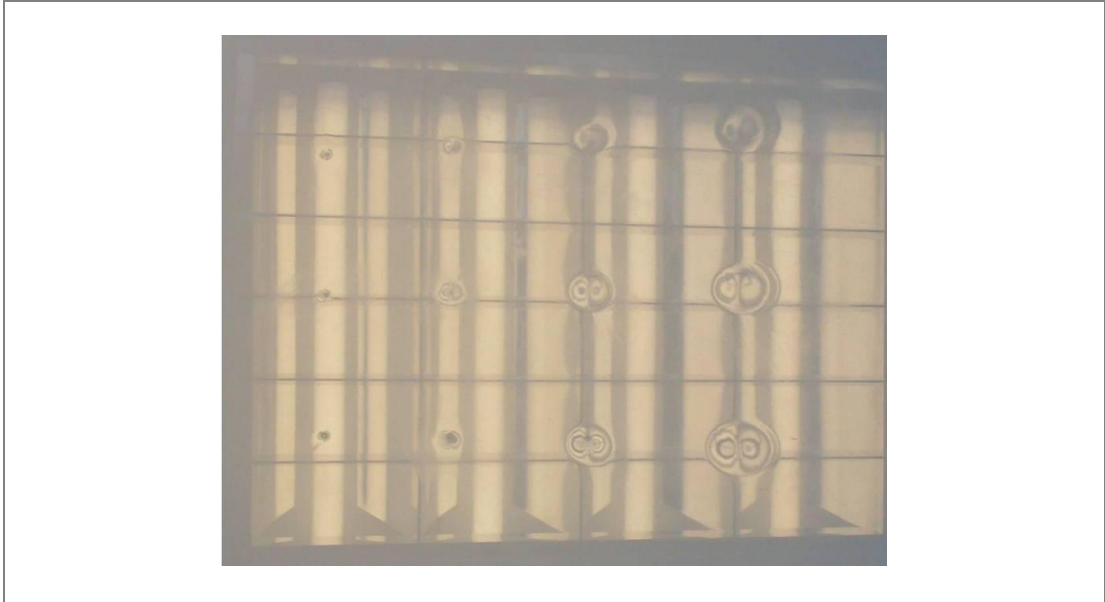
Humans are able to identify distortions in reflections of light, which also provide depth cues to the eye. Figure 6 illustrates the patterns of light reflected by a glossy surface containing several circular, hemi-spherically shaped surface flaws. The flaws are identifiable because they distort the reflection of grid pattern of the lighting luminaire (light fitting reflection housing).

**Figure 6** Surface flaws producing distorted reflections

The reflections seen in Figure 6, and those of people seen on the aircraft in Figure 8, are specular reflections, i.e. they are reflected by the surface of the material. The shape of the surface flaw determines how it distorts these specular reflections – a deep, sharply contoured flaw will produce different distortions to a much wider, less deep, softer contoured flaw. Glossy materials will produce clear, mirror-like undistorted reflections of a light source or object, semi-matt materials will distort the reflections, and matt materials will not reflect a discernable image of the original object.

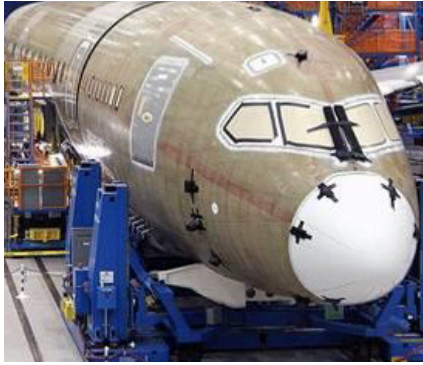
The majority of published literature [e.g. 7,8] on impact damaged composites refers to impact testing of unpainted laminates without a metal mesh. The appearance of the damage created would be seen on an aircraft only if it were to leave the factory without lightning strike mesh or paint, as seen in Figure 7. An aircraft inspector is more likely to be performing visual inspection of a fully finished aircraft, as seen in Figure 8.

**Figure 7** Unfinished structure of Boeing 787 aircraft\*

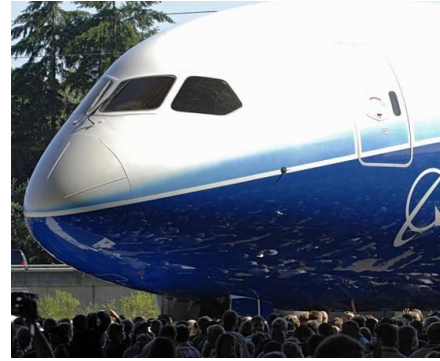
**Figure 8** Fully finished, painted Boeing 787 aircraft\*

A surface flaw produced by impact may have a different shape and appearance on a fully finished aircraft compared with that on an unpainted laminate without a mesh. Furthermore, as seen in Figure 8, in-service aircraft may be painted in a range of different colours. The flaw shape and size, the surface colour, and the surface finish may all affect the visual appearance of a surface flaw. Depth cues provided by a surface flaw on an unpainted laminate without a mesh may have little relevance to those provided by a painted laminate with mesh incorporated,

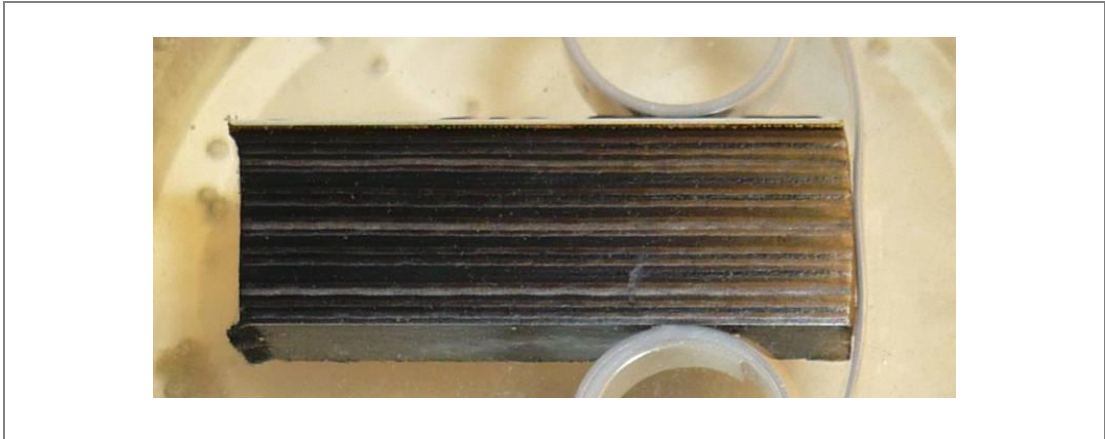
The lay-up was de-bulked every 5 plies. The lay-up for one of the 17 ply and one of the 33 ply panels included a single layer of glass fabric and a single layer of bronze mesh on one side of the panel before curing. After co-curing the carbon layup, glass fabric and bronze mesh at 180°C according to the manufacturers recommended cure cycle [37], the mesh incorporating side of the panels were painted by GKN Aerospace with primer and paint according to Airbus specifications [38]. Samples of undamaged laminate were sectioned and polished and examined using optical microscopy to confirm that the ply layup sequence was correct. Figure 9 shows a section through the laminate, illustrating that the laminate produced was of good quality, i.e. free of voids or resin rich areas, correct fibre directions for each ply. The completed painted and unpainted panels were cut into 100 mm x 150 mm coupons for impact testing.

**Figure 9** Section through 17 ply laminate with bronze mesh, glass fabric and paint layers

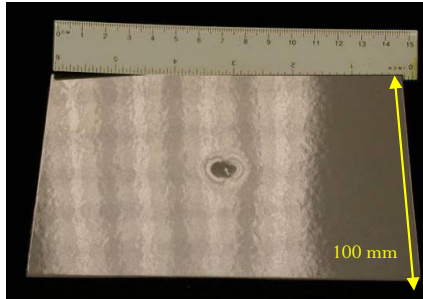
**Figure 10** 20 mm impact at 20 J on 17 ply painted laminate produced a smooth circular surface flaw

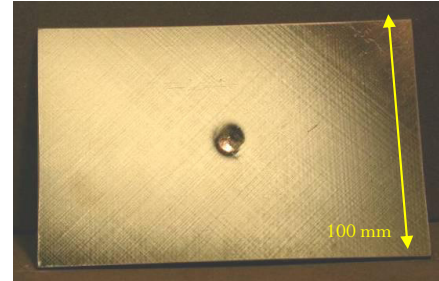
**Figure 11** 20 mm impact at 20 J on 17 ply unpainted produced a deeper, jagged edged surface flaw

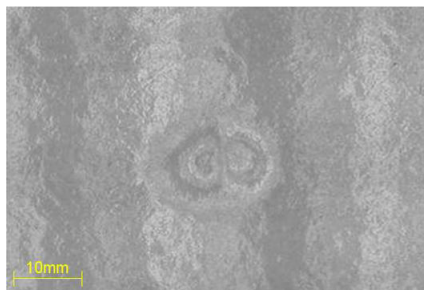
The shape of surface flaws produced by impact with a 20 mm hemispherical tup was similar on painted and unpainted laminates. However, on unpainted laminates the impact caused the upper plies to split, with small surface cracks evident, as seen in Figure 13. Cracks were not visible on the painted laminate, shown in Figure 12.

**Figure 12** 15 J, 20 mm impact on 17 ply painted laminate

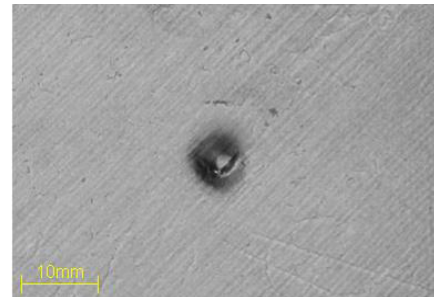
**Figure 13** 15 J, 20 mm impact on 17 ply unpainted laminate produced a less jagged flaw than in Figure 12 that also exhibited surface cracking

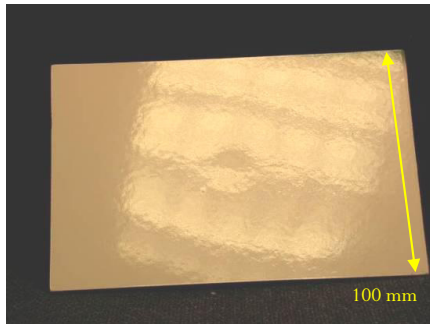
**Figure 14** 30 J, 87 mm impact on 17 ply painted laminate produced a wide, very shallow surface flaw

The appearance of surface flaws produced by impact with the 87 mm hemispherical tup on painted laminates (Figure 14), and unpainted ones (Figure 15), was very similar. The visual appearance was a rounded, very shallow, circular dent.

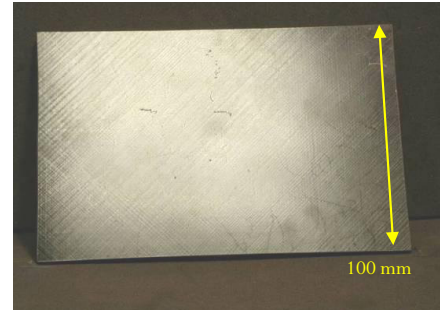
**Figure 15** 30 J, 87 mm impact on 17 ply unpainted laminate produced a more acute, dimple like flaw

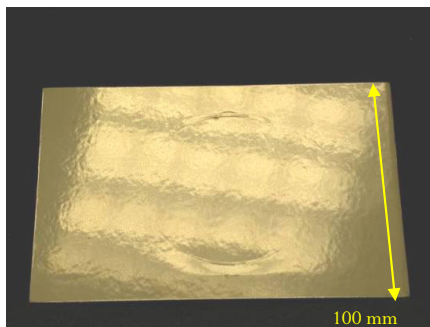
**Figure 16** 30 J, 70 mm flat cylinder impact on 17 ply painted laminate produced two distinct surface flaw areas with circular shaped depressions

On painted laminates (Figure 16), the impact from the cylinder left a shallower depression in the surface, but of greater area, giving the appearance of a more extensive surface flaw than was actually present. The depressions generally formed more of a complete circle on the painted coupons than on the unpainted coupons.

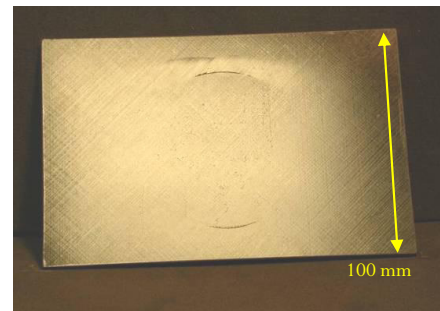
**Figure 17** 30 J, 70 mm flat cylinder impact on 17 ply unpainted laminate again produced two surface flaw areas with deeper, but less complete circular shaped depressions

Typical visual appearance of these surface flaws is a circular impression on the surface, which became more pronounced as impact energy increased. Due to natural curvature of the coupon surface, and coupon flexing during the impact strike, some impacts from this impactor resulted in two flaw sites that were opposing sections of a circular depression (Figure 17).

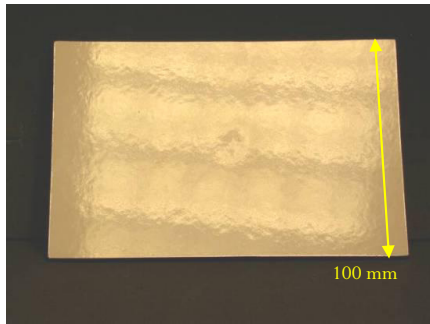
**Figure 18** 15 J, wedge shaped impactor on 17 ply painted laminate produced a small depression in surface

The appearance of surface flaws produced by the wedge shaped impactor on painted laminates (Figure 18), and unpainted laminates (Figure 19), was similar in shape. However, on unpainted laminates, the impact caused the upper plies to split, with small surface cracks becoming evident as seen in Figure 19. Typical visual appearance of surface flaws is of a small, rectangular impression, which at higher impact energies became surrounded by a shallow depression.

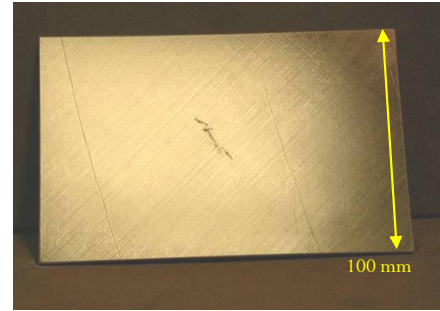
**Figure 19** 15 J, wedge shaped impactor on 17 ply unpainted laminate produced a small depression and surface cracking

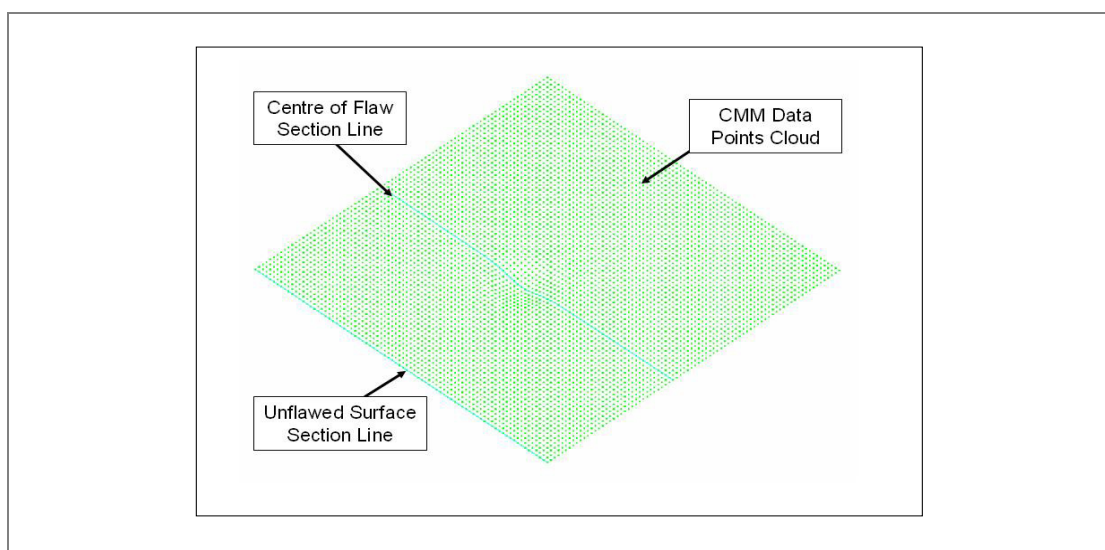
For each of the surface flaws, the series of points representing the profile through the surface flaw centre, and a series of points on the coupon surface close to the flaw area were identified within the CMM point cloud data (see Figure 21) by producing section lines through the points cloud. Once these two sections were isolated within the CMM points cloud, the other section lines were removed leaving only two section lines as seen in Figure 22.

**Figure 21** Section line positions on CMM data points cloud

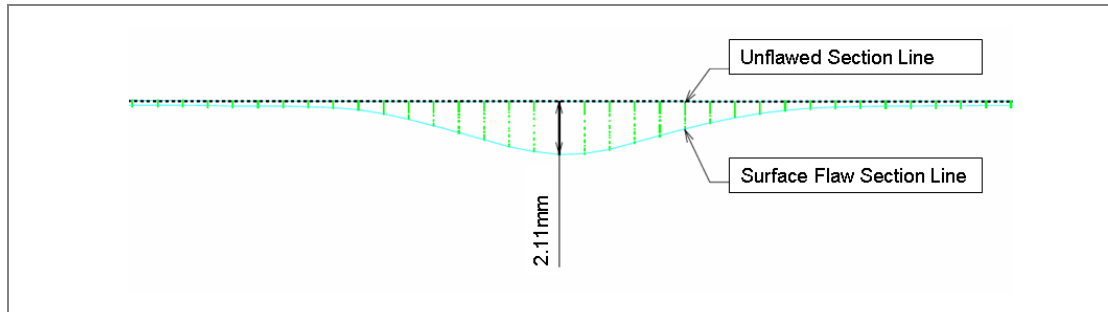
Vertical Z depth measurements were made every 1 mm along the line (Figure 22). The Z depth measurements were taken along a second flat section made through the coupon surface outside of the flaw area. The Z depth measurements were placed into a spreadsheet, as with the depth gauge measurements. This allowed comparisons to be made between the data obtained by the two measurement methods.

**Figure 22** CAD drawing of data obtained from 2.11 mm deep surface flaw using CMM machine, vertical data lines are 1 mm spacing

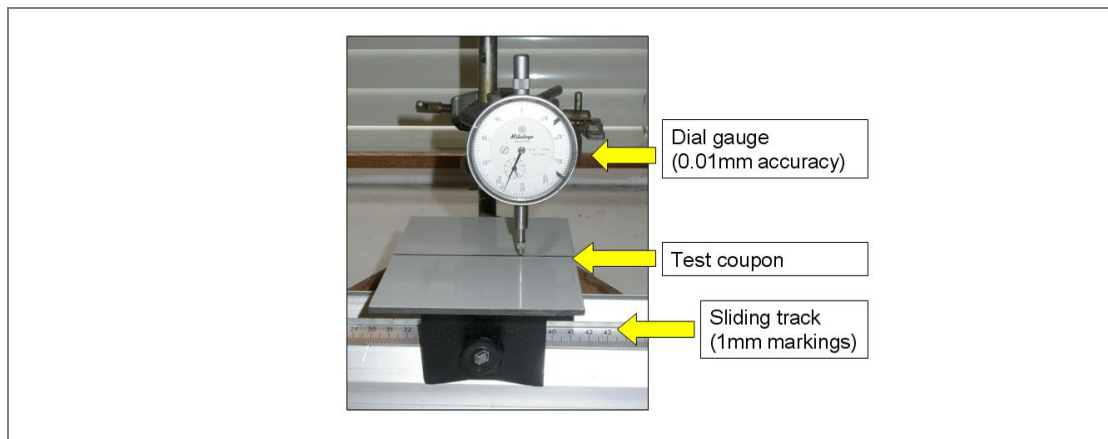
Depth measurements were made across the 100 mm width of the surface of each impact damaged coupon, through the centre of the surface flaw, at 5 mm intervals in undamaged areas and at 1 mm intervals within the flawed area, using a dial gauge (0.01 mm accuracy) and a sliding track (see Figure 23).

**Figure 23** Dial gauge depth measuring setup

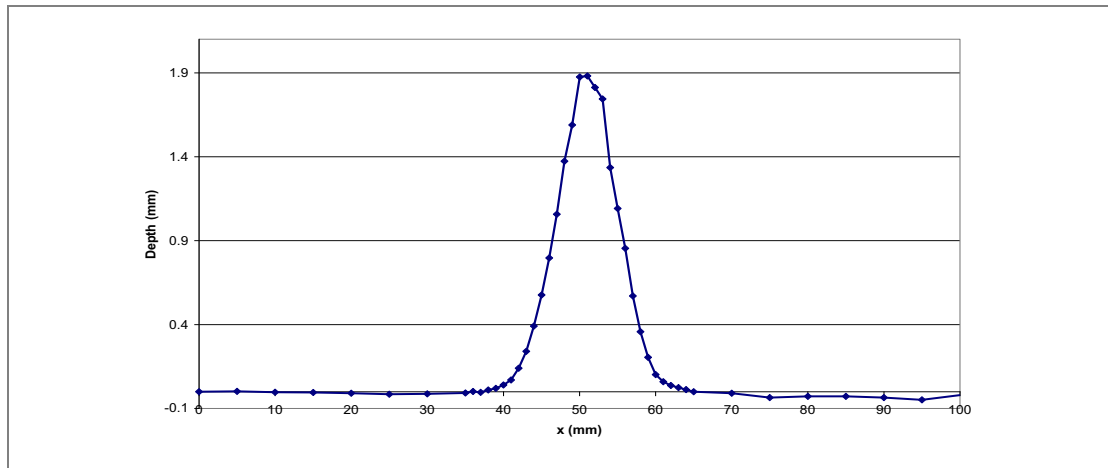
**Figure 24** Example profile of section through surface flaw produced from depth gauge measurements.

Figure 24 illustrates an example of the flaw profile resulting from a 30 J impact with a 20 mm impactor on a 17 ply painted laminate. The maximum flaw depth could be obtained directly from the maximum deflection of the dial gauge. Flaw width was more difficult to measure as the depth profiles exhibited some small change in surface position even at several mm from the approximate edge of the defect. To define the width of the flaw as the point where zero surface deflection occurred would result in a width occupying a much larger portion of the test sample than was evident in the visual appearance of the defect. To obtain a flaw width relevant to the visual appearance the following procedure was followed.

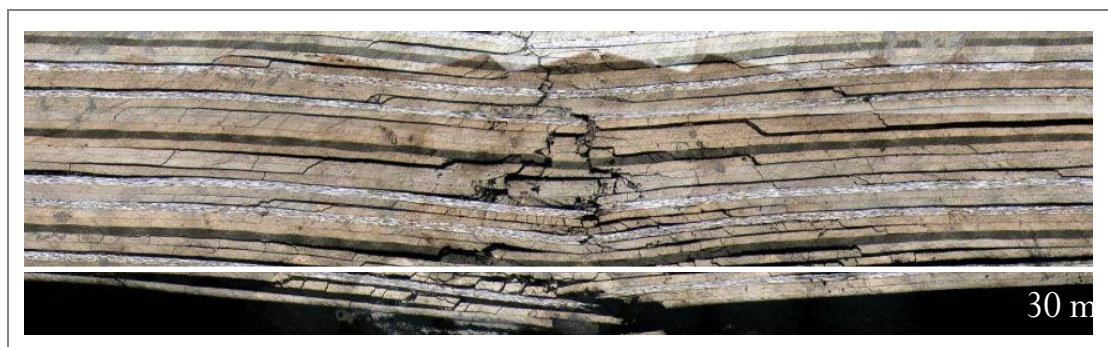
**Figure 25** Section through 50 J, 20 mm impact on 33 ply painted, mesh covered laminate

A microscope fitted with a digital camera was used to take multiple small photograph images of the finished sections. The 3 mm x 3 mm images were then combined into a composite image (example shown in Figure 25) giving a view through the 30 mm section of damaged laminate. From these composite images, it is possible to see the sectional profile of the surface flaw, and the extent of the subsurface damage. Furthermore, it is easy to visualise the severity of the subsurface damage compared to the relatively small size of the surface flaw.

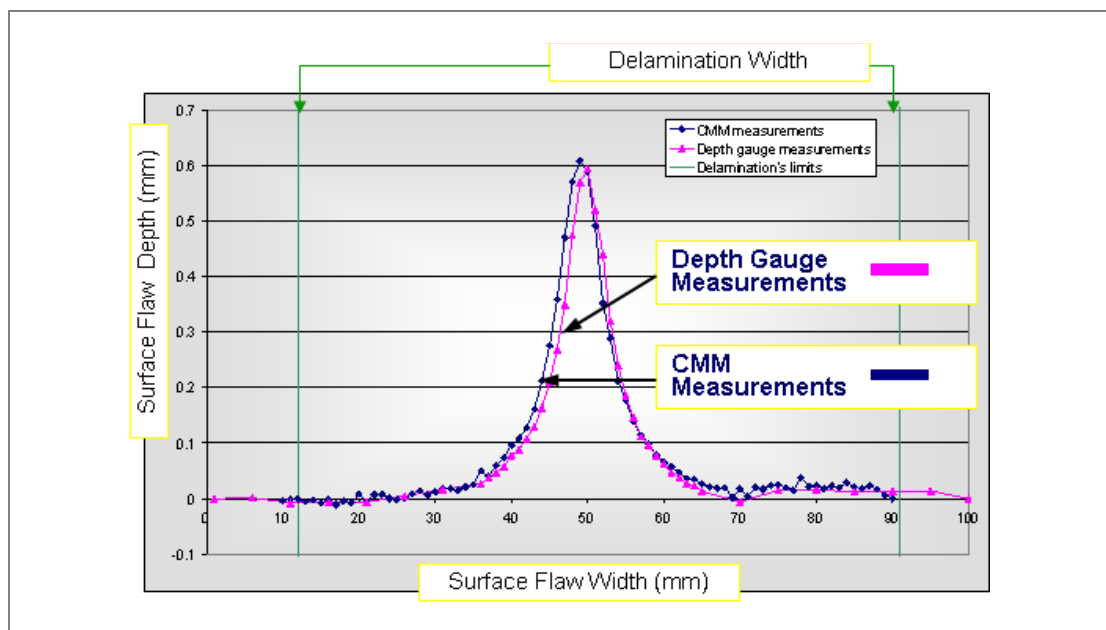
The results of the C-scan, depth gauge and CMM work for the set of 12 surface flaws [9], were combined into graphs, to show the surface flaw sectional profile and subsurface damage width for each flaw. Examples are given in Figures 26–29. Where a surface flaw was too small for width measurement, no value is given.

**Figure 26** Graphical representation of depth gauge, CMM and C-Scan measurements of impact damage and surface flaw on a coupon

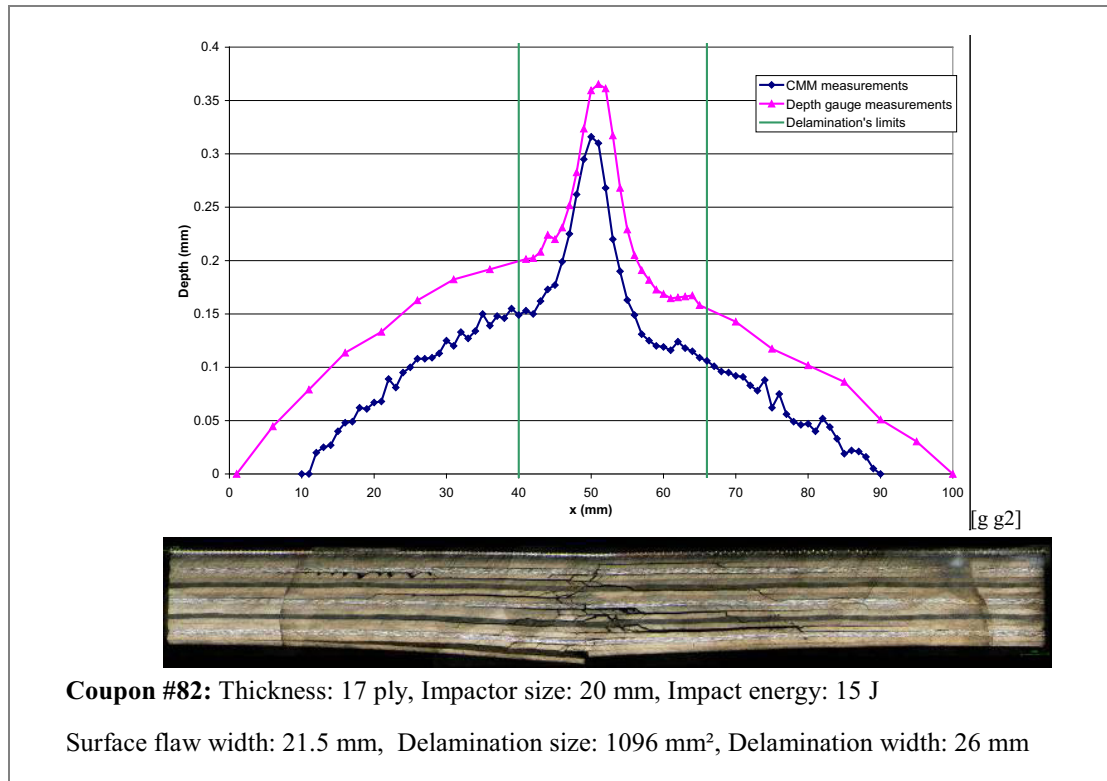
**Figure 27** Section graph, section photograph and measurement data for surface flaw on Coupon #82

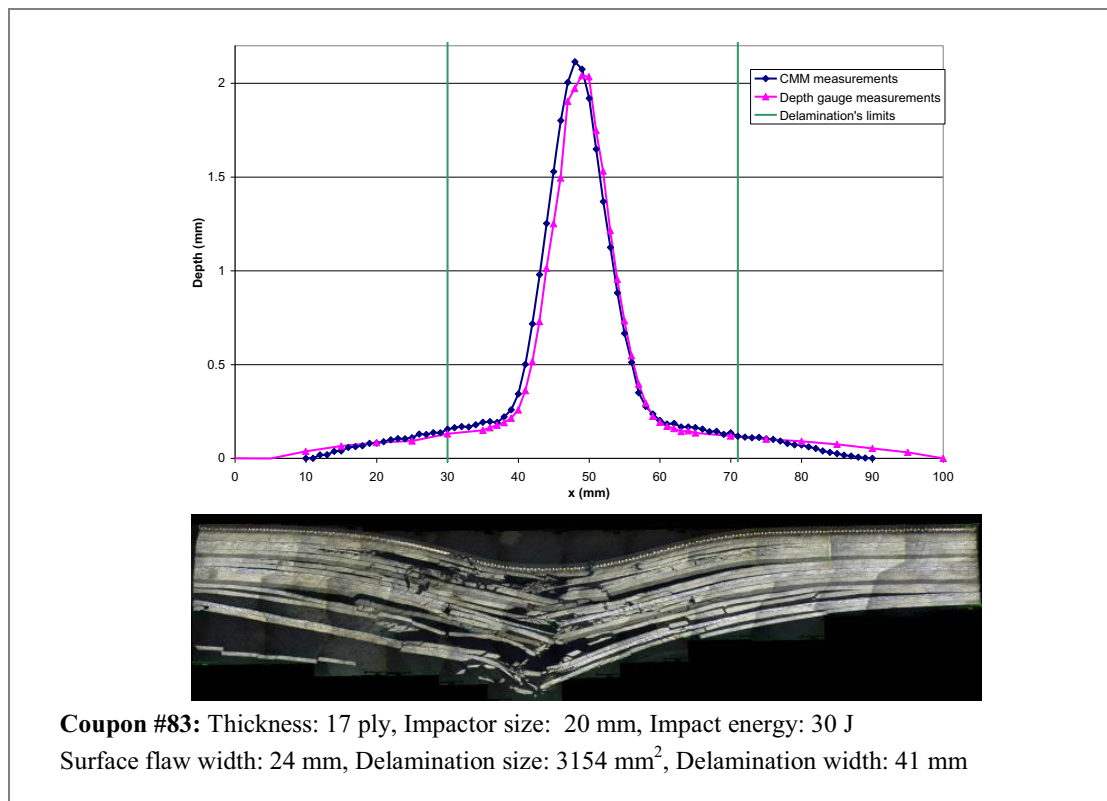
**Figure 28** Section graph, section photograph and measurement data for surface flaw on Coupon #83

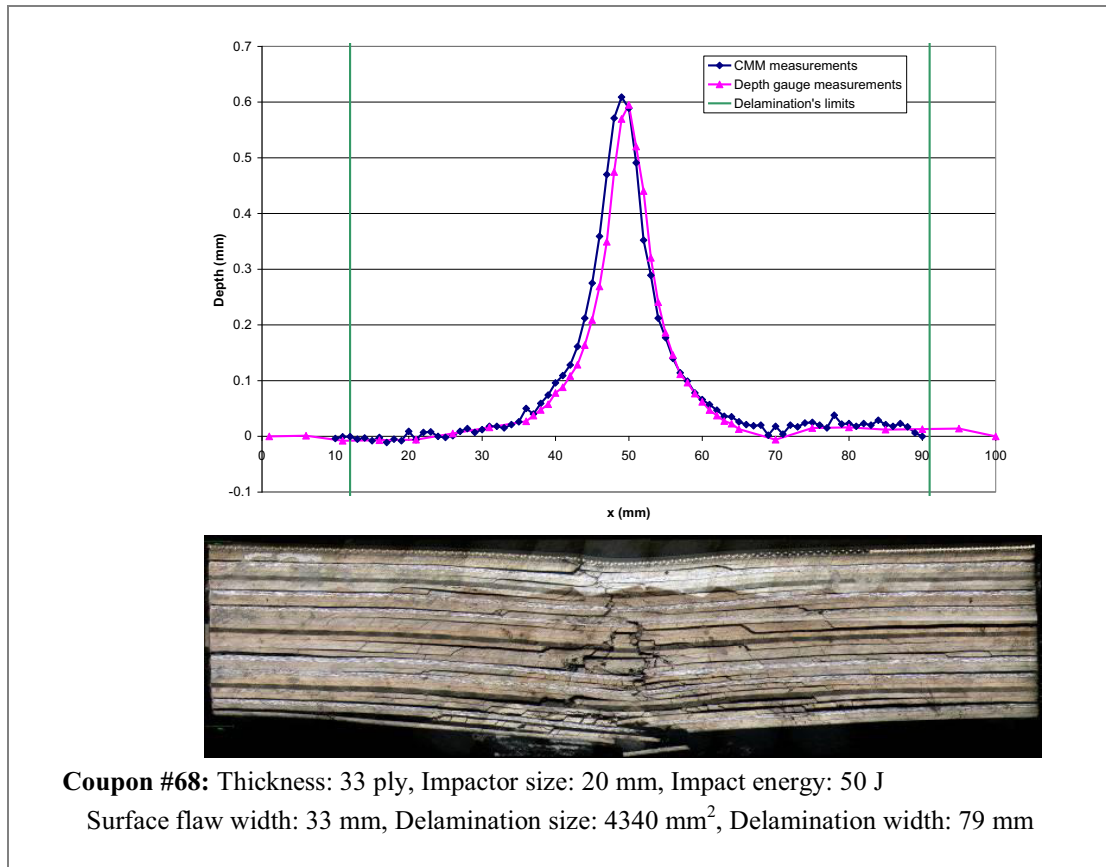
**Figure 29** Section graph, section photograph and measurement data for surface flaw on Coupon #68

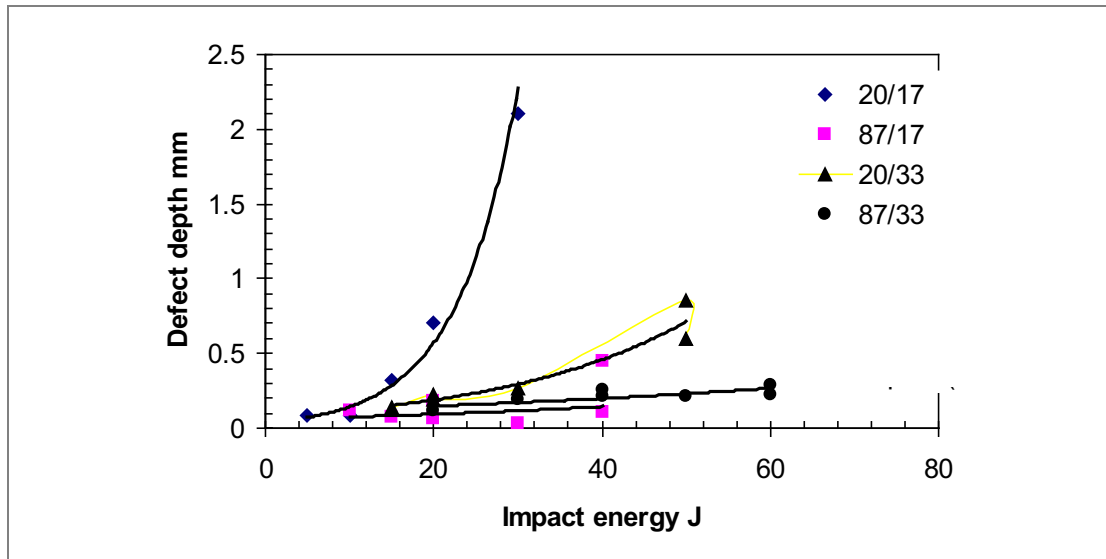
**Figure 30** Plot of impact energy vs. flaw depth for the 4 laminate and impactor diameter combinations

It can be seen that the relation between impact energy and flaw depth can be represented as 4 families of points, each representing one of the 4 variants. Each curve characterises the relation between impact energy and flaw depth for the particular combination of laminate thickness (17 or 33 ply) and impactor diameter (20 or 87 mm). There are similar relations between impact energy and flaw width, but as can be seen in Figure 31 the relation is much more approximate with considerable scatter in data points. This increased scatter in width is almost certainly a consequence of the difficulties in measuring and defining defect width. There is no definite boundary to the edge of the defect and the defect surface gradually merges with the undamaged part of the laminate.

From the data in Table 2, it is possible to observe that for higher energy levels (>20J) the delamination area measured on the C scan can be significantly larger than the flaw area calculated from  $(width/2)^2$ . The results for coupon 69 and 86 both illustrate this to good effect. The delamination width for coupon 69 is almost 3 times greater than the flaw width, and over 4 times greater for coupon 86. The data illustrate that lower energy impact damage can produce a 21.5 mm wide flaw (#82) that has less subsurface damage beneath than a 22.5 mm wide flaw (#86), due to the use of a differently shaped impact object. Furthermore, the flaw on coupon 68 is less wide than the flaw on coupon 66 (33 mm vs. 60 mm), yet coupon 68 received a lower energy impact and has similar delamination size to coupon 66. This illustrates that flaw width can depend on the shape and size of the impacting object. The relation between impact energy, defect depth and defect width for the four variants of impactor diameter (20 mm /87 mm) and two thicknesses of laminate (17 ply/ 33 ply) are shown in Figures 30 and 31.

Because of the difficulties of creating a selection of defects of reproducible geometry via impacts on composite laminates, it was decided to machine into facsimile samples a series of defects representative of size and geometry of the 4 families in Figures 30 and 31 above. The advantages of doing this are firstly that specific shapes and sizes can be accurately reproduced many times if necessary in samples of different colour and surface finish. Secondly noting that the defects in Figures 30 and 31 fall into 4 families, if the relation between impact energy and defect depth is known for each family, defects of size intermediate between impact data points can be created, independently of having performed an impact test under those conditions. This facility allows the visual inspection trials to be performed with selections of defect size optimised for each trial.

Figures 36 and 37 can be compared with Figures 30 and 31; both showing the relation between impact energy and flaw depth and width (radius = width/2 for Figure 36). The difference between them is that Figures 30 and 31 use directly measured width and depth data, whereas 36 and 37 show depth and radius derived from geometric variables fitted to the original flaw profile measurements. There are close similarities in the two sets for the depth measurements. In the case of the width (radius) measurements, there is significantly less scatter in the case of derived radius values than for the direct width measurements. This difference can be explained by the curve fitting process giving a more consistent representation of flaw width than was the case for direct measurement which as already noted was subject to significant measurement errors.

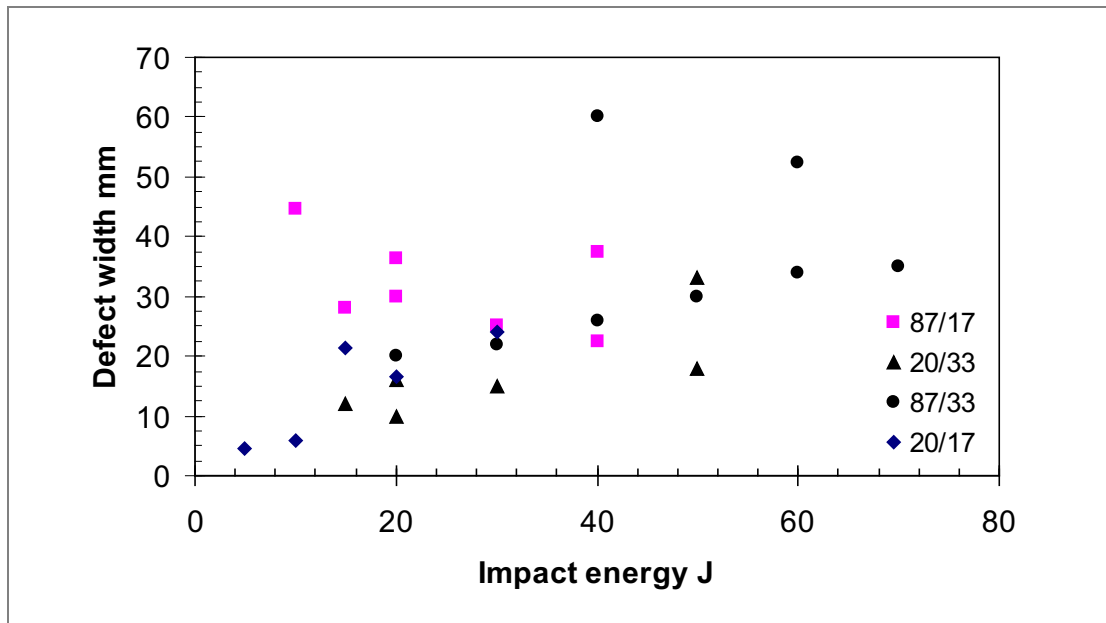
**Figure 31** Plot of impact energy vs flaw width for the 4 laminate / impactor combinations

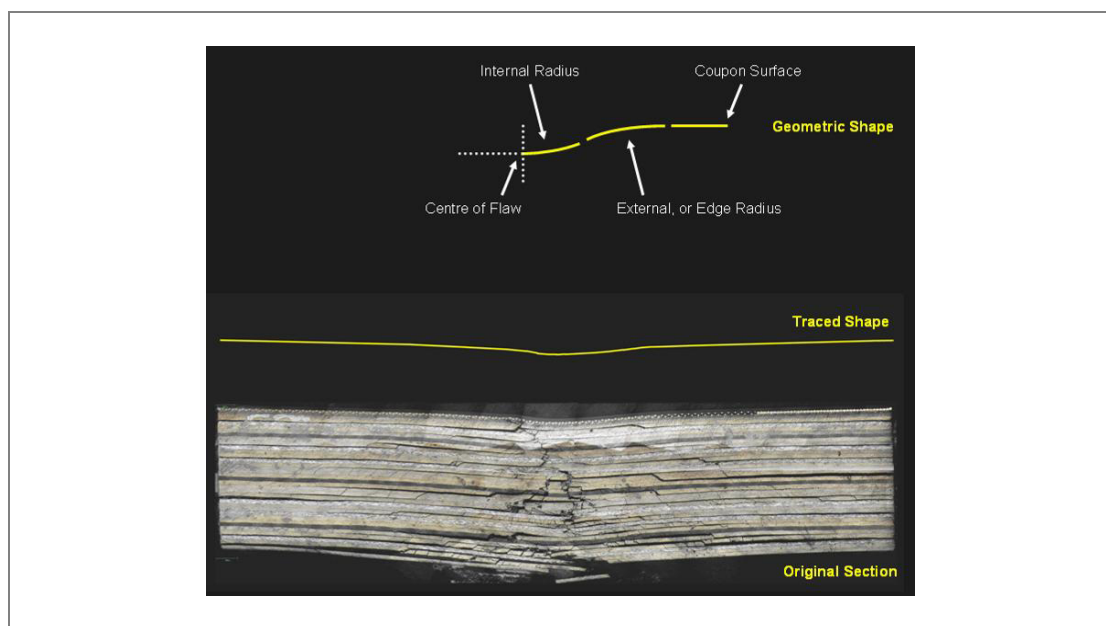
The flaw shapes in Figures 32 and 33 show a section through the surface flaw on an impact damaged coupon. Above the section photograph, a line is shown, which is a direct trace of the surface flaw. It was possible to draw the traced flaw shape using geometric, or parametric lines Figure 34 illustrates the way in which section lines through a surface flaw were constructed using geometric variables to define the section shape. These parameters were used to characterise the sectional profile of each surface flaw.

**Figure 32** 20 mm/50 J Surface flaw on a 33 ply coupon

The section lines through the CMM points data were created as splines, and were non-parametric, i.e. they have no geometric features such as radii within them. New geometric lines, as described in Figures 32 and 33 were overlaid to match the shape of the non-parametric surface flaw section lines. The geometric variables of the lines were adjusted until the geometric line fitted as best as possible to the original CMM points data (see Figure 35). From these fitted lines, it was possible to derive geometric variable values describing the original shape.

The two options discussed above concern the production of a multi-variable POD model, which would give visual inspection reliability as a function of surface flaw depth and width. However, each of the flaw geometry variables described in Figure 32 has the potential to affect visual inspection reliability by altering the level of shadow, shine and specular reflection distortion produced by the surface flaw. In order to develop a truly multi-variable model of visual inspection reliability, it is conceivable that a series of experiments in which a range of different flaw sizes, where only a single geometric variable is adjusted may be required.

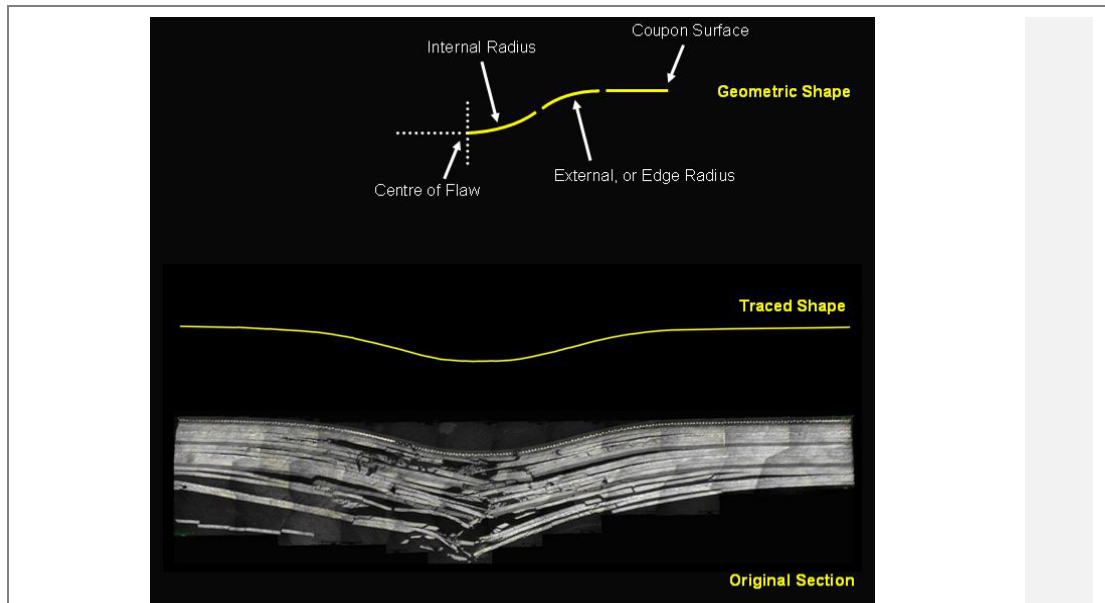
**Figure 33** 20 mm/ 30 J Surface flaw on a 17 ply Coupon

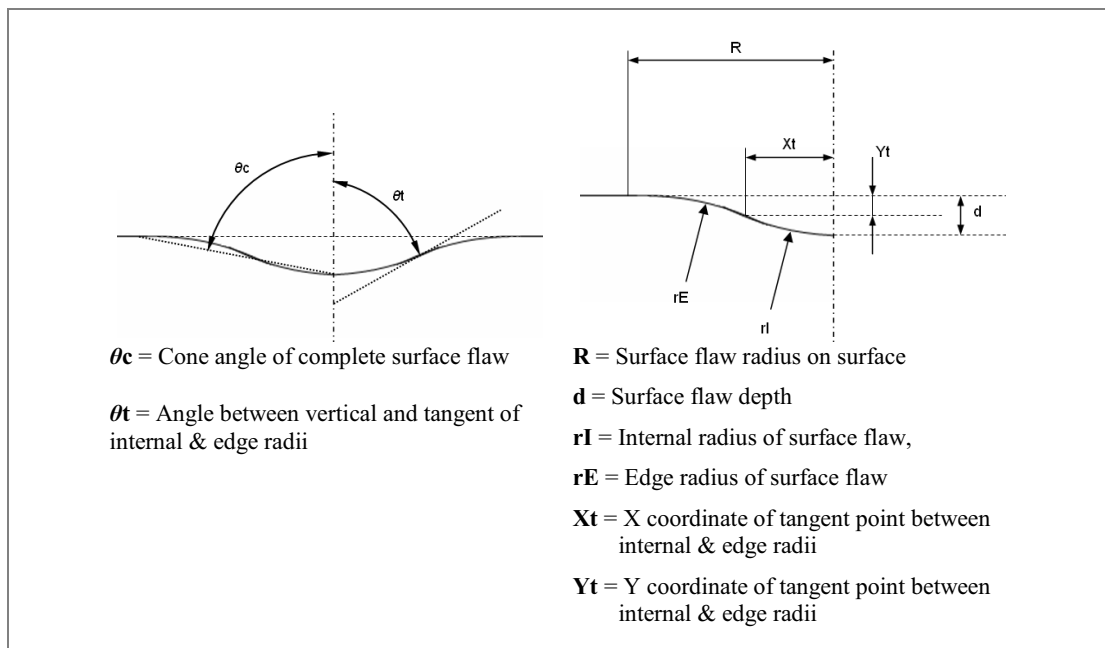
**Figure 34** Geometric variables used to reconstruct a surface flaw section

The sectional profile of surface flaws was recreated in a CATIA CAD system, by overlaying geometric lines, constructed using the variables in Figure 34, onto the CMM points data of the surface flaws.

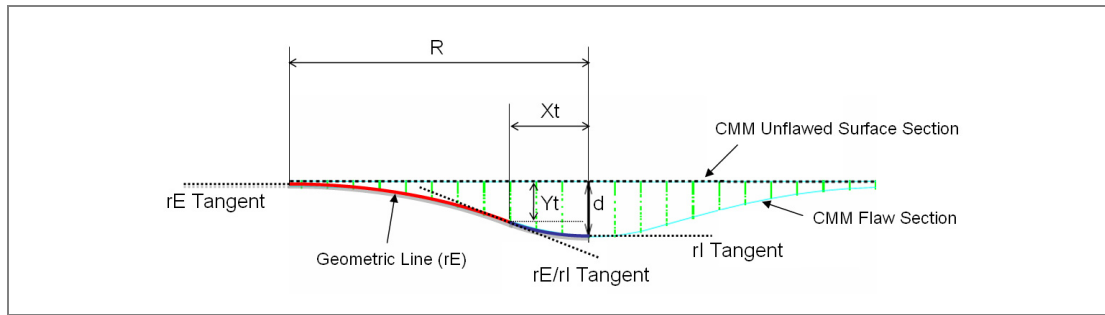
**Figure 35** Construction of geometric lines to match CMM data section lines

In order to ensure a smooth transition between the surface flaw lines and the original flat surface, without a visible join line, the tangent at the end of curve  $rE$  where it meets the planar surface was set to be horizontal (i.e. the same as the surface). To ensure symmetry, and not create a V shape at the centre of the flaw, the end of curve tangent of  $rl$  at the flaw centre line was constrained to be horizontal. A final tangent constraint was placed between the join of curves  $rE$  and  $rl$ , in order to ensure a smooth, step-less transition between the curves. These tangents can be seen in Figure 35.

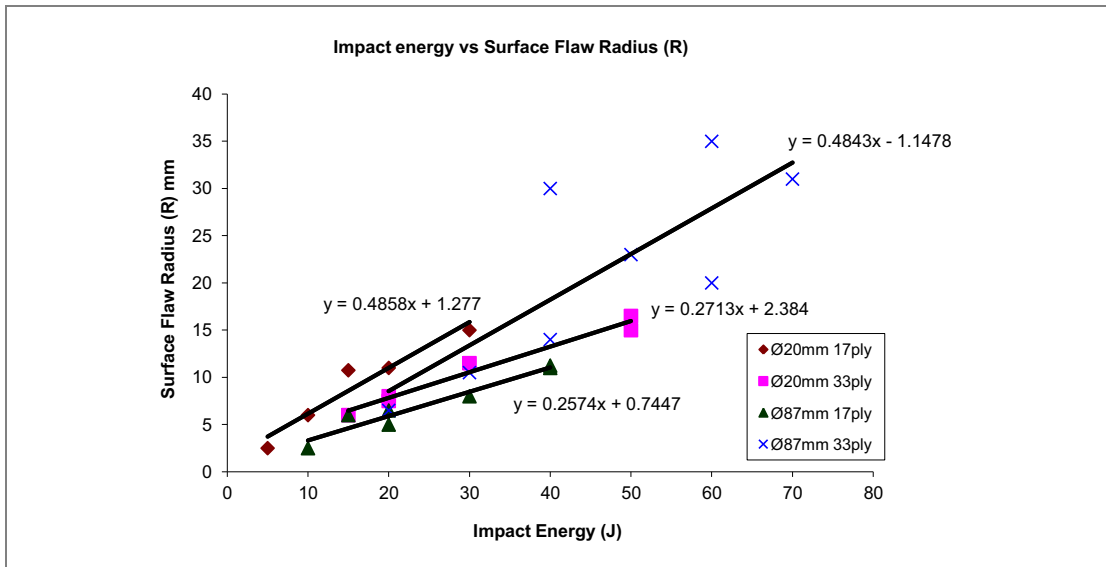
**Figure 36** Plot of impact energy vs. surface flaw radius with lines of best fit

The data in Table 3 were plotted so as to identify relationships between the geometric variables for each combination of ply thickness and impact diameter. Best-fit lines were constructed to the data points. Graphs describing flaw width vs. impact energy, depth vs. energy, width vs.  $Xt$  value, and depth vs.  $Yt$  value are shown in Figures 36 to 39.

Table 4 gives the equations of the lines obtained by the best fit-line method from Figures 36–39. Also given is the energy range for which the relationship remains valid. All the relationships are only valid for impacts greater than 4J; impacts below this

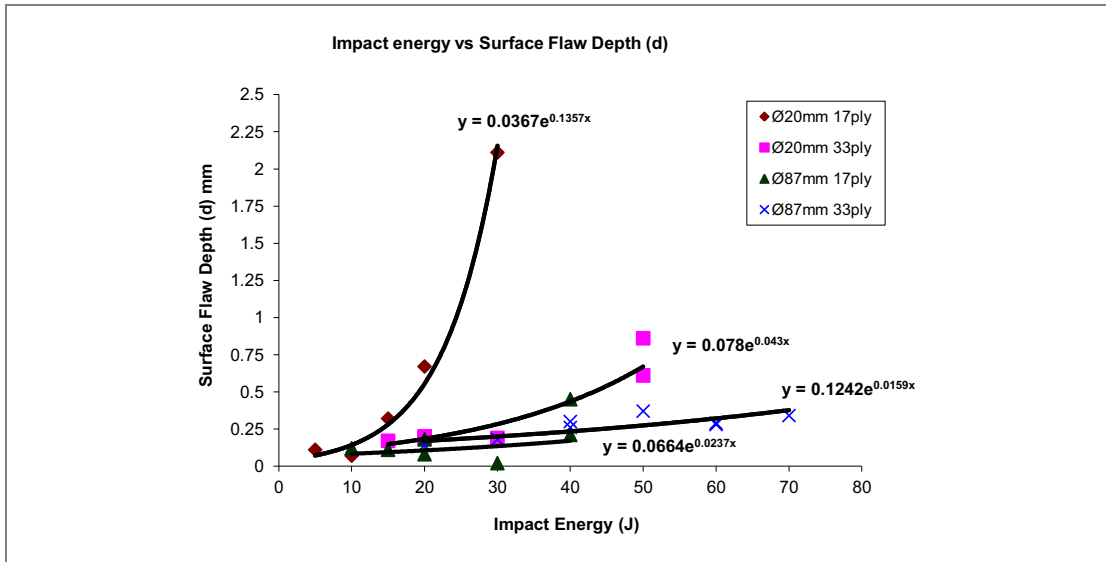
**Figure 37** Plot of impact energy vs. surface flaw depth with exponential curves of best fit

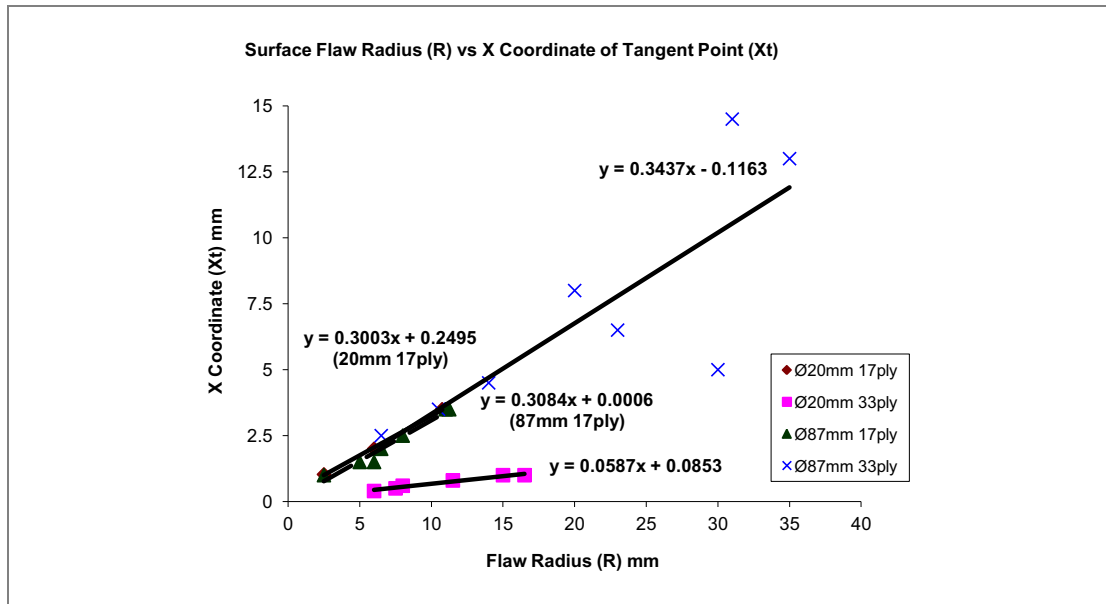
**Figure 38** Plot of surface flaw radius vs. Xt with lines of best fit

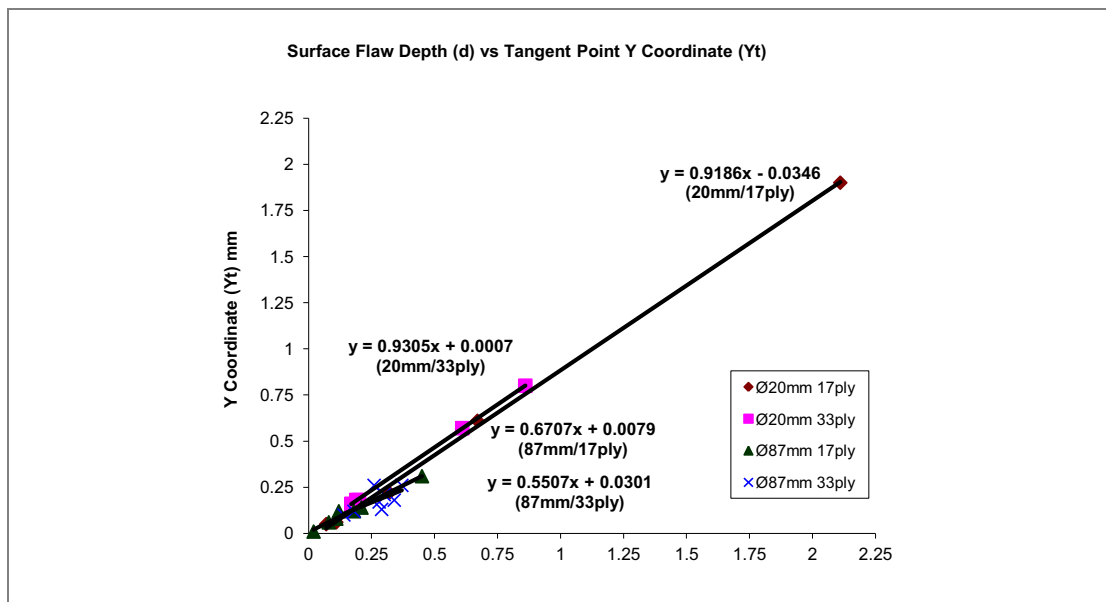
**Figure 39** Plot of surface flaw depth vs. Yt with lines of best fit

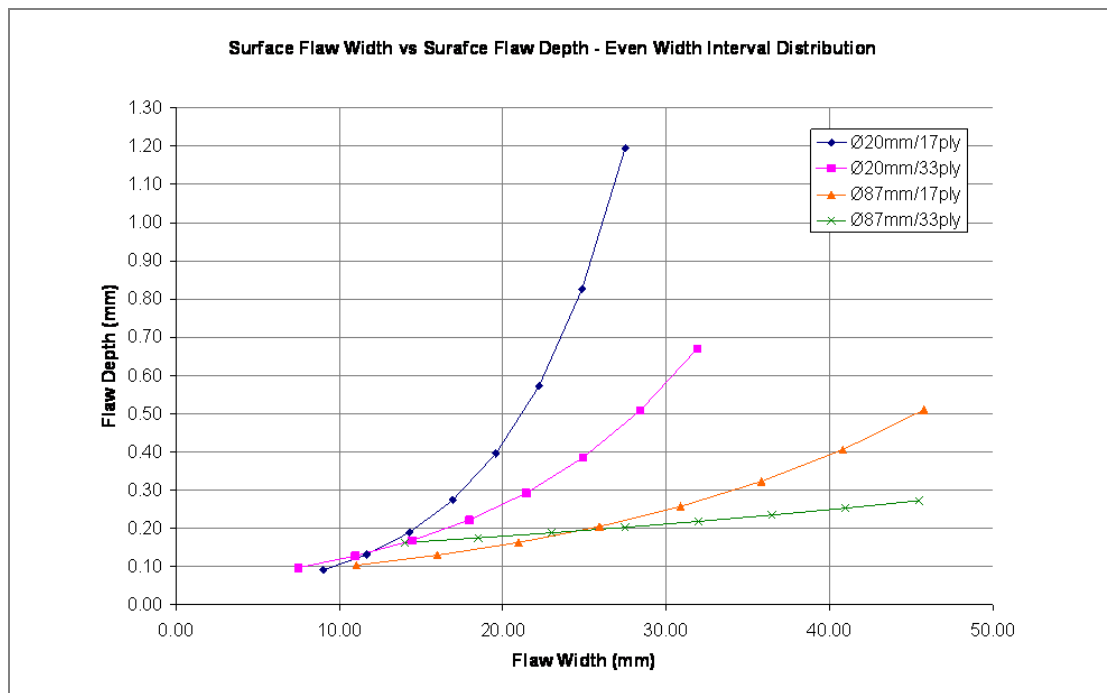
Using the widths in Table 5 and the relationships in Table 4 to calculate flaw depth, a graph of flaw width vs. flaw depth can be produced, as seen in Figure 40. When using an even width interval, there are 9 flaws greater than 30 mm wide, and 6 flaws that are deeper than 0.6 mm.

**Figure 40** Graph of flaw widths vs. flaw depths with even spacing between flaw widths

Using the same method as for the graph in Figure 40, the plot of flaw width vs. flaw depth seen in Figure 41 was produced using the flaw widths from Table 6. On this graph, it can be seen that with the new distribution, there are now only 4 flaws wider than 30 mm and there is only one flaw greater than 0.6 mm deep.
