**Paper 2013/03**

**Reliability of Damage Detection in Advanced  
Composite Aircraft Structures**

**Prepared for CAA by:**    **L Cook**  
                                  **A Boulic**  
                                  **D Harris**  
                                  **P Bellamy**  
                                  **P E Irving**  
                                  **Cranfield University**

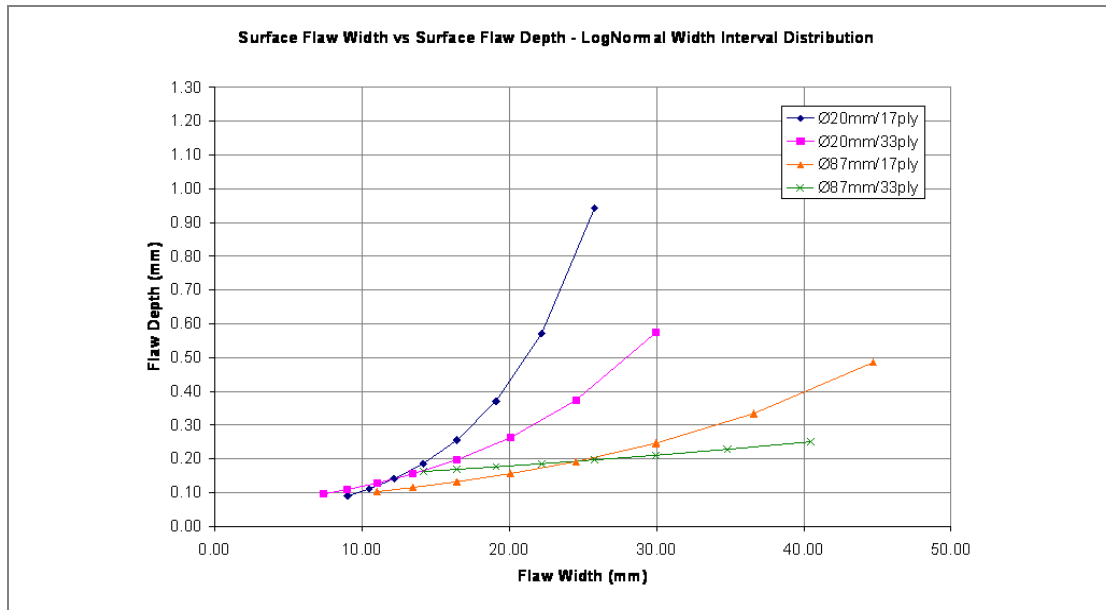
Using the same method as for the graph in Figure 40, the plot of flaw width vs. flaw depth seen in Figure 41 was produced using the flaw widths from Table 6. On this graph, it can be seen that with the new distribution, there are now only 4 flaws wider than 30 mm and there is only one flaw greater than 0.6 mm deep.

**Figure 41** Graph of flaw widths vs. flaw depths with even spacing between lognormal of flaw widths

There is a significant effect of ply thickness as Figure 76 shows. However ply thickness will influence defect shape particularly defect width as Figure 41 demonstrates. Hence this effect is a manifestation of the effect of defect width on detection probability.

Figures 77 and 78 show the combined and separate effects of colour and impactor diameter on probability of detection. As for the ply thickness, impactor diameter will affect the defect profile, 87 mm diameter impactors producing wider defects for a given depth as Figure 41 indicates. Figure 77 and 78 show that colour is more dominant than impactor diameter, and that sometimes probabilities of detection are increased with increasing diameter, and on other occasions they are decreased.

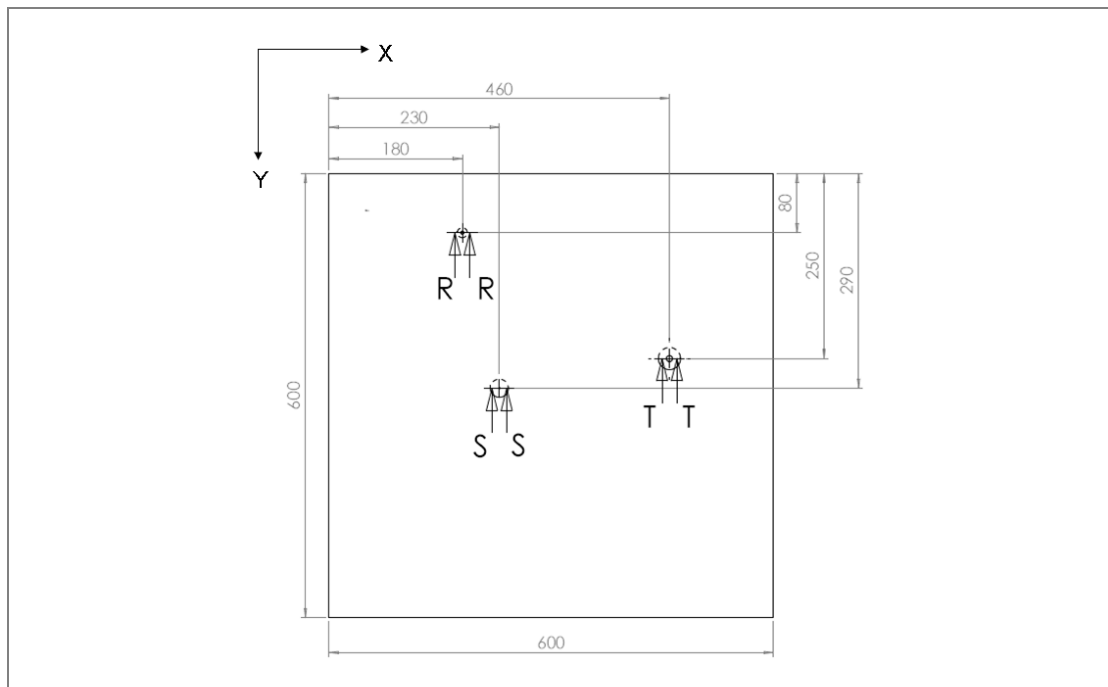
The X and Y coordinates in Table 8 specify the location on the inspection face of the panel of the vertical centre line of the defect. The coordinate origin is at the top left corner of the panel. Figure 43 illustrates the X/Y coordinates specified on a specimen panel with 3 surface flaws.

**Figure 43** X/Y coordinates used for placement of flaws on to specimen panels

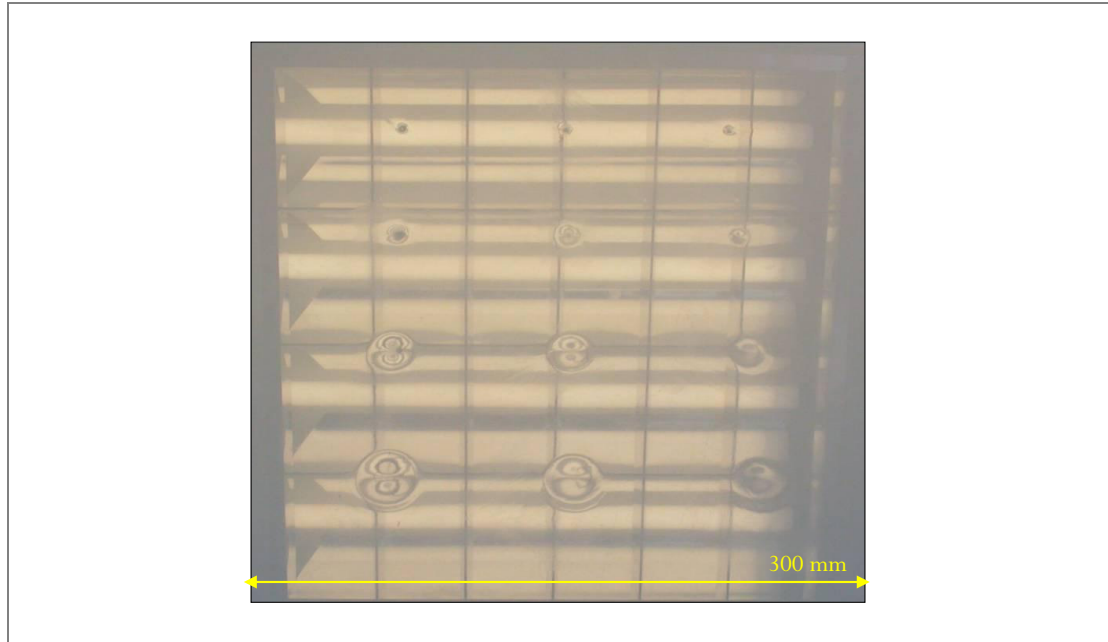
After NC machining the surface flaw into 3 mm thick Plexiglas panels, the flaw area was polished to return the flaw site to its original surface finish. Figure 44 illustrates a test piece that contains 12 surface flaws produced in this way, and can be compared with Figure 45 which shows a photograph of an actual impact damage surface flaw on a painted/mesh laminate.

**Figure 44** Test piece containing Surface flaws

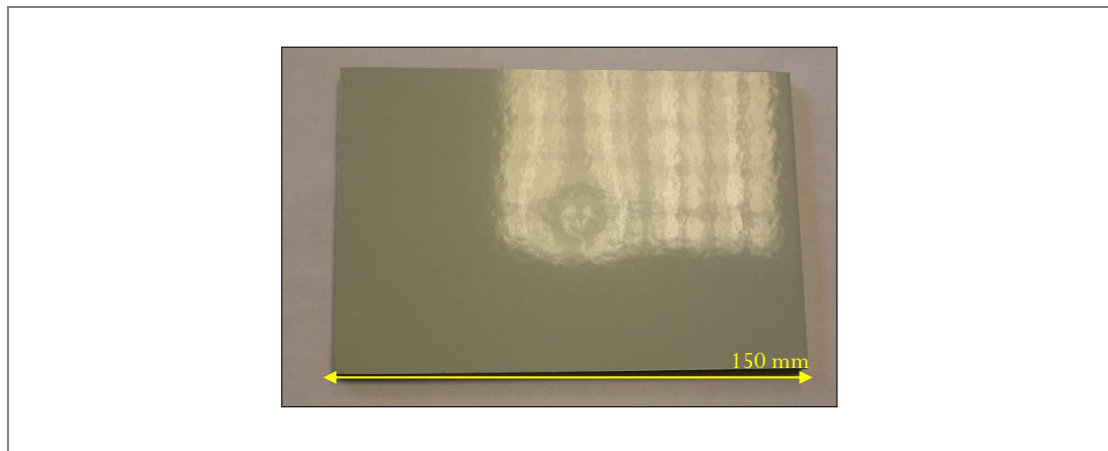
**Figure 45** Impact damage surface flaw on a painted/ bronze mesh CFRP laminate

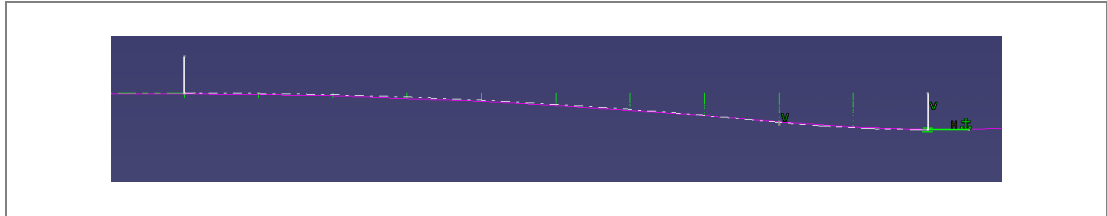
Five selected flaws on each colour of specimen underwent CMM measurement to check for conformity to the original specification. An example of a comparison between the CMM data, and the original flaw specification can be seen in Figure 46. The CMM data taken from the machined flaw run are barely distinguishable from the specified geometry.

**Figure 46** CMM data (pink solid line) and specified geometry (white dashed line) of 22.2 mm/ 0.57 mm deep NC machined surface flaw

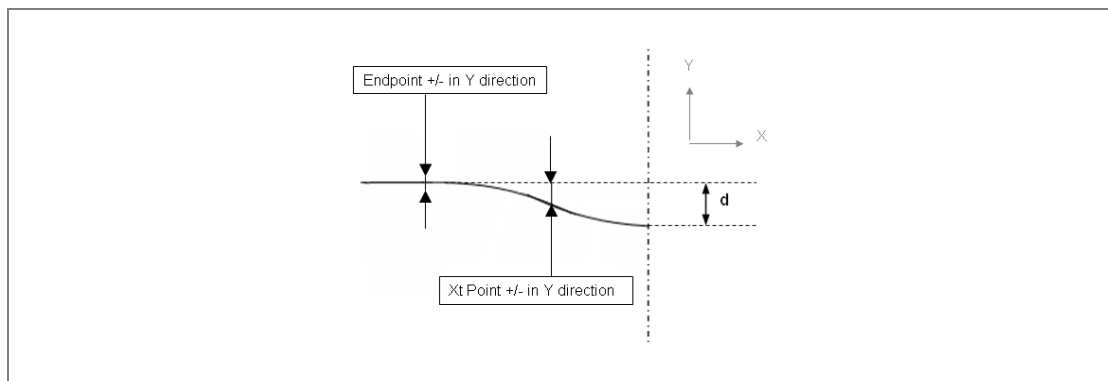
Three Y-Axis measurements of the CMM data were made using CATIA at the endpoint, the Xt point, and the centre point of the flaw, as shown in Figure 47. Table 9 details the findings. One can see in Table 9 that there was maximum average discrepancy across the different coloured panels of 15% on flaw #9 between the specified flaw depth, and the actual flaw depth (as obtained by subtracting the endpoint measurement from the total specified depth). However, the other flaws measured had an average depth discrepancy of less than 5%. The average discrepancy between the actual and specified depth at the Xt point was less than 10% for all surface flaws measured. The surface flaws were deemed to be within an acceptable tolerance of the original size specifications, and the overall shapes conformed to the design specification.

**Figure 47** Checking points for CMM data vs. original specification

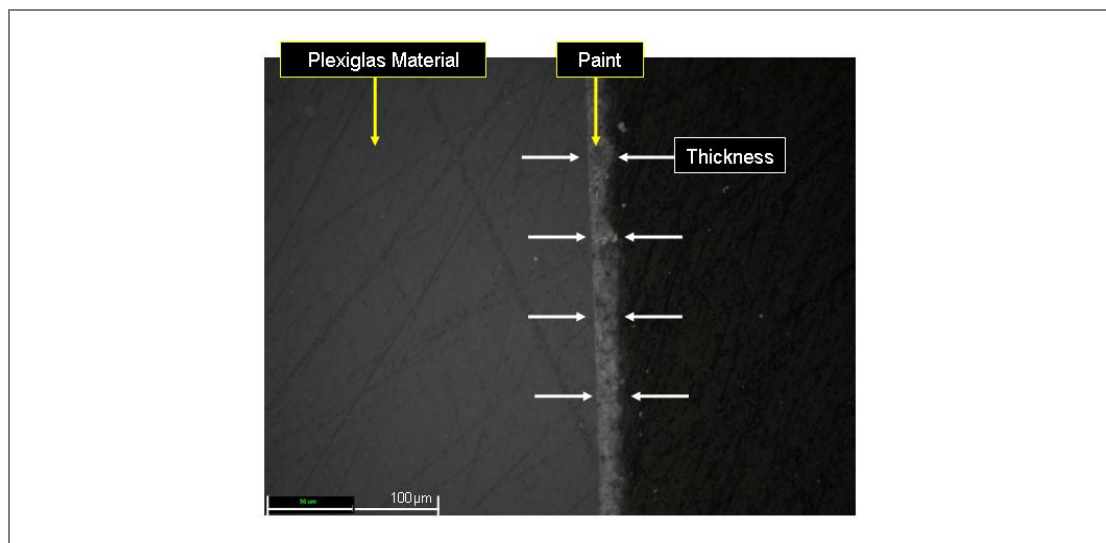
For the matt specimens, the thickness of the paint was measured. This was accomplished by metallographic sectioning of samples of a painted Plexiglas test piece. Figure 48 details the image obtained using a microscope. The measurement of the paint thickness was made using the microscope image processing software. The thickness was measured in several different places, and was found to be consistently within 12µm to 20µm, and therefore the defect geometry was not significantly influenced by the matt coating.

**Figure 48** Section of painted Plexiglas material used for thickness measurements

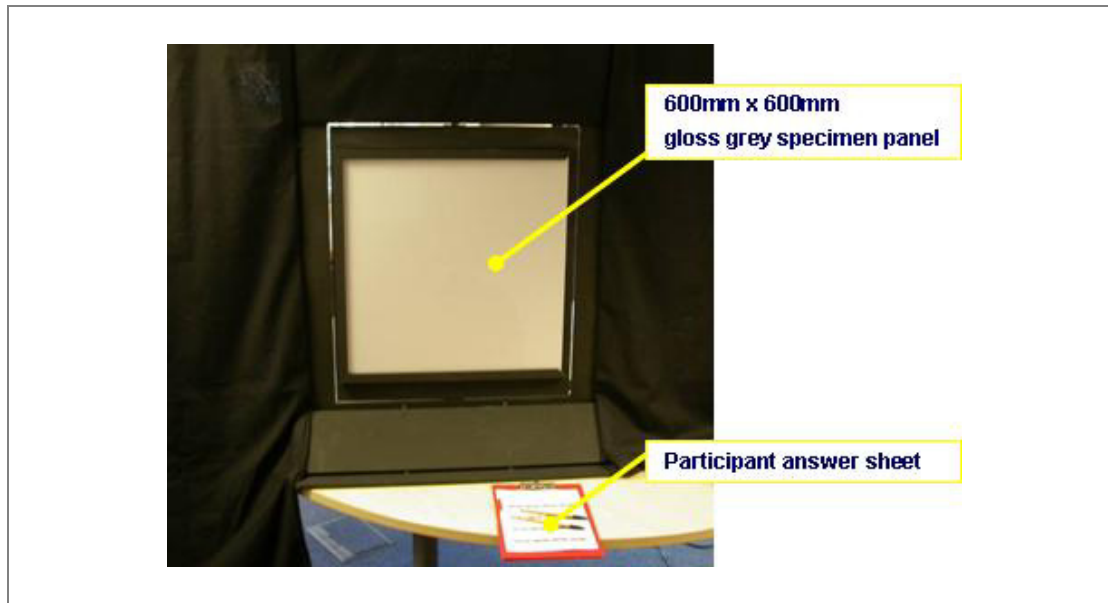
A pivoted display stand was used to display the specimens to the participants (see Figures 49 and 51). The design of the stand allowed the participants to inspect the panel, after which the operators swung the panel round and replaced it with the next specimen, without the participants seeing the changeover.

**Figure 49** Specimen display stand for visual inspection trials

Figures 49 and 50 show the inspection trials experiment as it was set up in the meeting room. The display stand was table mounted, and curtains attached to it in order to provide a screen behind which the personnel performed the panel changeover. A small, detachable display curtain hid the panels from view whilst they were swung into the inspection position.

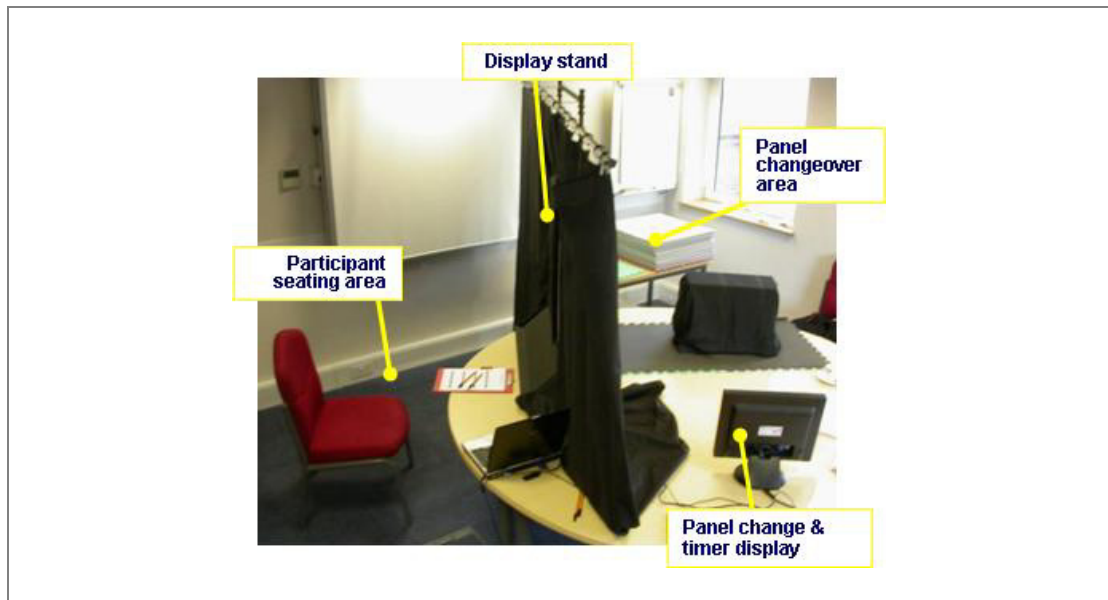
**Figure 50** Specimen display stand setup in meeting room

For the inspection trials with matt finish specimens, only 16 unflawed specimens were available. In order to display the 48 required unflawed specimens, the set of 16 unflawed specimens were displayed cyclically. The specimen sequence was displayed on the panel change screen (see Figure 50) for these trials, and the flawed and unflawed specimens were kept in separate piles. The changeover operator chose the correct flawed specimen, or an unflawed specimen, as instructed by the panel change screen. Prior to the first trial with a matt finish specimen set, the flawed specimens were stacked in the correct order in which the display screen would request their display for inspection. Upon removing a flawed specimen from the display stand, operator 2 restacked the flawed panels in the reverse order ready for the next trial, in which the display sequence reversed, as described for the gloss specimens. Two different timing presentations were used, one for forwards order trials and one for reverse order trials.

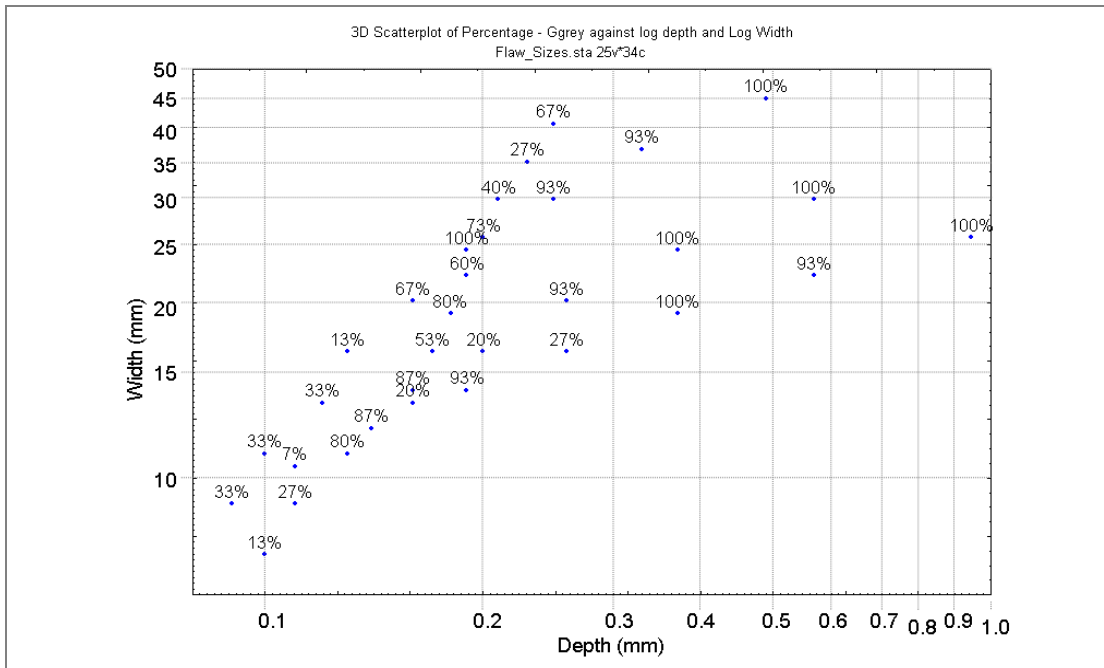
**Figure 59** Scatter plot of % of participants detecting each flaw vs. flaw depth and width for gloss grey specimens

A second method of presenting the results was to use Statistica statistical data analysis software [46] to produce scatter graphs, with the percentage of participants detecting each flaw plotted against the corresponding flaw depth and flaw width of each flaw (see Figures 59–64). A natural log scale is used for the X and Y-axis, allowing greater separation of individual data points at smaller values of width and depth. The scatter plots allowed the detection percentage for each flaw to be compared in terms of depth and width against the other flaws in the specimen set. For example, in Figure 59 it can be seen that on the gloss grey specimens, there is no clear correlation between flaw width and detection %. However, all flaws greater than 0.3 mm deep were detected by more than 90% of participants. On gloss grey specimens, there were instances of greater than 90% detection when flaws were below 0.3 mm. On gloss blue specimens, however, there were no instances of greater than 90% detection when flaw depth was below 0.3 mm.

All of the plots in Figures 59–64 have a number of similar features, differing in detail with changes in sample colour and surface finish. At small values of depth and width percent detections are low and approach zero. The lower limit of the data is at flaws of 0.1 mm depth and 10 mm width. The upper limit of data is at dents approaching 1 mm deep and 30-40 mm wide. Detections approached 100% for these large flaws. The extent of the region of 90-100% detections changed depending on the colour and

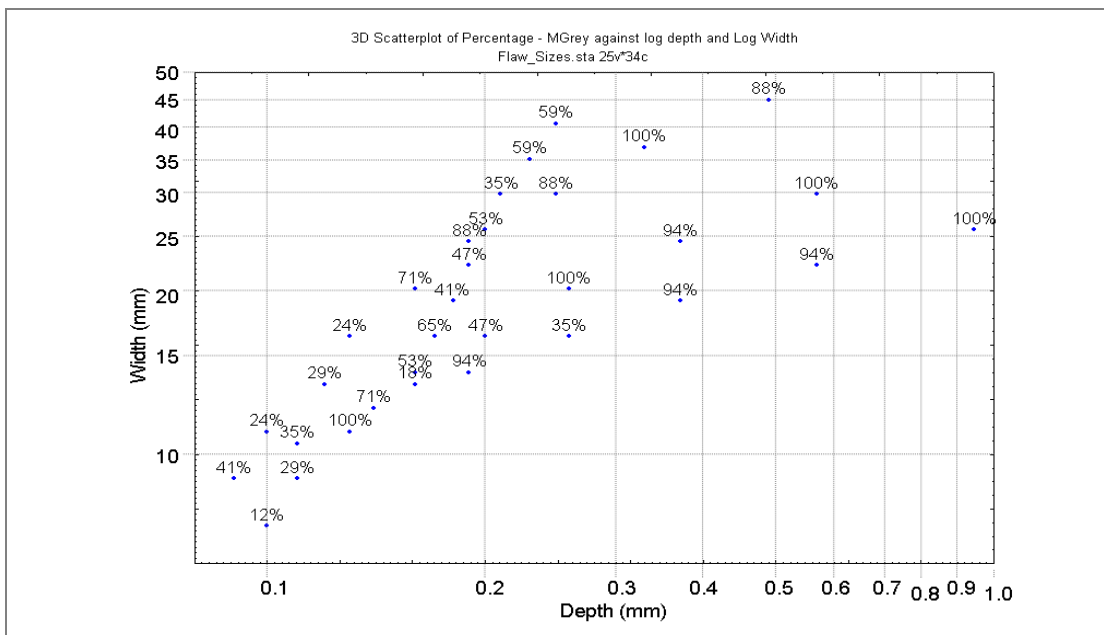
**Figure 60** Scatter plot of % of participants detecting each flaw vs. flaw depth and width for matt grey specimens

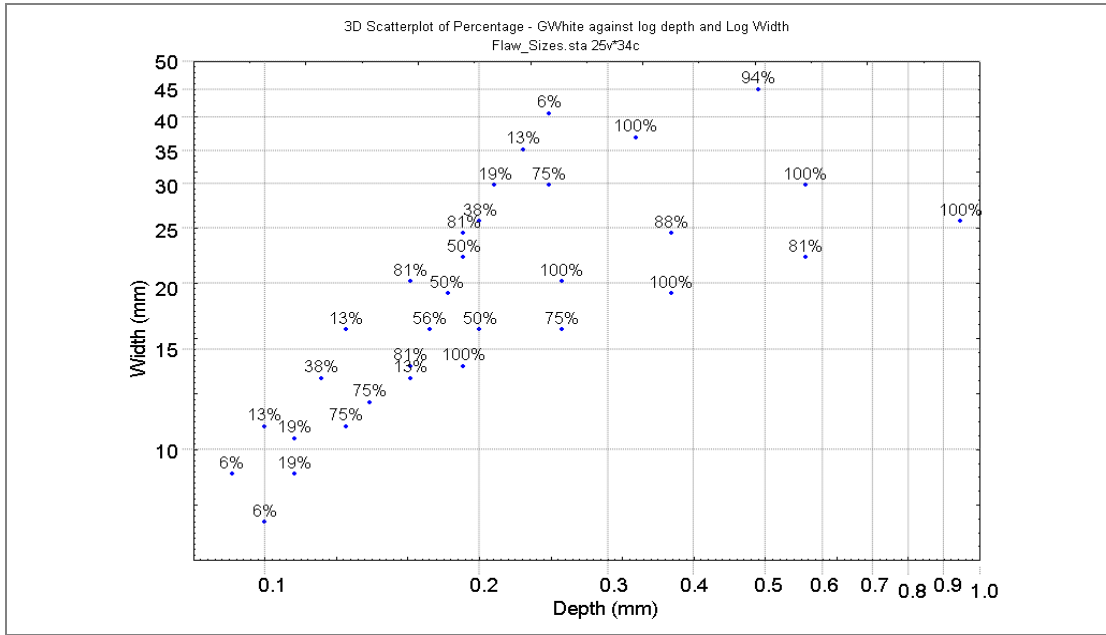
**Figure 61** Scatter plot of % of participants detecting each flaw vs. flaw depth and width for gloss white specimens

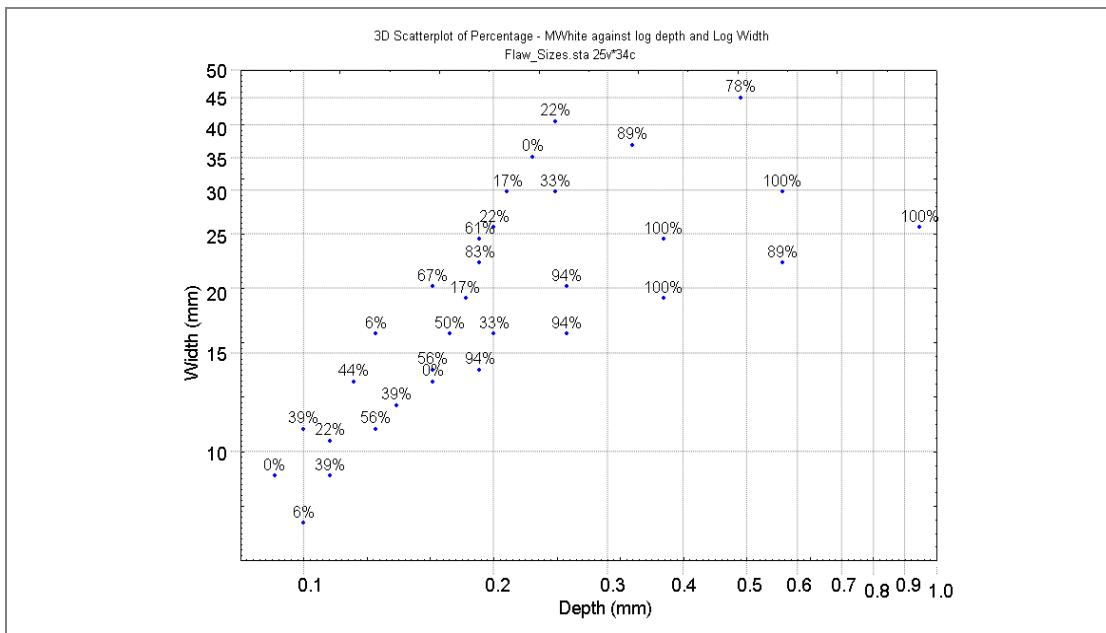
**Figure 62** Scatter plot of % of participants detecting each flaw vs. flaw depth and width for matt white specimens

When viewing the scatter plots, it became apparent that the levels of detection percentage appeared to form bands, or contours, of constant detectability. In order to explore the possibility of detectability bands further, the wafer plot function of Statistica was used to fit the scatter plots with contours representing percentage levels of detection. The wafer plots are shown in Figures 65–70. The wafer plots also use a natural log scale on the X and Y-axis. The contours on the wafer plots are best fit lines of constant detection percentage, and allowed changes in detection rates due to colour or finish to be easily identified. Furthermore, the effects of flaw width and depth on detection rates were easily visualised on the wafer plots.

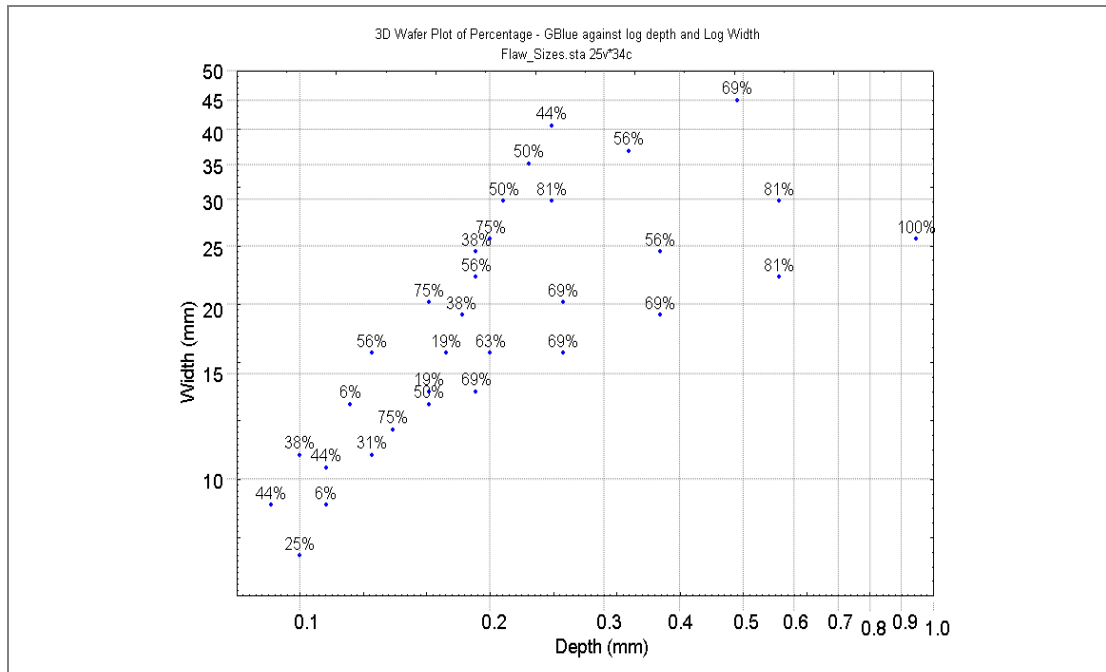
**Figure 63** Scatter plot of % of participants detecting each flaw vs. flaw depth and width for gloss blue specimens

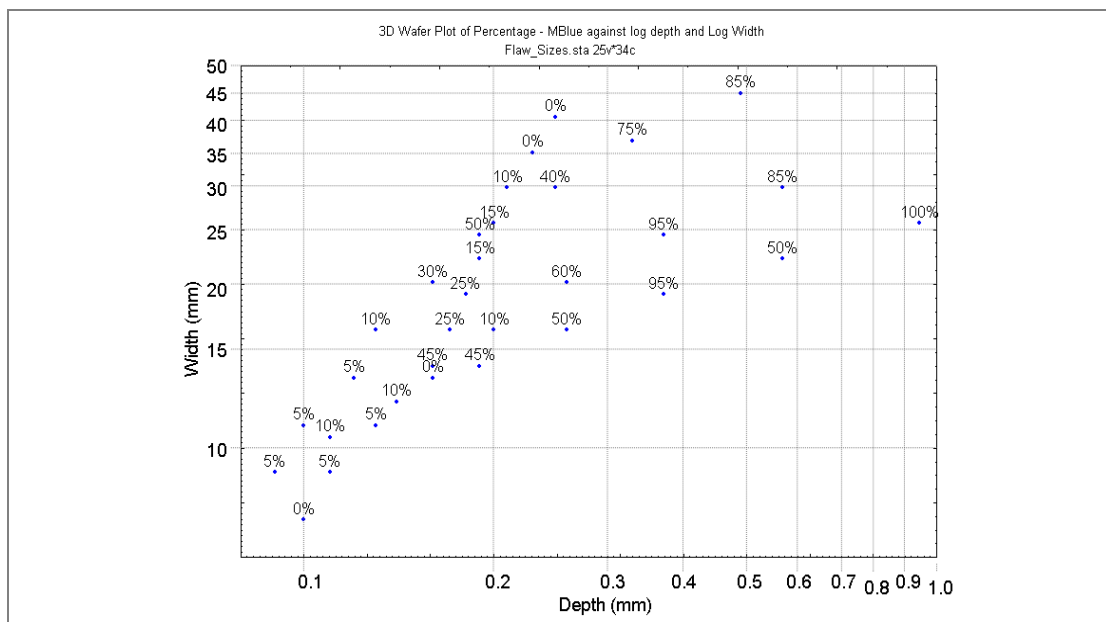
**Figure 64** Scatter plot of % of participants detecting each flaw vs. flaw depth and width for matt blue specimens

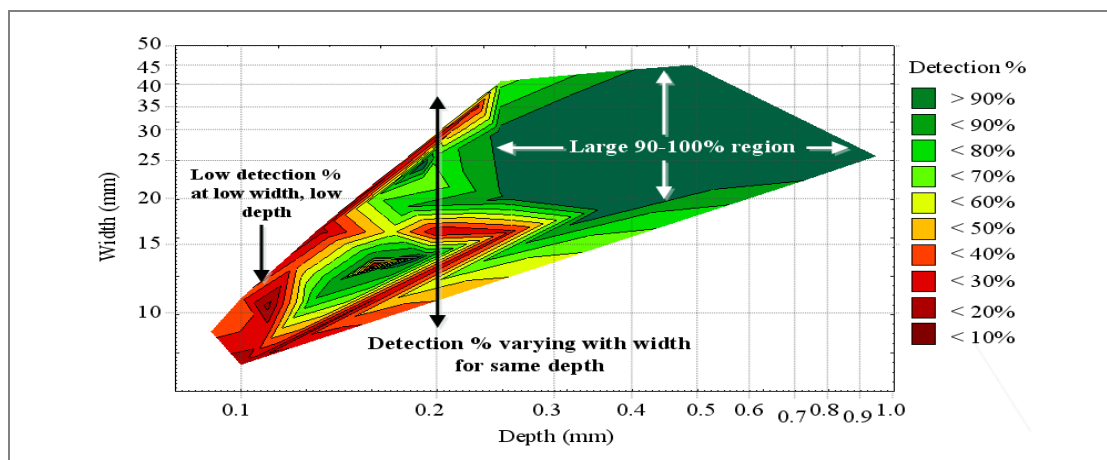
In Figure 65, the wafer plot of gloss grey results shows a large region of width and depth greater than 20 mm and 0.3 mm respectively in which flaws were detected by over 90% of participants. The contours indicate that for flaws of small depth and width, the detection was at its lowest rate. If a nominal flaw depth of 0.2 mm is chosen, the wafer plot illustrates that flaw detection rates can vary between <10% and >90% as width varies; i.e. detection can vary for the same depth of flaw, depending on the flaw width.

**Figure 65** Wafer plot of gloss grey results with comments

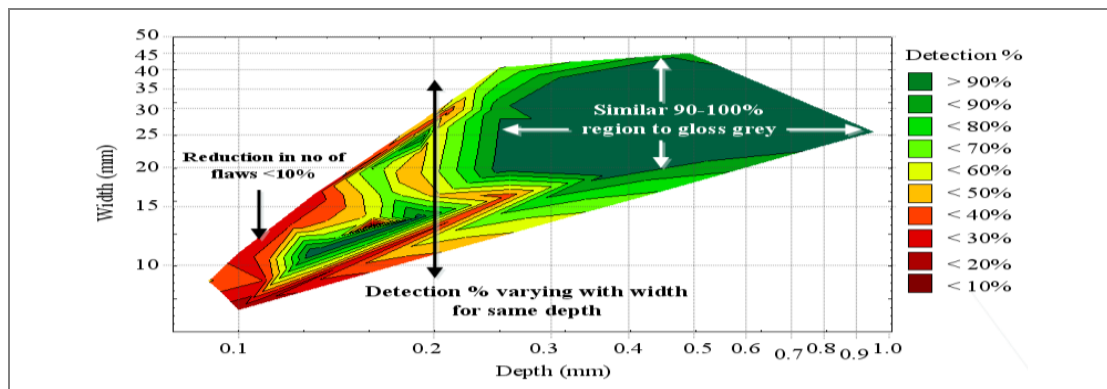
Figure 66 illustrates the wafer plot for the matt grey results. It can be seen that the matt finish has little effect on detectability of flaws greater than 0.25 mm deep; the region of 90-100% detection is similar in size and shape to the same region on the gloss grey diagram. There is a slight change to the contour shape for flaws of smaller width and depth, where the <10% detection band is no longer present. As also observed for the gloss grey specimens, the detection contours vary with width for constant depths. The overall implication is that there is little difference in detection rates on gloss and matt grey specimens.

**Figure 66** Wafer plot of matt grey results with comments

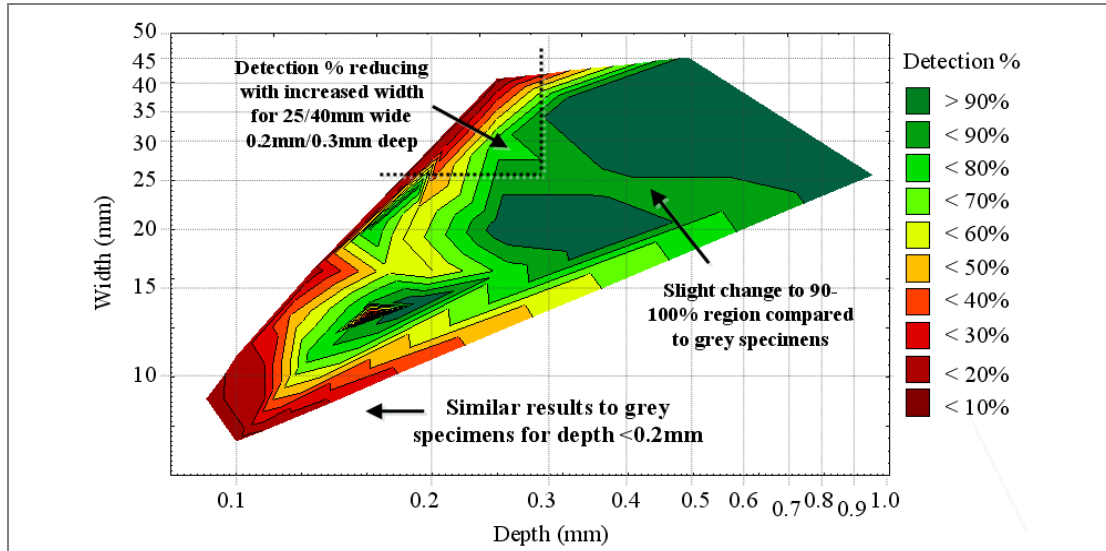
In Figure 67, the wafer plot of the gloss white specimens illustrates that there are some differences compared to the results with grey specimens. The large area of 90-100% detection has changed shape slightly. For flaws between 0.2 mm - 0.3 mm deep, and >25 mm wide, the detection percentage reduces as width increases. However, for flaws below 0.2 mm deep, there is little difference to the detection contours compared to the gloss and matt grey results. This implies that there are slight differences in detection rates on gloss white specimens compared to gloss and matt grey specimens.

**Figure 67** Wafer plot of gloss white results with comments

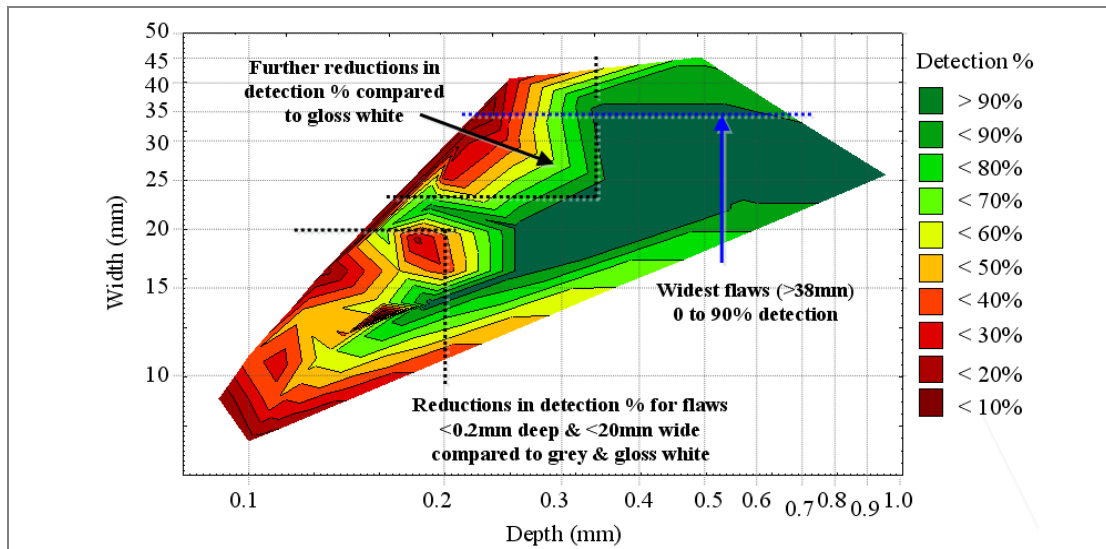
In Figure 68, which shows the results from matt white specimens, there are notable differences to the contour shapes found in the gloss white results. The large area of >90% detection has changed shape, and no longer includes flaws wider than 38 mm. The detection of flaws >38 mm wide now varies from <10% to >90% depending on flaw depth. For the flaws between 0.2 mm and 0.3 mm deep and >25 mm wide, there is greater variation in detection rates compared to the same region on the gloss white results. Detection of flaws <0.2 mm deep and <20 mm wide saw reduced rates on the matt white specimens compared to the gloss grey and white, and matt grey specimens. The results seen in Figure 68 imply that the matt finish altered detection rates on the white specimens.

**Figure 68** Wafer plot of matt white results with comments

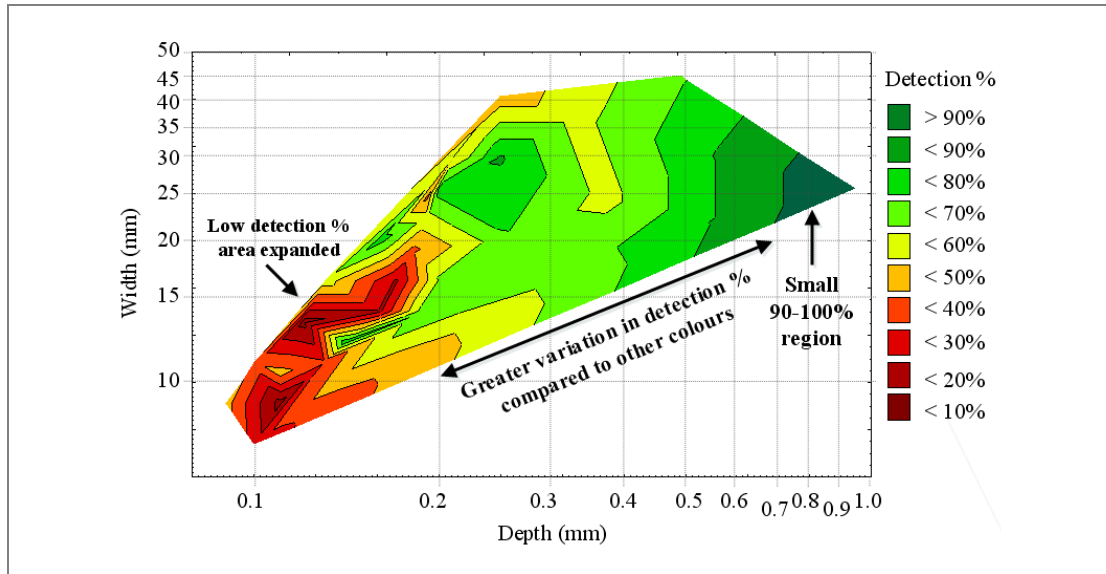
Figure 69 shows the results obtained from the gloss blue specimens. In this plot, it can be seen that there is a significantly different shape to the detection contours compared to the results from grey and white specimens. The lower limit of the region of >90% detection has shifted to 0.7 mm deep compared to that of the grey and white results (0.25 mm deep). The detection contours for flaws >0.2 mm vary less with flaw width than on the other plots (fig 69-72 and 73). For the gloss blue specimens, detection varies mostly with flaw depth. The area of low detection percentage (<30%) covers a larger width and depth range on the gloss blue results compared to the grey and white results. From the plot in Figure 69, it can be seen that different detection results are obtained from gloss blue specimens than from grey and white specimens.

**Figure 69** Wafer plot of gloss blue results with comments

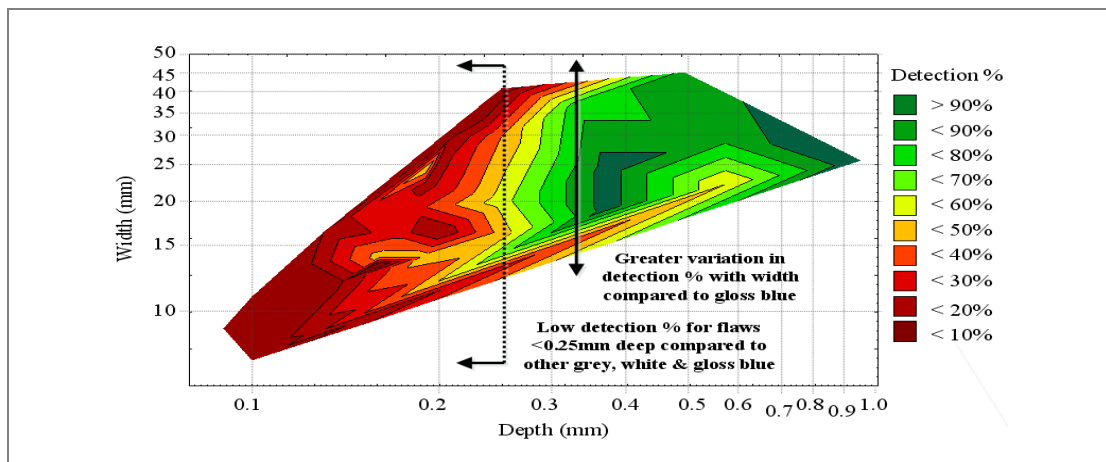
Figure 70 illustrates the results from the matt blue specimens. It can be seen in Figure 70 that there is greater variation in detection percentage with width than on gloss blue specimens. It can also be seen that detection of flaws with <0.3 mm depth is reduced to below 50%. The results seen in Figure 70 imply that a matt blue finish gives different detection results to a gloss blue finish.

**Figure 70** Wafer plot of matt blue results with comments

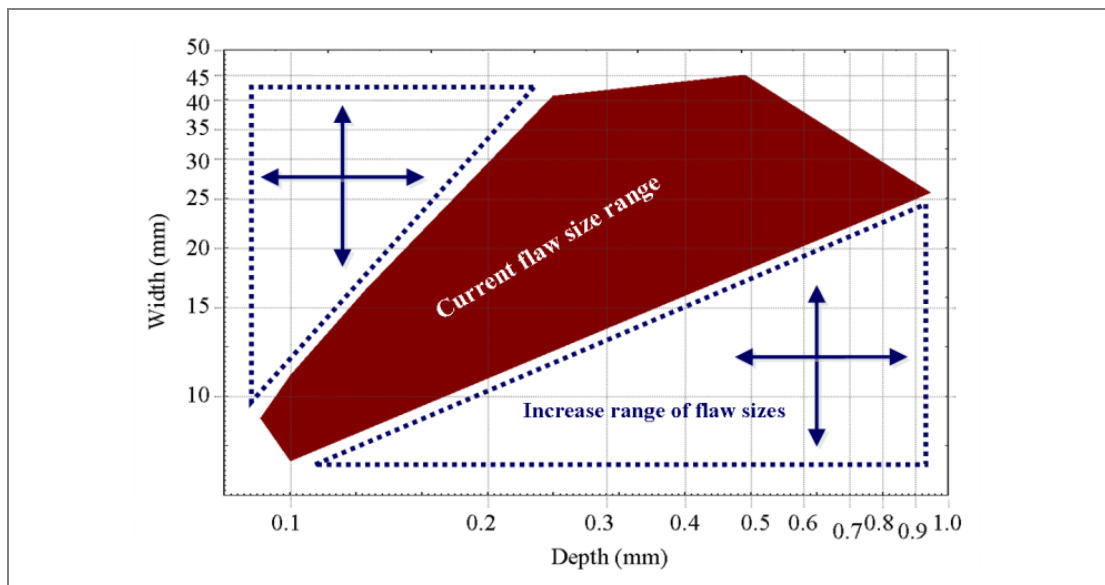
The flaws used in this study represented impact damage that occurred due to impacts from a 20 mm and 87 mm hemi-spherical object on a 17 ply and 33 ply painted, mesh incorporated laminate. As seen in Figure 71, this results in a flaw size and shape range that occupies only a selection of possible flaw depths and widths. Flaw sizes outside of this range could conceivably be produced by impact objects of different sizes, or on different laminate thicknesses to those used in this study. Future work should include an extension to the range of geometries studied so that the additional areas shown in Figure 69 are included.

**Figure 71** Illustration of flaw size range used in study, and possible additional range of flaw geometries which could be studied

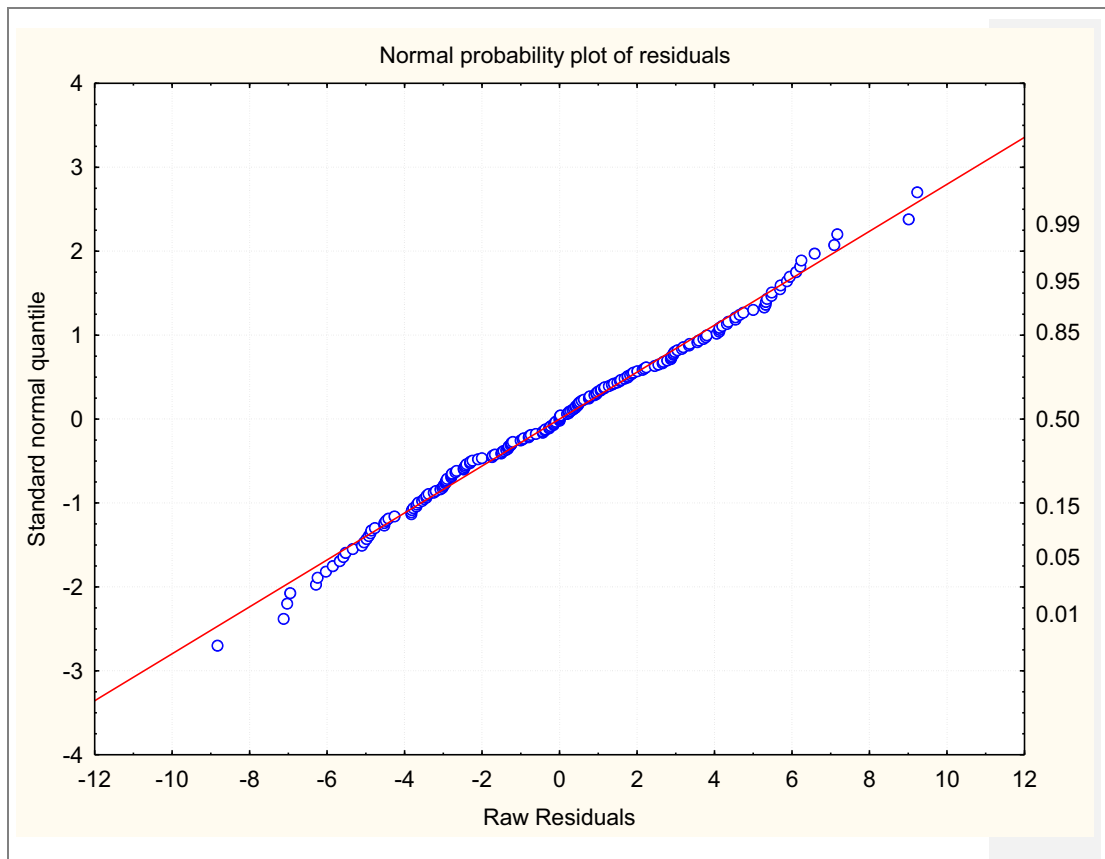
**Figure 72** Plot of standard normal quantile vs residuals for all the inspection data contained in Appendix 3, showing a close adherence to a normal distribution

Blue, Grey), panel surface finish (Gloss or Matt), impactor diameter (20 mm or 87 mm) and laminate thickness (17 ply or 33 ply). All interactions between these categorical descriptors were included. Some of the parameters will not be independent variables in that the flaw width and depth will depend on the ply thickness and the impactor diameter. Table 13 shows the significant effects identified. This is equivalent to an analysis of variance table but as a non-linear model is being fitted to the data, the same exact techniques to estimate the effects cannot be used using maximum likelihood estimation. A significant p value ( $p < 0.05$ ) indicates that there is a significant effect of the parameter in question. Figure 72 shows that the fit of the data to the model is reasonable as the residuals follow a normal distribution. This is indicated by the close adherence of the data to a straight line as shown in Figure 72.

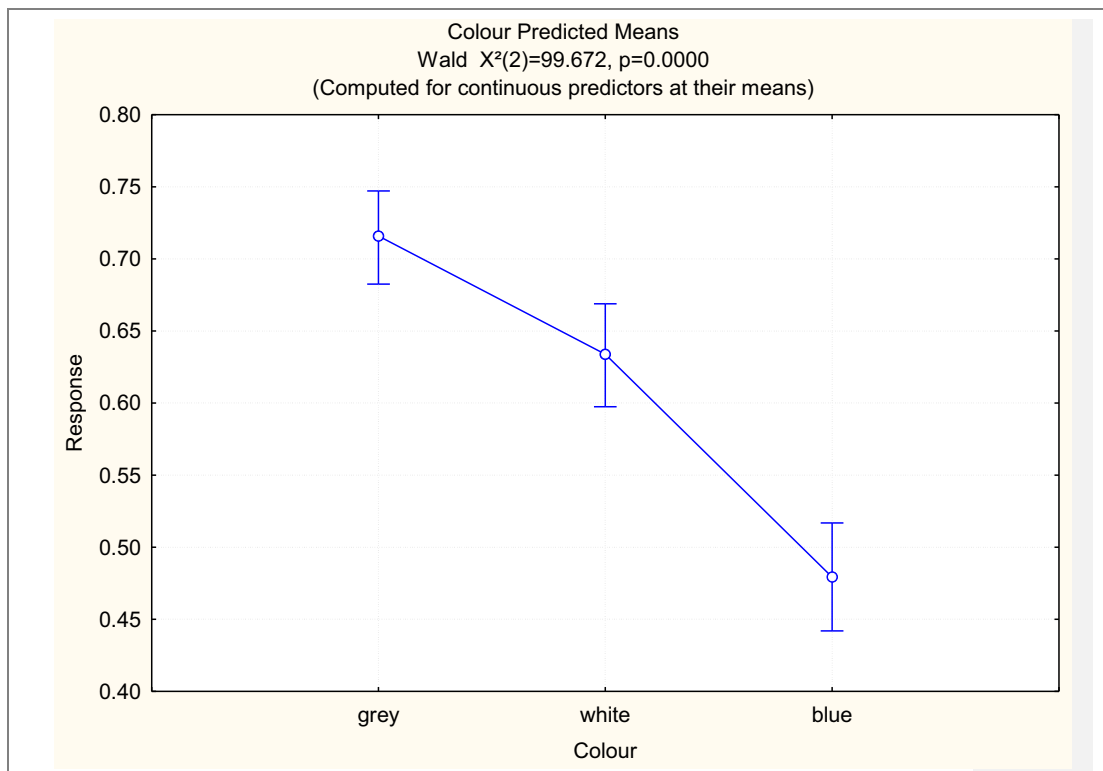
Figure 73 shows that detection probability is greatest in grey samples and is reduced almost by half in the blue ones. White samples have intermediate values.

**Figure 73** Effect of sample colour on probability of defect detection; both surface finishes combined; mean width and depth defect sizes.

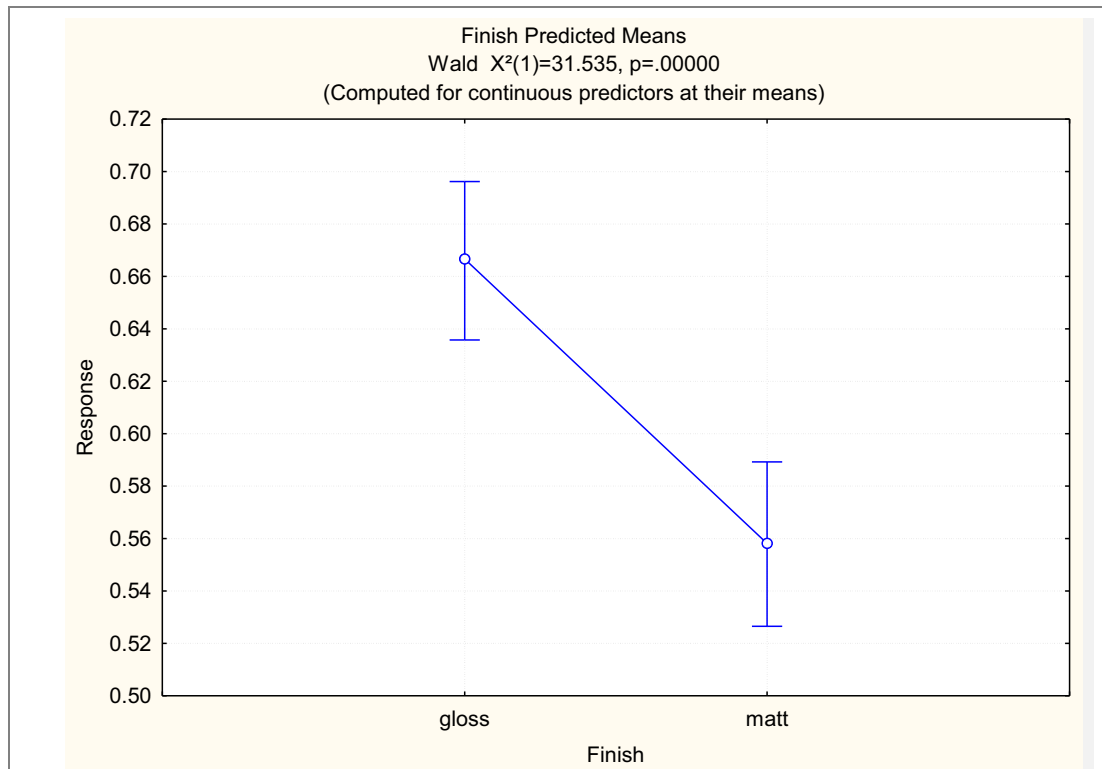
The effects of surface finish on probability of defect detection for all colours combined are shown in Figure 74. It can be seen that matt surface finish reduces the probability of detection from 0.66 to 0.56

**Figure 74** Effect of sample surface finish, all colours combined on detection probability; mean width and depth defect sizes

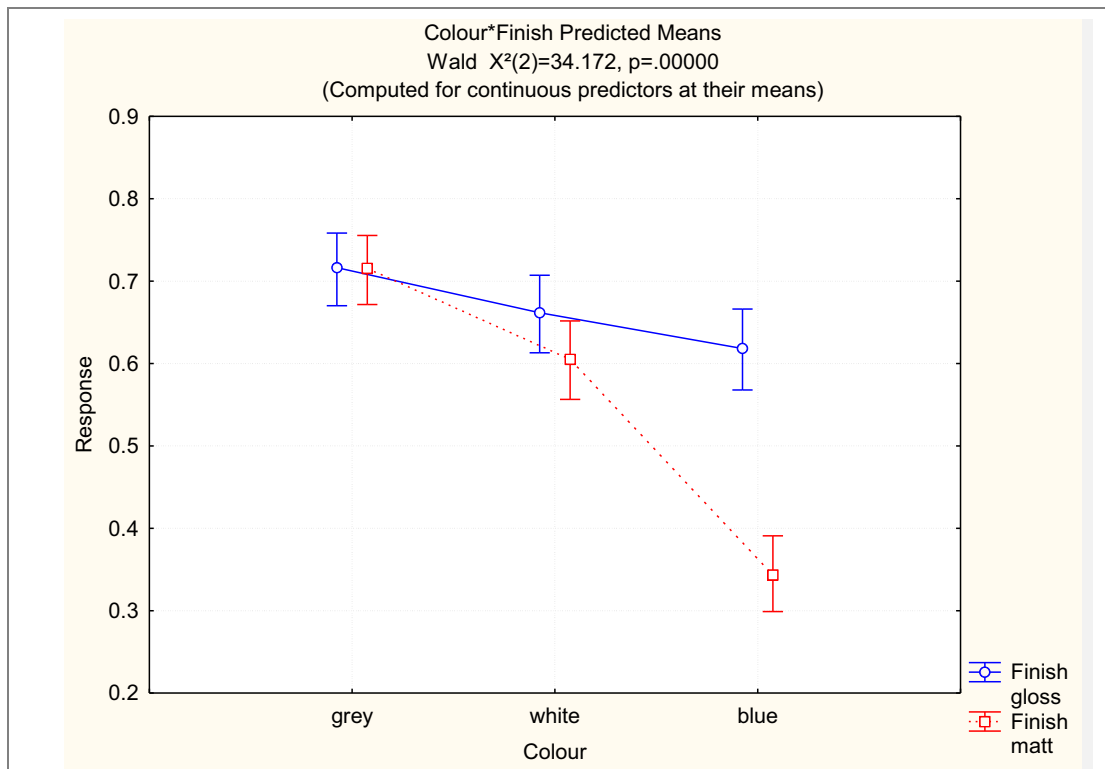
Figure 75 shows the effects of colour and surface finish with their effects considered separately. In this more detailed representation it can be seen that for grey samples there is no significant effect of surface finish, a slight effect for the white- still not statistically significant, and a major effect of surface finish for the blue samples. In the blue samples a matt surface finish reduces the detection probability by a factor of 2. there is still some small effect of colour on detection probability in the gloss surfaces, with blue once again having the lowest probability of detection. All these effects are considered at the mean values of defect depth and width.

**Figure 75** Effects of sample colour and surface finish on probability of defect detection; colour and surface finish separated; flaw width and depth at mean values
