**Paper 2013/03**

**Reliability of Damage Detection in Advanced  
Composite Aircraft Structures**

**Prepared for CAA by:**    **L Cook**  
                                  **A Boulic**  
                                  **D Harris**  
                                  **P Bellamy**  
                                  **P E Irving**  
                                  **Cranfield University**

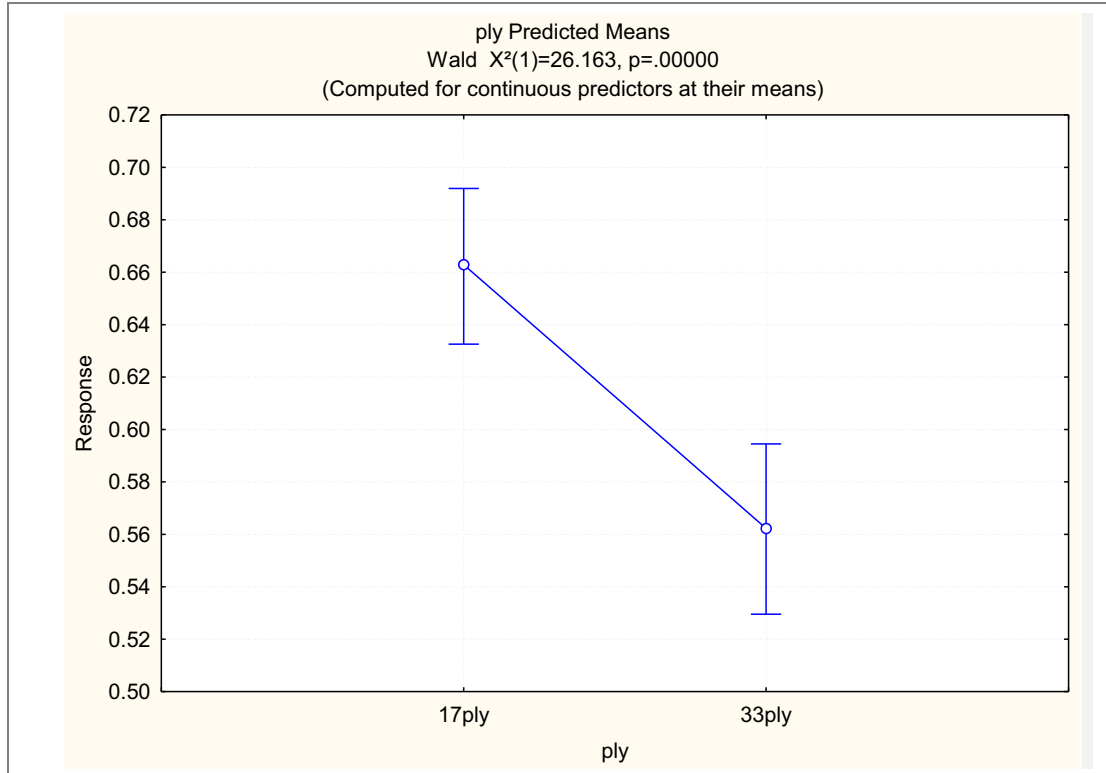
There is a significant effect of ply thickness as Figure 76 shows. However ply thickness will influence defect shape particularly defect width as Figure 41 demonstrates. Hence this effect is a manifestation of the effect of defect width on detection probability.

**Figure 76** Effect of impact sample thickness on detection probability; all colours and surface finishes combined; mean values of defect depth and width

Graphs are shown only for those effects that were significant in Table 13. They are easy to interpret except perhaps for the two interaction effects. Colour\*finish is looking at how the differences in probability of detection between the two surface finishes varies across the 3 colours – so Figure 76 shows that there is a significant difference in the detection probability of the two finishes only in the blue colour. This difference (in the blue) is enough to give a significant difference in finish for the all colours plot (Figure 73). This shows how important it is to include interaction effects in statistical analysis. The other interaction that was significant was colour\* impactor diameter mm – in this case the effect of impactor diameter was not significant on its own. This interaction has been plotted in two ways (Figures 77 and 78) to help interpretation – it can be seen that there is no significant difference in the probability of detection between grey and white when surface flaws are formed by 20 mm impactors but there is a difference for 87 mm diameter impactors.

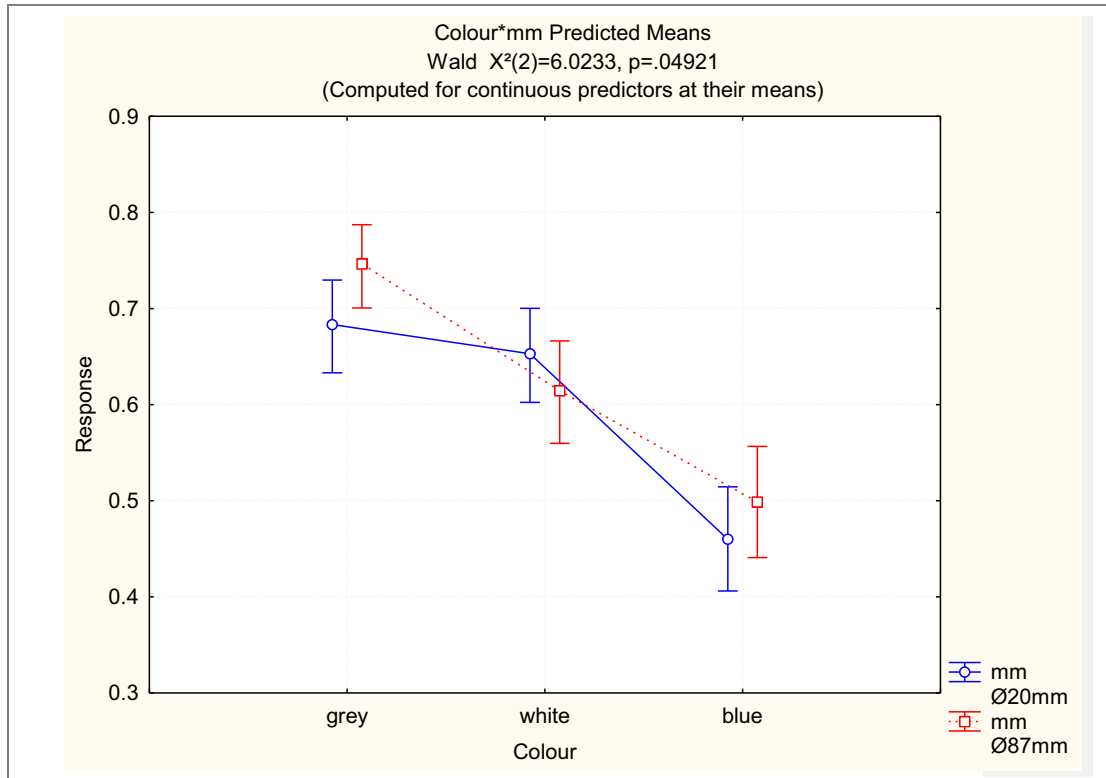
Figures 77 and 78 show the combined and separate effects of colour and impactor diameter on probability of detection. As for the ply thickness, impactor diameter will affect the defect profile, 87 mm diameter impactors producing wider defects for a given depth as Figure 41 indicates. Figure 77 and 78 show that colour is more dominant than impactor diameter, and that sometimes probabilities of detection are increased with increasing diameter, and on other occasions they are decreased.

**Figure 77** Effect of colour and impactor diameter on inspection reliability

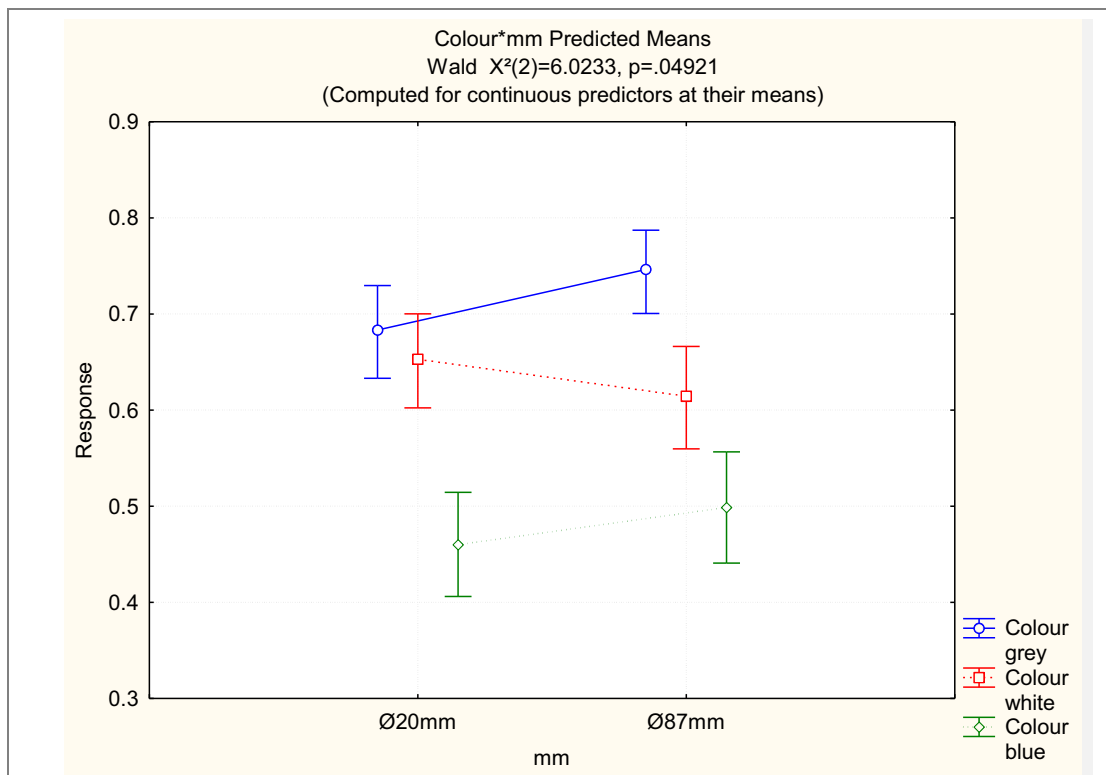
**Figure 78** Effect of impactor diameter on inspection reliability in different colour samples

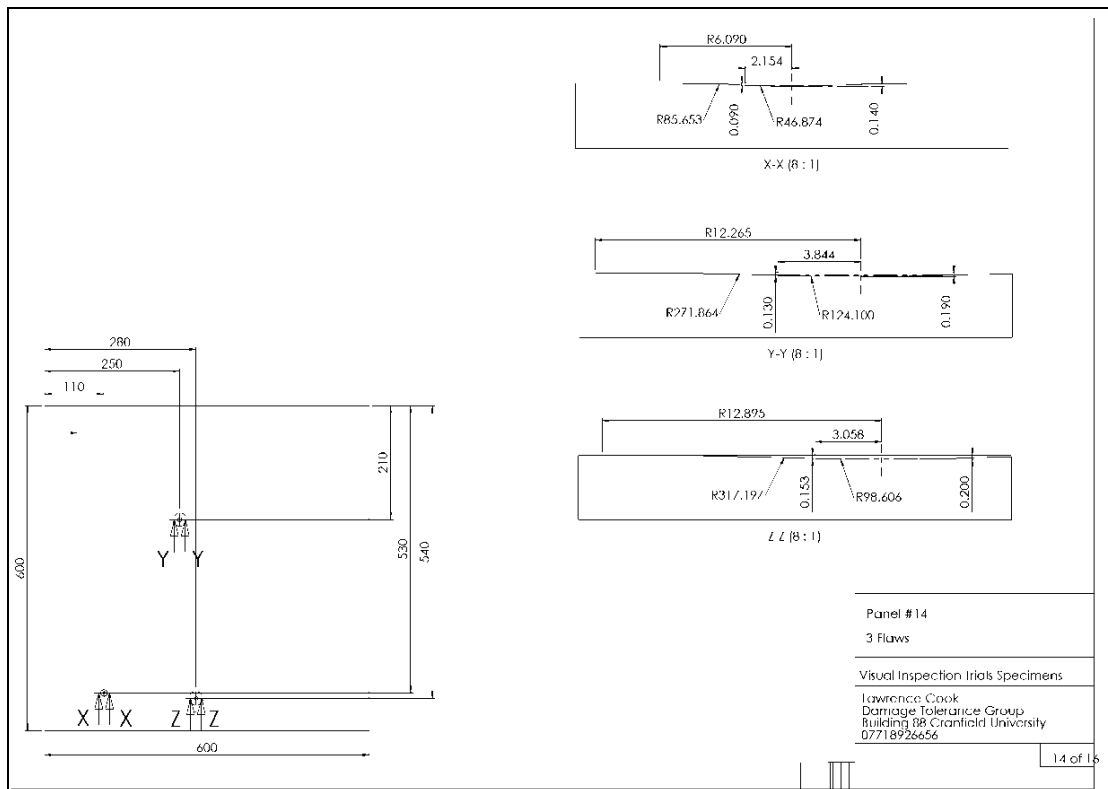
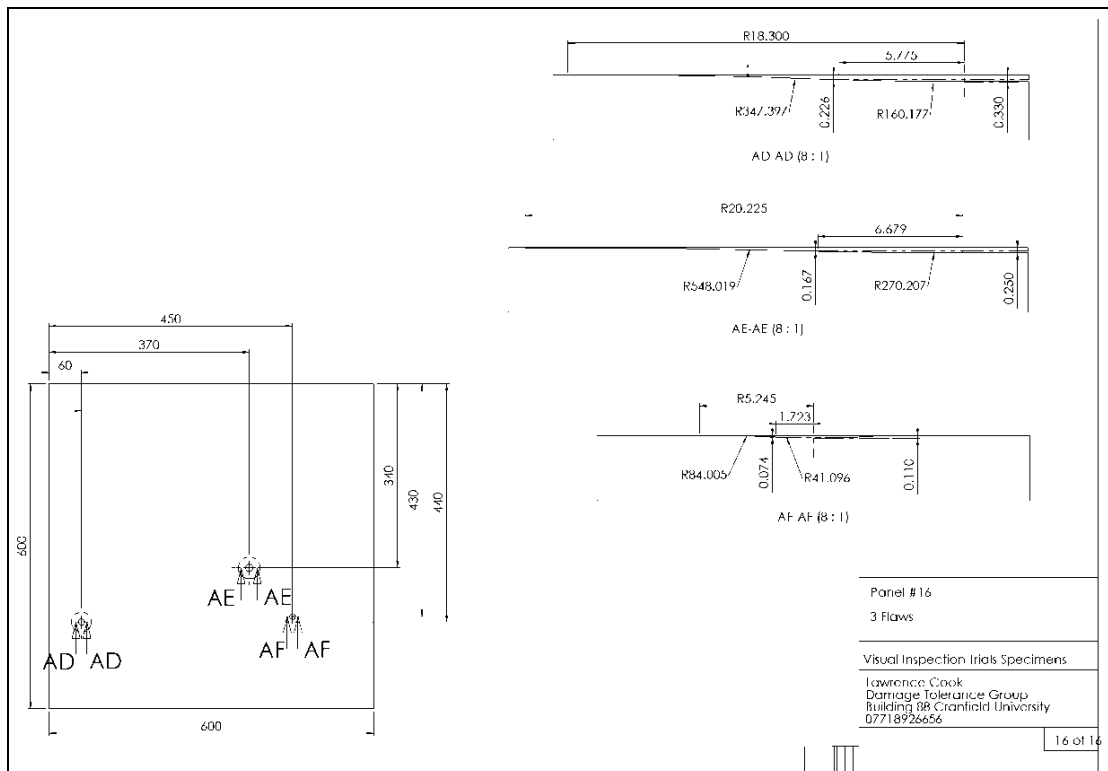
## Characterisation of impact damage surface flaws
