Aircraft Maintenance Incident Analysis

CAP 1367

Published by the Civil Aviation Authority, 2015

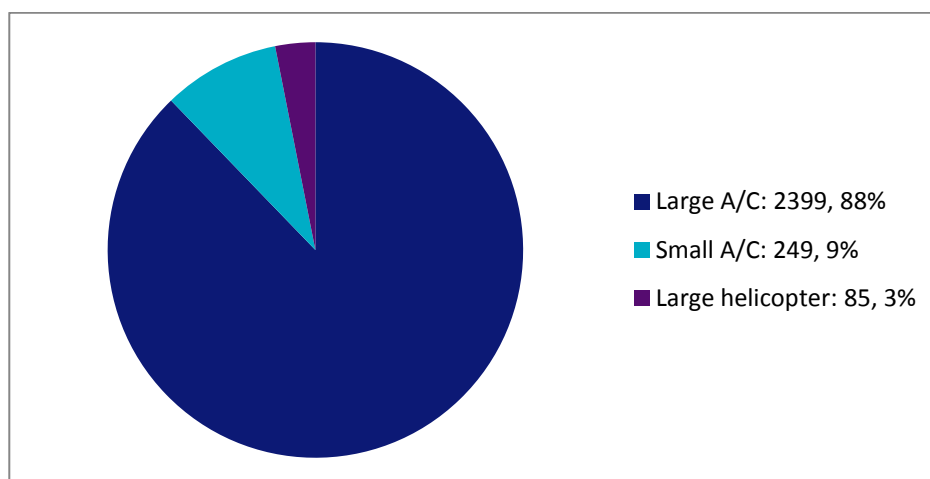
Figure 1: Overall breakdown of analysis

- 4.13 The resulting data set for the period covered 2733 events and these were analysed in accordance with the above taxonomy. The breakdown by aircraft category is shown in figure 1.

- 4.14 It can be seen that with 88% the largest proportion of events relate to large aeroplanes. This is not surprising as the 'mandatory' elements of the MOR scheme apply to these aircraft rather than the smaller, more General Aviation focused sectors.
- 4.15 Large helicopters, the bulk of which are operated in support of the North Sea oil industry or for search and rescue purposes made up only 3% of the data set. The total UK fleet of such helicopters is small in relation to the equivalent fixed wing fleet. Despite this, the relatively low level of reported events is surprising given the knowledge that there is a greater intensity of maintenance activities on such aircraft.

- 4.16 Small aircraft reported incidents, both aeroplanes and helicopters, contributed to only 9% of the total. It should be noted that it is not mandatory to submit reports for many events related to small aircraft so there are likely to be additional events that are not captured in the MOR data held by the CAA. The focus of this review is therefore understandably and predominantly related to large aircraft and those used for commercial air transport.

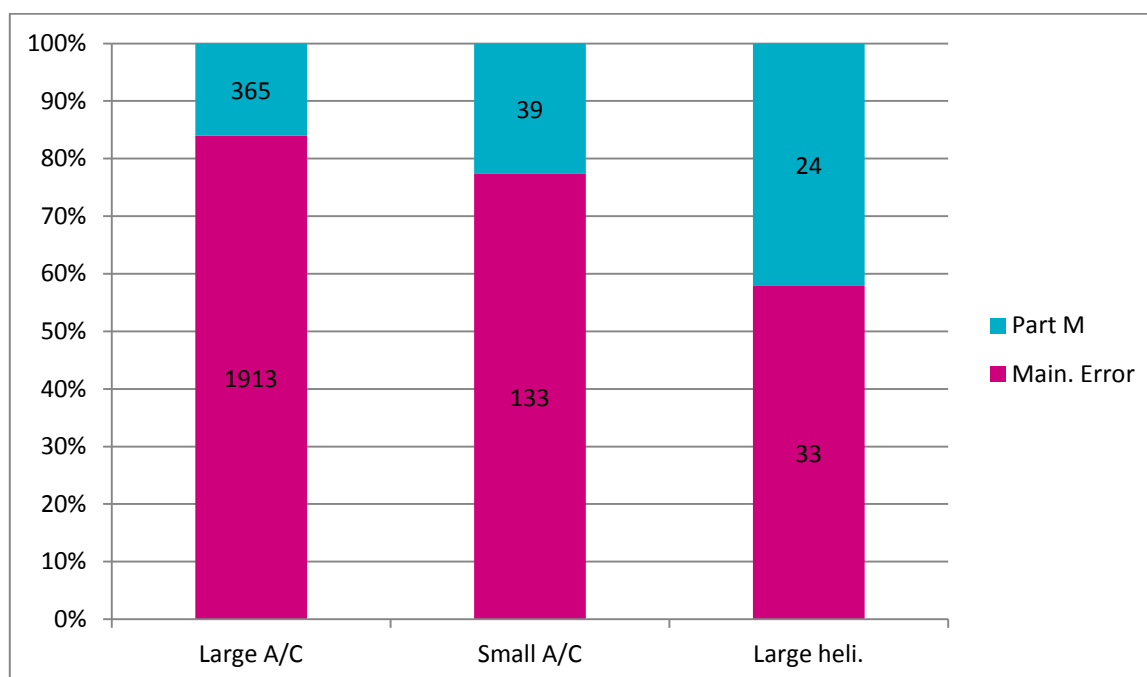
Figure 2: Breakdown of events, Part M vs maintenance error

- 4.17 The data set broke down into events related to Part M – maintenance management issues and maintenance error events. The analysis is shown in figure 2. It can be seen that, whilst there were small variations in the balance between the two classes of events the proportion was relatively consistent across the aircraft categories. What is significant is the slightly larger proportion of Part M – maintenance management issues reported for large helicopters. Since these relate mainly to maintenance overruns on life limited components this is not surprising given the much larger number of life controls and overhaul periods prescribed for such aircraft. This can also be linked to errors introduced during the migration of data to new computer systems.

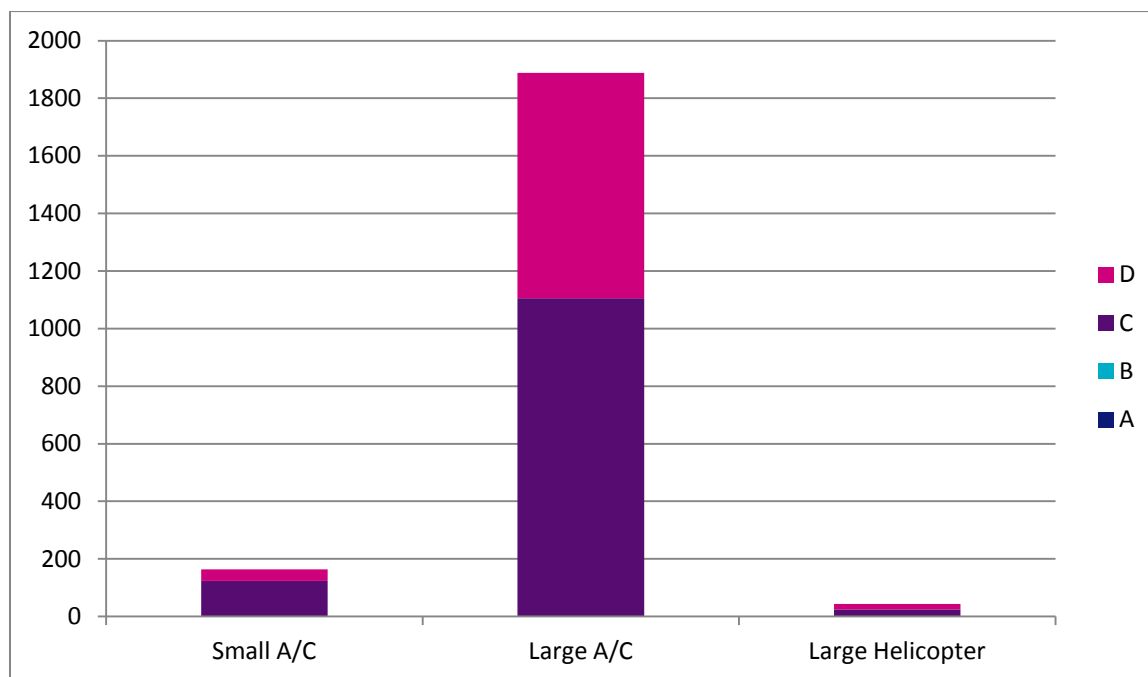
Figure 3: Maintenance error-risk distribution, all categories 2005-2011

- 4.18 The occurrences of maintenance error can be further analysed at a high level to show a correlation with the CAA classification of the MOR when received by the CAA. This is shown in Figure 3. The most significant MORs, typically involving accidents, are classified as category A with the lesser reports, usually closed on receipt by the CAA as category D.

- 4.19 It can be seen from this that the bulk of the maintenance related MORs are classified by the CAA as Category C. That does not mean they are not significant and many require CAA investigation of the circumstances surrounding the MOR.
- 4.20 There are two reasons for this. The first is to ensure that the operator or maintenance organisation is reacting properly to the occurrence. This will initially be to rectify the problem in order to return the aircraft to service. The secondary function will be to further analyse the event and determine the root cause in order to put in place corrective measures to prevent a reoccurrence.
- 4.21 By comparison, the further high level analysis of the Part M related errors yields the results shown in figure 4.

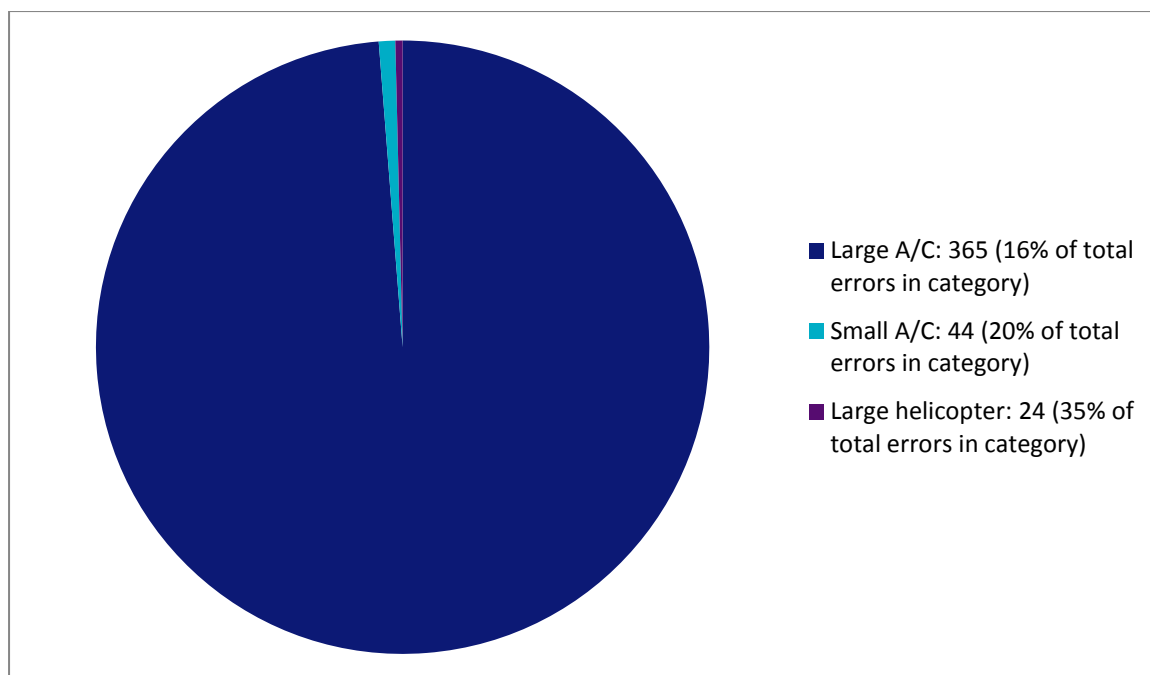
Figure 4: Distributions of Part M errors reported 2005-2011

- 4.22 Figure 4 shows that there were 433 reported Part M errors. Of these 303 (70%) related to overrun of overhaul lives, airworthiness directives or maintenance inspections called out as part of the Approved Maintenance Programme, of these approximately 40 reports indicated a non-compliance with an Airworthiness Directive. This is often a reflection of poor maintenance planning where due maintenance is not carried out and not re-planned within the appropriate timescale. In some instances the overrun is linked to a data entry issues. A more detailed review of the contributing causes also suggests that there may be some evidence of a conflict between the accomplishment of the work and commercial pressures to continue operating the aircraft.

- 4.23 A further 130 (30%) reports highlight errors in setting up the data in the first place. These errors are often simple transcription errors between the hard copy paperwork following maintenance and the electronic database used to manage the planning function. For example, inputting component life data following their fitment to the aircraft and forecasting next due tasks. Such errors can lead to an overrun if not detected by some other intermediate means, such as unscheduled component replacement or a detailed audit of the database.

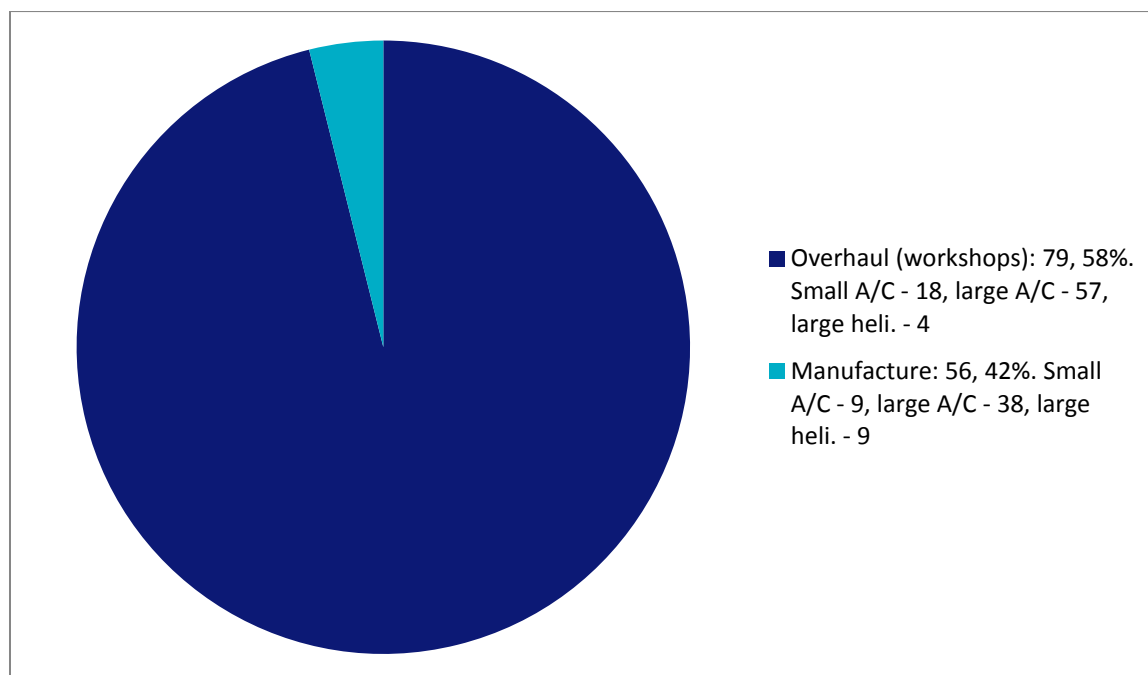
Figure 5: Distribution of events considered as manufacturer or overhaul errors, data 2005-2011

- 4.25 These are events which, following analysis of the underlying circumstances, are issues that have their roots in an error at the time of manufacture or which are attributed to an overhaul agency and not therefore a direct error within the operator's system. Both of these failures can involve human error but the fact that they occurred in third party organisations clouds the available data and the ability to mine the data and find the underlying root causes.

- 4.24 The final baseline or high level category to pick up on is the number of reports that are attributable to manufacture and overhaul, see Figure 3.

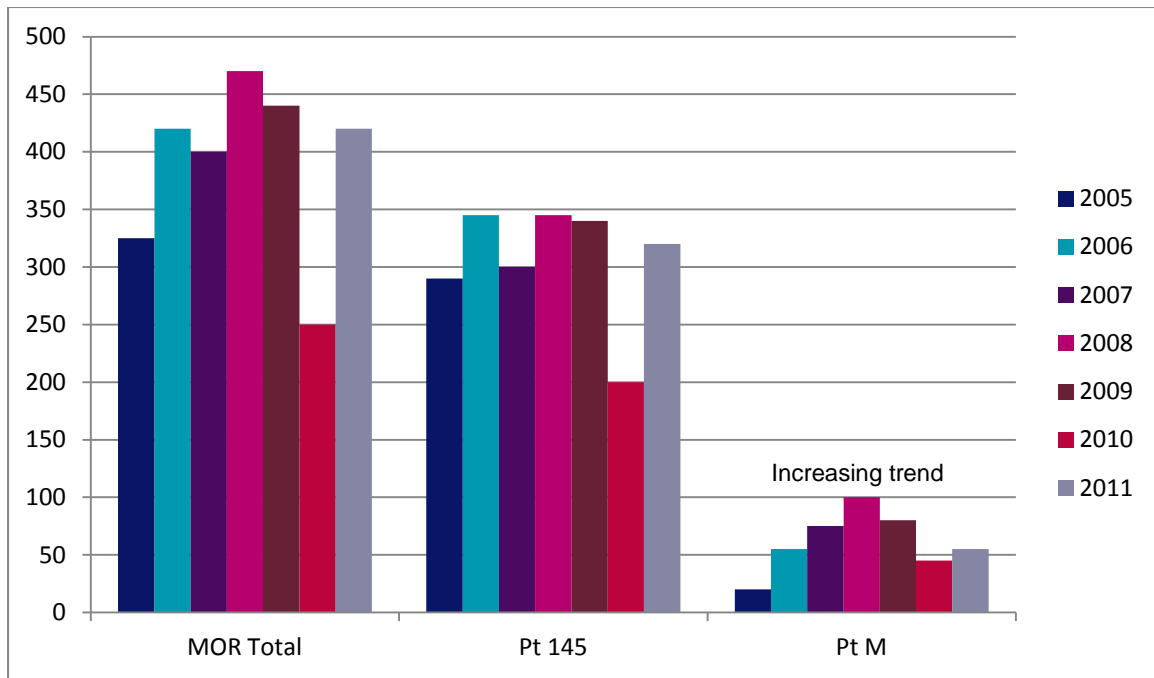
Figure 7: Maintenance MOR reporting levels 2005-2011

- 4.31 The number of maintenance related MORs received each year is shown in figure 7. It can be seen that the overall reporting levels are fairly consistent.

- 4.32 No explanation can be made for the apparent decrease in reporting in 2010 although it is recognised that the overall level of industry activity, in terms of aircraft operation had decreased as a result of the global financial crisis. The increase in reports for 2011 perhaps reflects increasing ‘commercial’ pressure and the resulting impact of manpower reductions increasing the risk of an error being made.

- 4.33 The increasing trend noted in Part M reflects the introduction of the Part M requirements in 2005 and the learning curve associated with the transition to the new structure. Further detail on the typical error causes is given in later Chapters.

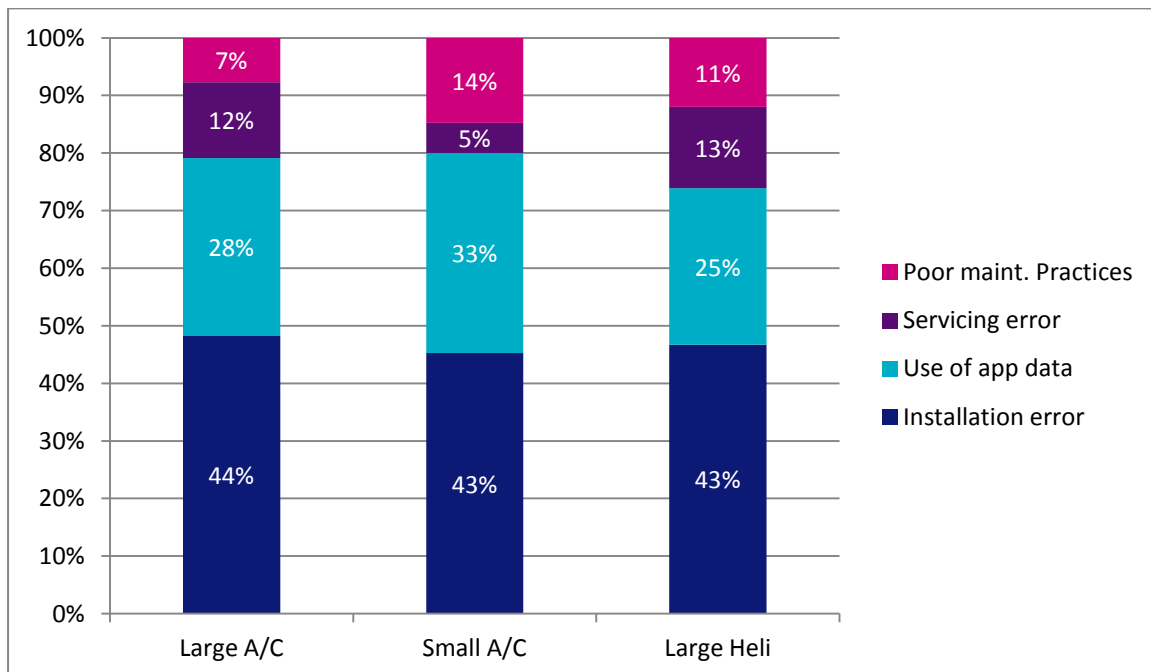
Figure 10: Maintenance error distribution comparison, common categories 2005-2011

4.38 The more detailed analysis of the root cause of the events is also able to be derived. This is shown in Figure 10 for the global data set.

4.39 The 100% figure represents 2108 MORs overall, 1890 for large aircraft, 174 for small aircraft and 44 for large helicopters.

4.40 From these figures it can be seen that the most likely error type is ‘incorrect installation’. The next highest is the use of approved data, or rather the

likely lack of it. Incorrect installation includes failure to fit all required components (e.g. seals or spacers), incorrect routing of electrical cables and incorrect applied torque. 'Use of approved data' includes the proper use of approved data such as the maintenance manual, service information or repair drawings.

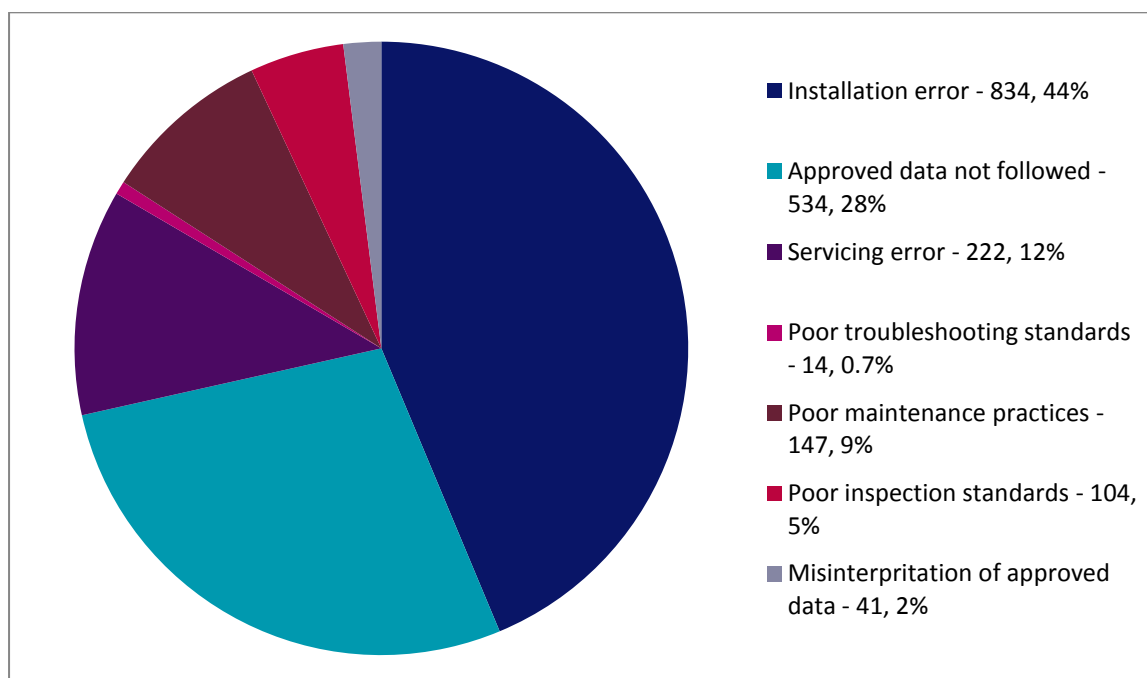
Figure 14: MOR maintenance error types 2005-2011

- 5.11 It is clear from the supporting data behind the reports that in many cases the engineer concerned did not use the latest available manuals or approved data to carry out the task. This highlights a cultural issue where, due to the information perhaps not being readily available, the engineer reverts to basic engineering skills. This does not, however, cater for critical dimensions or tasks when carrying out rigging etc.
- 5.12 Figure 14 provides an illustration of the MOR maintenance error types for the period 2005 – 2011. This tends to speak for itself.

- 5.13 This clearly shows that installation error and not following approved data collectively represent around 72% of the reported events. The failure to use approved data is, of course, a key underlying causal factor in the case of incorrect installation events.
- 5.14 Of the 834 events relating to installation error the following list represents a broad analysis of the associated factors (a few random events are not included):

- 6.11 In a similar manner to the analysis of maintenance error types for large aircraft, as shown in paragraph 5.2.2. and Figure 14, Figure 21 provides that information for the small aircraft category.

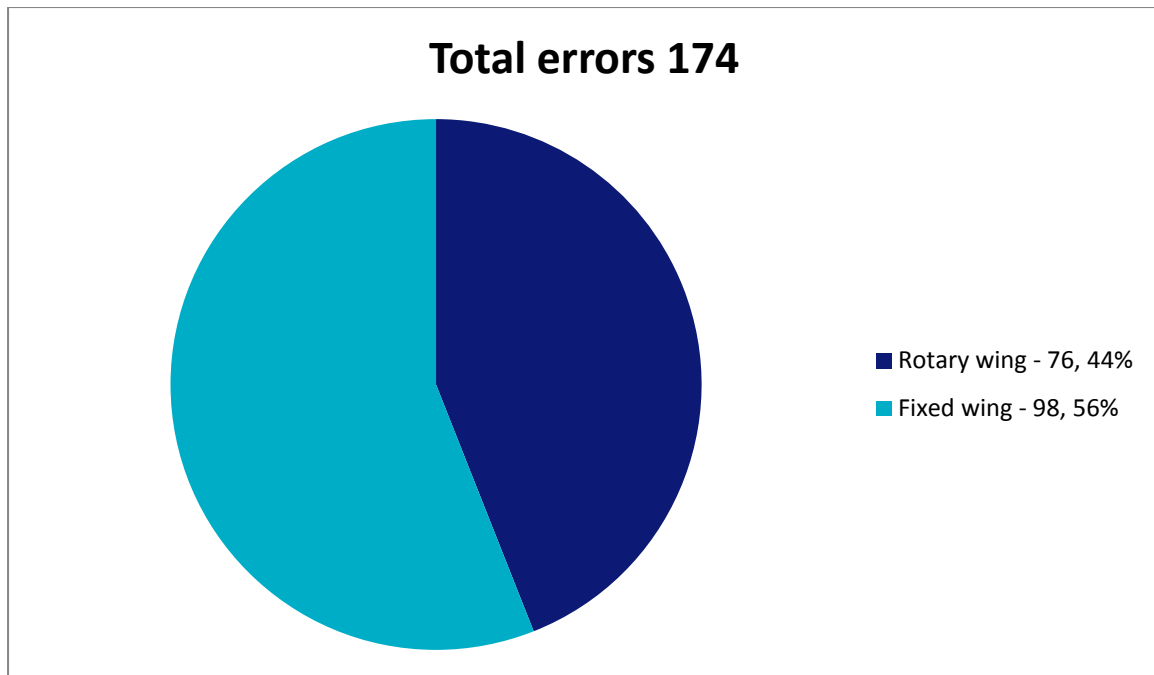
- 6.3 Figure 19 shows the global data for the small aircraft category. A total of 174 events were analysed ranging across a range of fixed wing aircraft such as the DHC-1 Chipmunk to BN-2 Islander and smaller rotary wing types such as the Robinson R22 to the Sikorsky S76. Fixed wing was responsible for 98 of these events (some 56%) with the remaining 76 events (44%) relating to rotary wing. Proportionally however there are far more small fixed wing aircraft than rotary wing so it tends to reinforce the belief that there are fewer reports on large helicopters than there ought to be.

Figure 19: Global MOR data for maintenance error, small aircraft

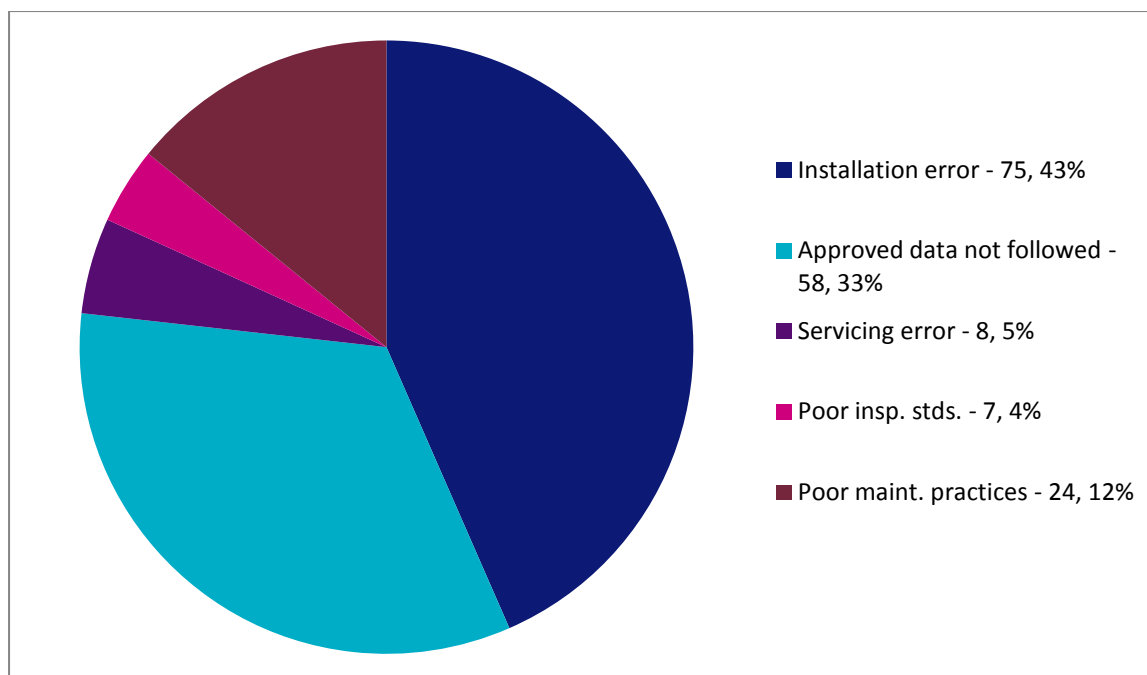
Figure 21: MOR maintenance error types 2005-2011, small aircraft

- 6.12 Whilst, based on the limited data available, Installation Error was similar in proportion to large aircraft, the percentage of Approved Data not Followed (33% against 28%) and Poor Maintenance Practices (14% against 9%) for small aircraft is higher than for large aircraft. This may well be a reflection on the culture of small aircraft maintenance, the lack of organisational focus on quality control and the absence of training available for new entrants. However, without carrying out an individual re-assessment of each MOR the actual reasons cannot be determined.

6.15 Installation error is also a cause for concern, as was the case for large aircraft. In this case it accounted for 75 events or 43% of the total (for large aircraft the figure was 834 events or 44% of the large aircraft total). For small aircraft this breaks down into the following causal factors:

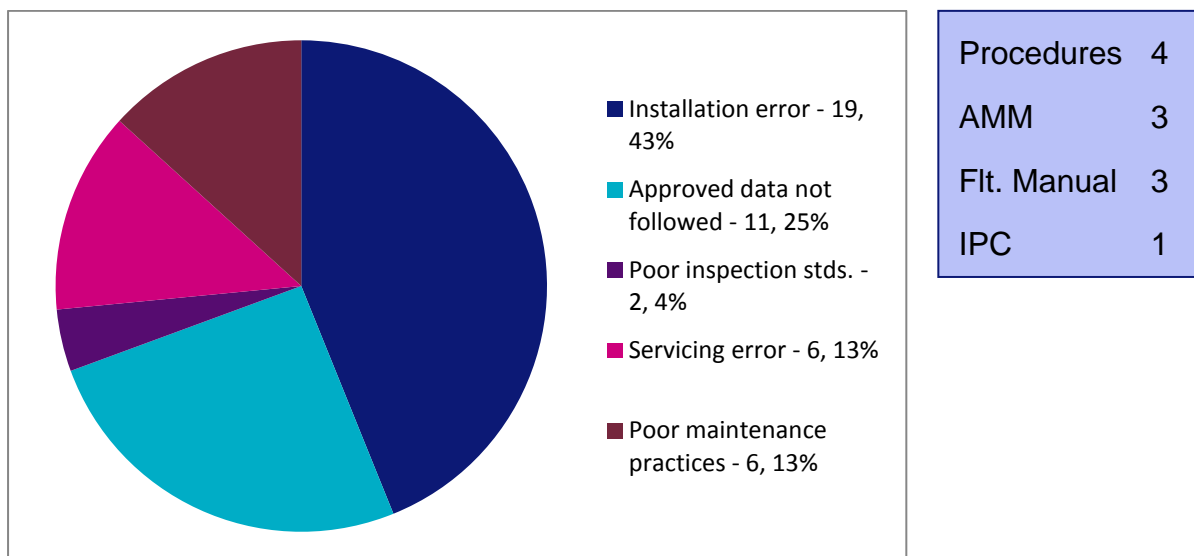
7.8 A further more detailed breakdown of the maintenance error types is shown in Figure 23.

Figure 23: Large helicopter MOR maintenance error types

7.9 The highest proportion of error as shown in Figure 21 relates to incorrect installation. This accounted for some 43% or 19 of the 44 events. The more detailed breakdown of these events was as follows:
