**DUAL CHILD OCCUPANCY  
OF AN AIRCRAFT SEAT**

*Roger N Hardy*

PREPARED BY CRANFIELD IMPACT CENTRE LTD  
AND PUBLISHED BY  
CIVIL AVIATION AUTHORITY LONDON JULY 1993

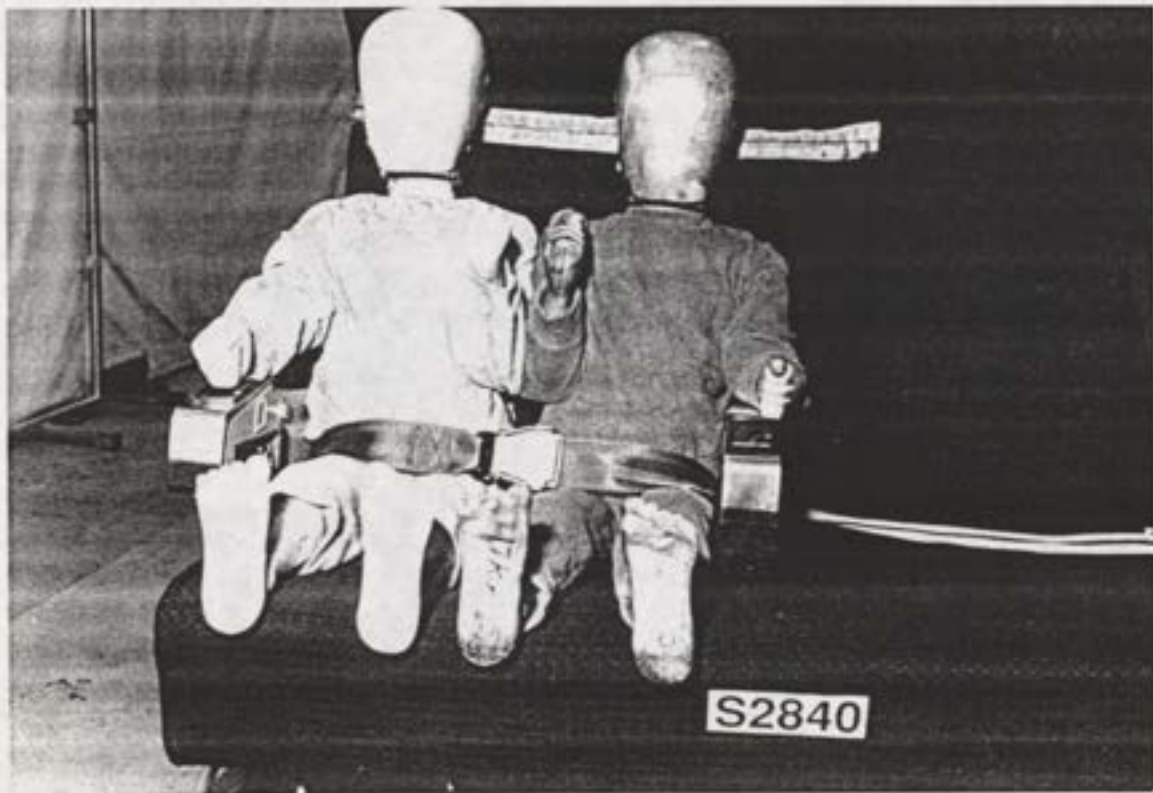
Figure 5 Positions of the two 3 year dummies on the aircraft seat

It was just possible to position the two 3 year dummies on the standard width seat in a shoulder to shoulder position. However, this was only possible by positioning the non-adjacent arms of the dummies on the arm rests. The bodies of the two dummies completely filled the available space between the arm rests, as shown by the photograph in Fig 5. In addition, the buckle of the lap belt lay between the two dummies, in a position where, in the case of children, it could easily be tampered with.

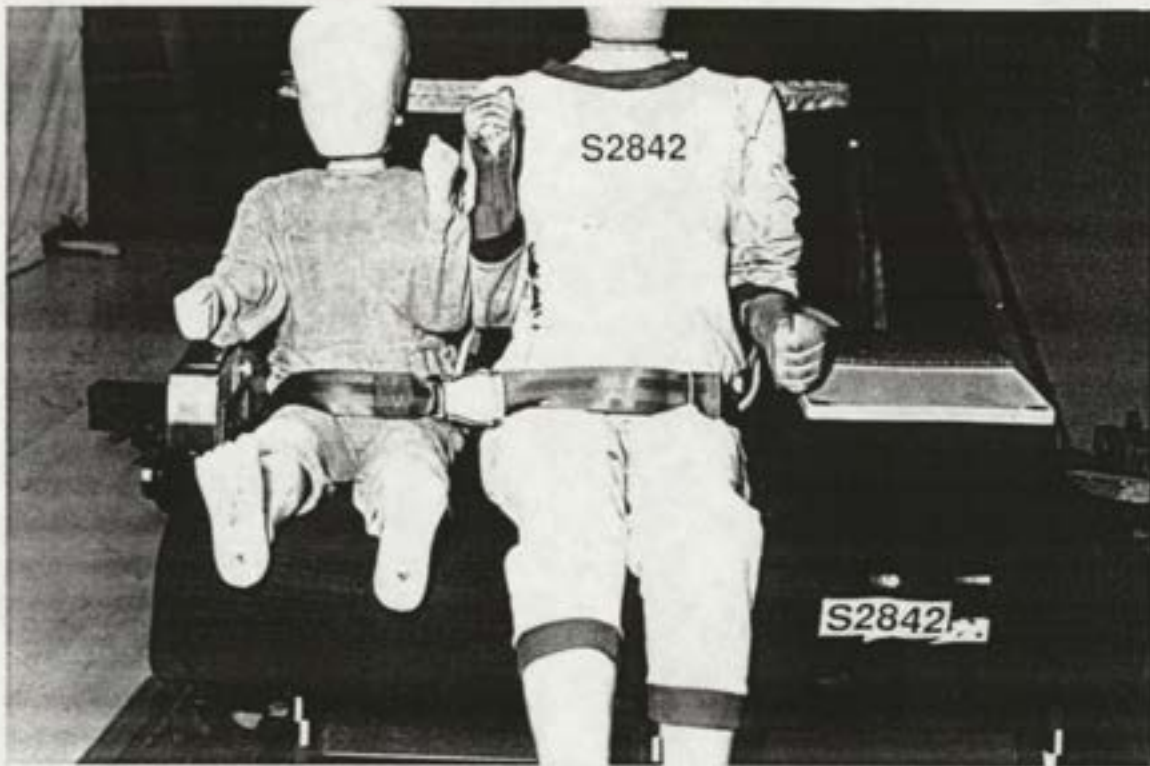
Figure 8 Positions of the 3 year and 10 year dummies on the aircraft seat

In the case of the test with the 3 year and 10 year dummies, even with the wider seat configuration it was necessary to position the left arm of the larger dummy on the wide central arm rest, as shown by the photograph in Fig 8. The left belt anchorage again lay within the longitudinal projections of the larger dummy's hips. Consequently, the lap belt webbing was wrapped around the left hip of the dummy, as show by the photograph in Fig 9. Also, the buckle of the lap belt lay between the two dummies. The location of the (raised) arm rest used in the standard seat width configuration can just be seen behind the neck of the larger dummy in Fig 8.

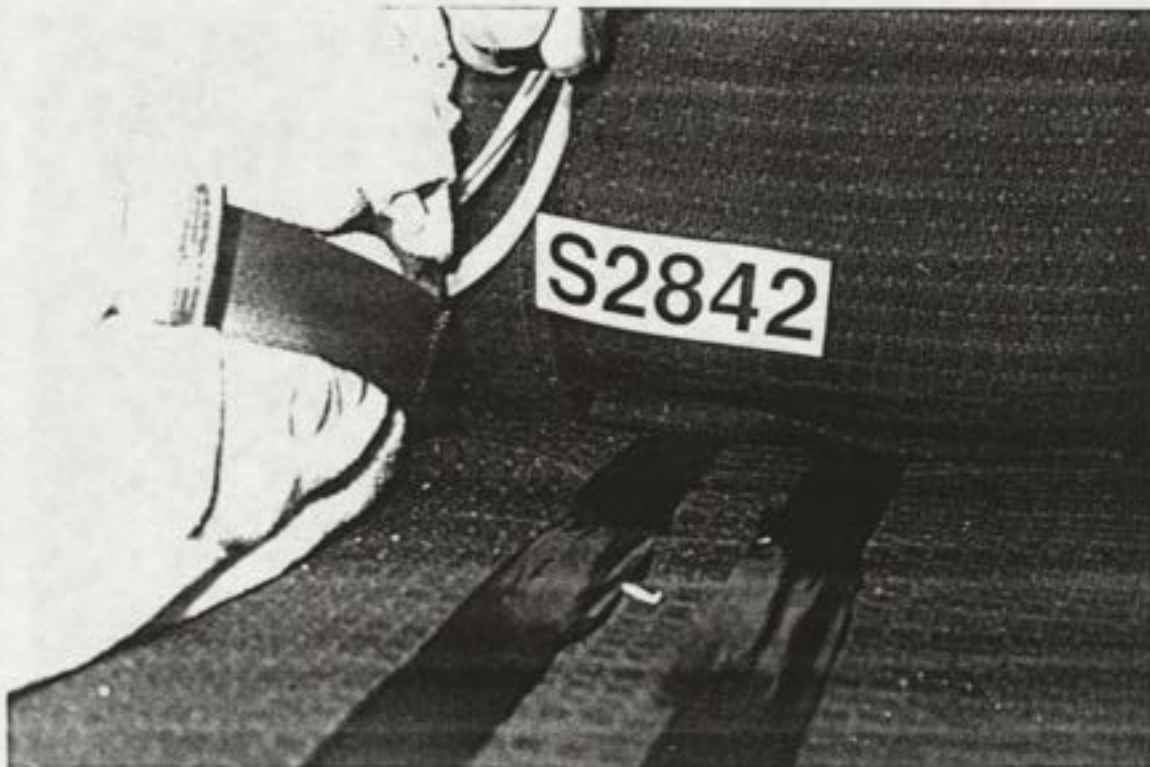
Figure 9 Wrapping of the lap belt around the left hip of the 10 year dummy

In response to the motion of the sled both dummies initially moved forward on the aircraft seat. The use of the wider seat configuration caused the lap belt to be wrapped around the left hip of the 10 year dummy (due to the position of the belt anchorage within the longitudinal projections of the dummy's hips) so that the 10 year dummy was pushed towards the 3 year dummy. Consequently, the motion of the 10 year dummy across the seat combined with the twisting motion of each dummy produced a hip to hip contact. The pelvis of the 3 year dummy was then squeezed between the 10 year dummy, on the left, and the lap belt on the right. As the dummies rotated forward from the hips and about the time of head to leg contact, the compression forces on the pelvis of the 3 year dummy became too great and the pelvis broke apart. The connection between the legs and torso of the dummy was thus severed. Inspection of the pelvis after the test suggested that the failure was initiated at the right wing of the pelvis structure where it was loaded by the lap belt.

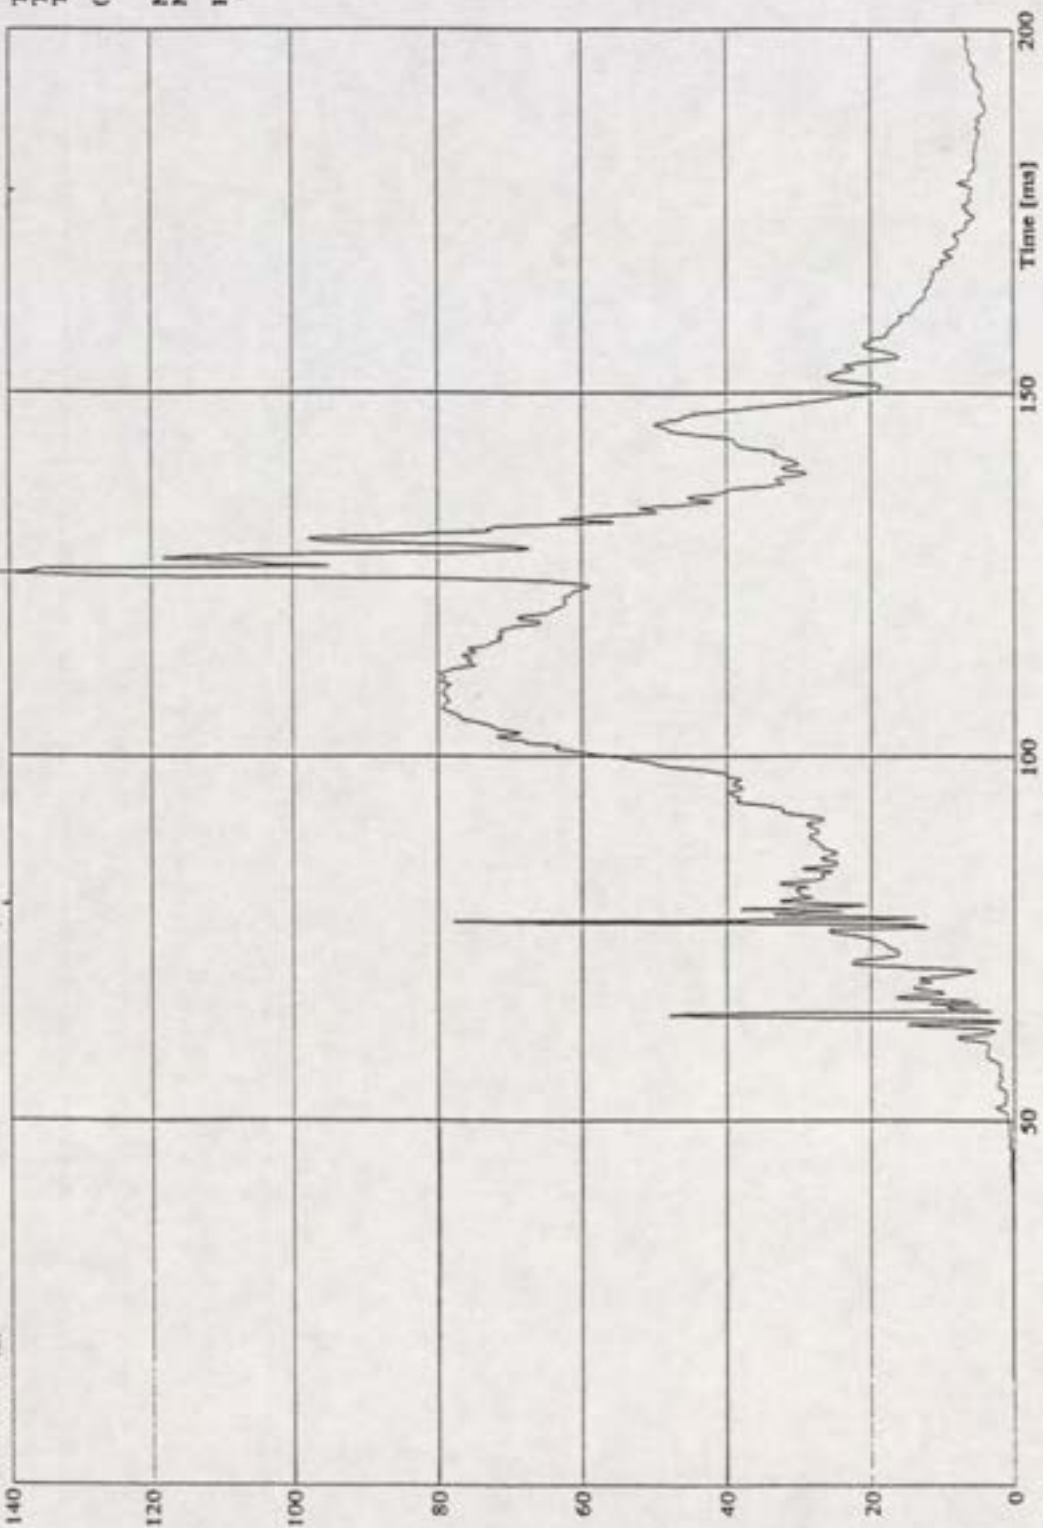
# HEAD ACCELERATION RESULTANT (P3)

Max. 144g | 125.0ms |  
Min. 0g | 0.0ms |  
HIC = 1727  
(T1 = 98.3ms T2 = 134.9ms)

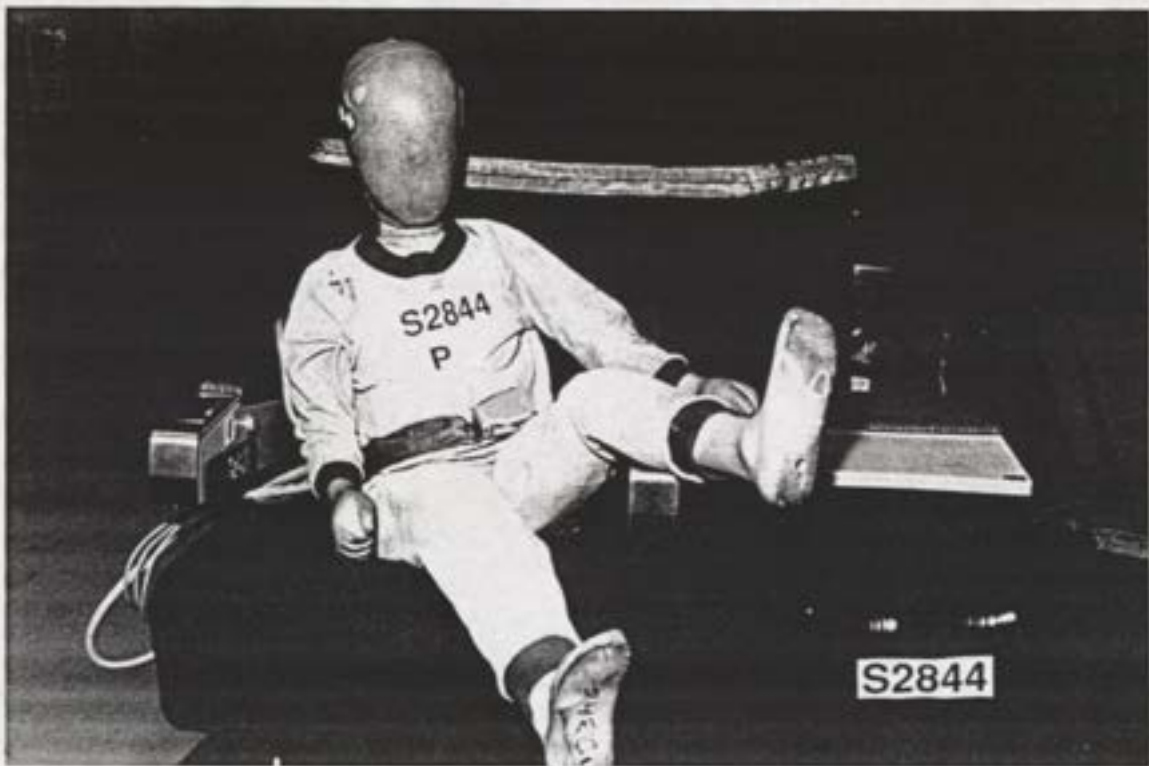
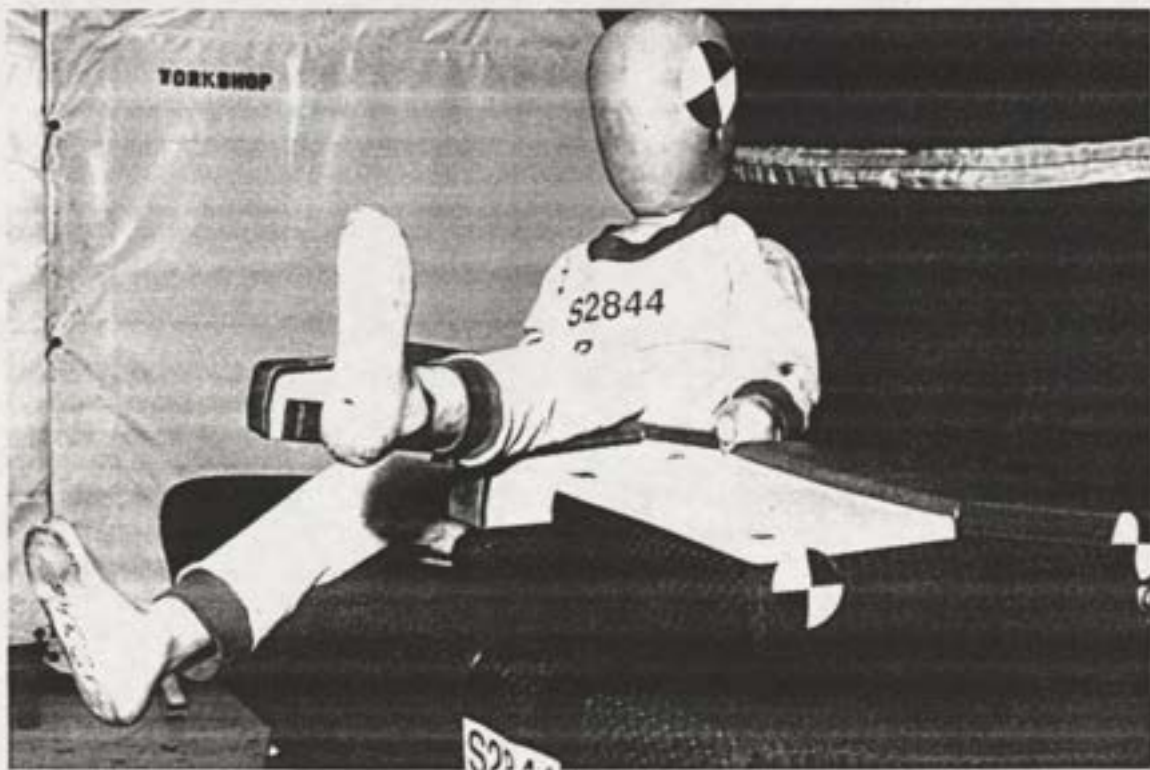
Figure 15a Position of the 6 year dummy after test

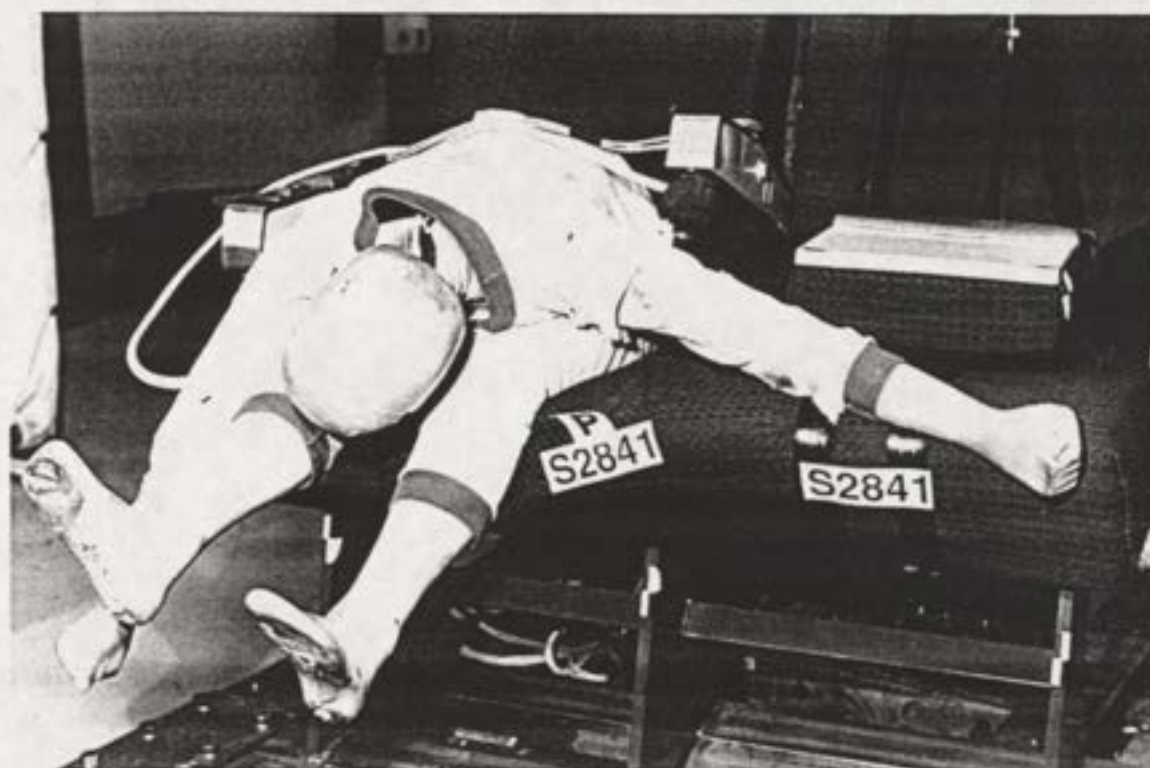
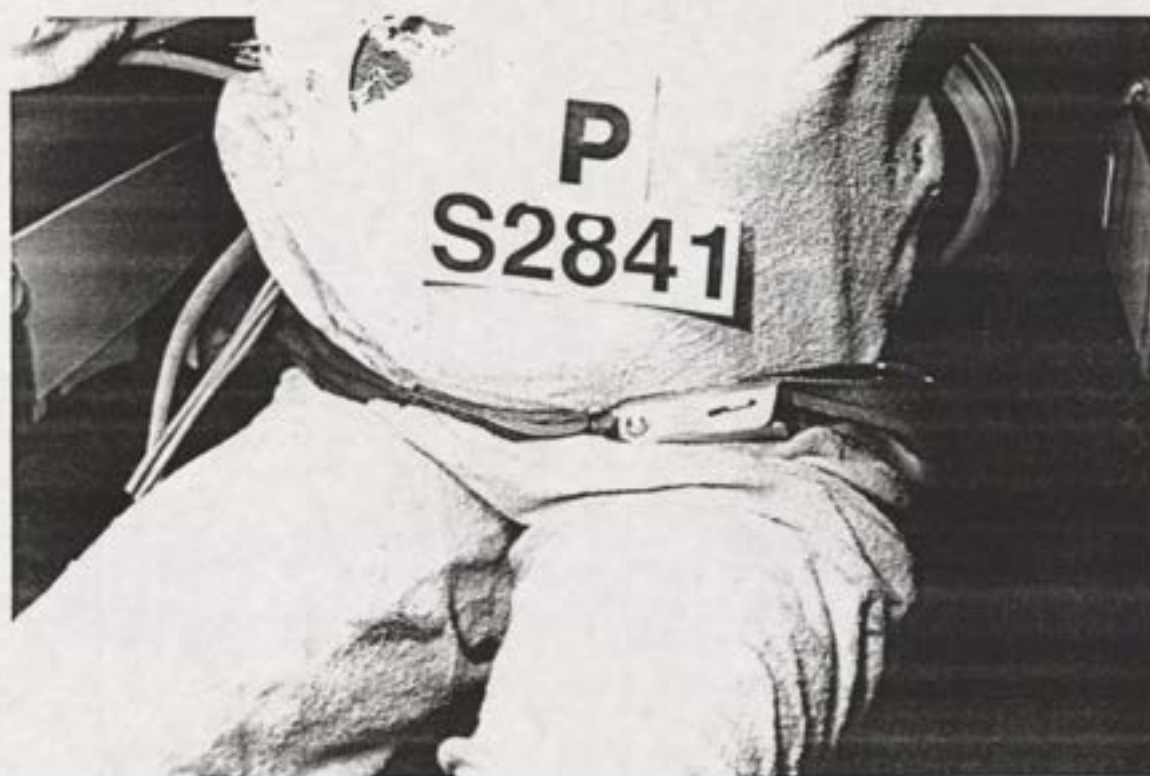
Figure 16a Position of the 10 year dummy after test

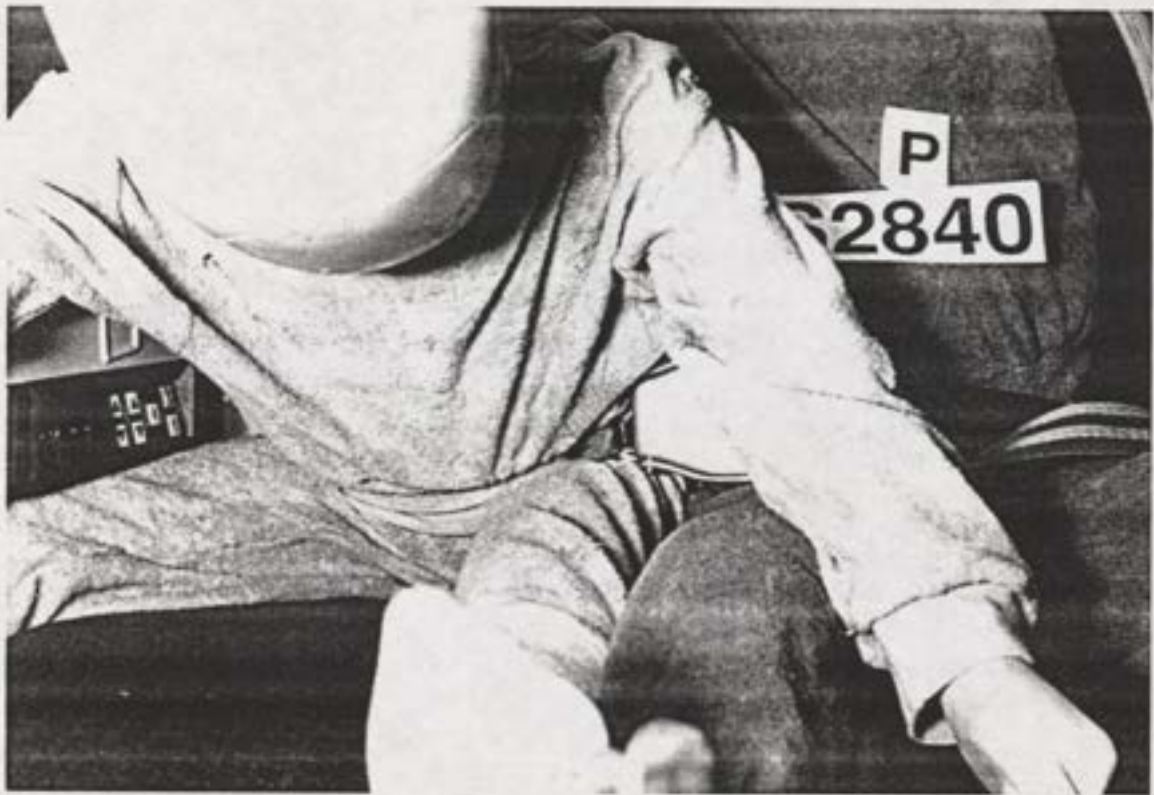
Figure 17a Positions of the 3 year dummies after test

In response to the motion of the sled both dummies initially moved forward on the aircraft seat as the slack in the lap belt was eliminated. However, as only one hip of each dummy was directly restrained by the lap belt, the dummies then twisted away from each other. That is the right dummy rotated clockwise about a vertical axis and the left dummy rotated anti-clockwise about a vertical axis. The dummies were pushed even closer together by the twisting motions and generated a hip to hip contact, in addition to the shoulder to shoulder contact. Lateral compression forces were imposed on the pelvis of each dummy by virtue of the hip contact, the inertias of each dummy and the constraint imposed by the lap belt. This type of loading was absent from the test with only one 3 year dummy, since both hips of that dummy were restrained by the lap belt.

Thereafter, each dummy rotated forward from the hips and ultimately struck the leg that was adjacent to the other dummy with its head.

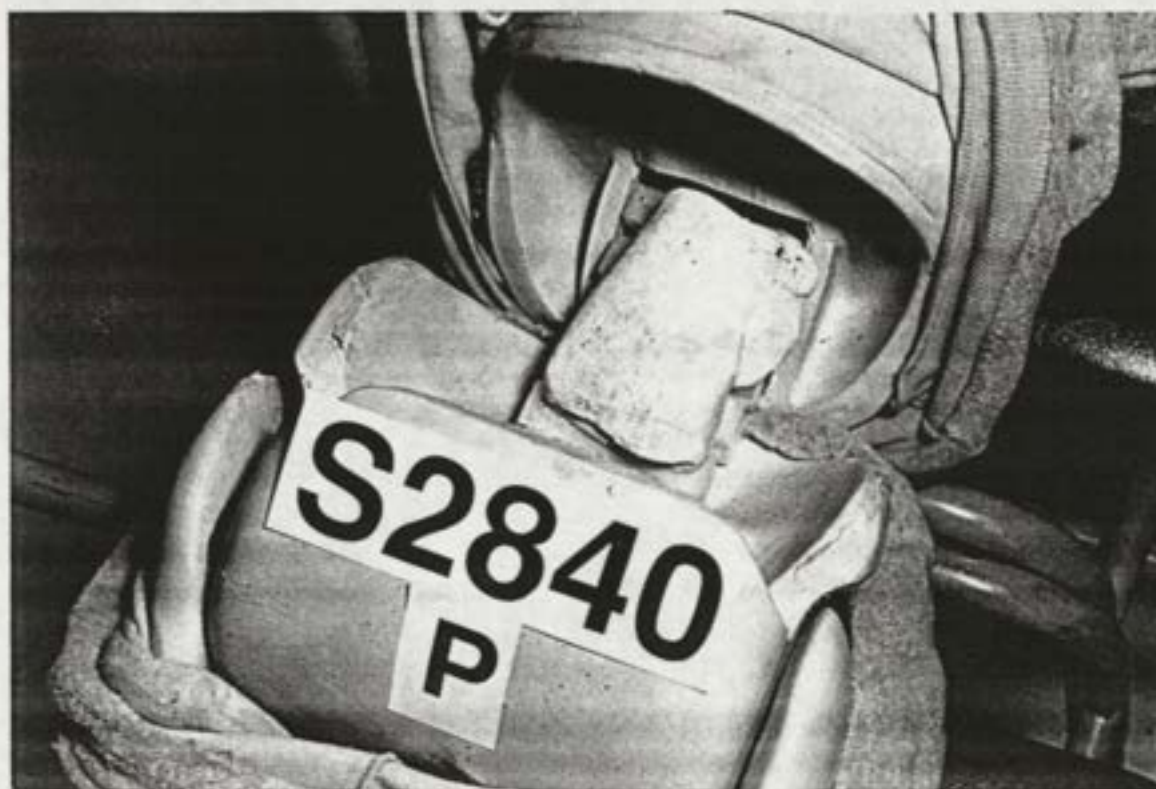
Figure 17b Distortion of plasticine after test

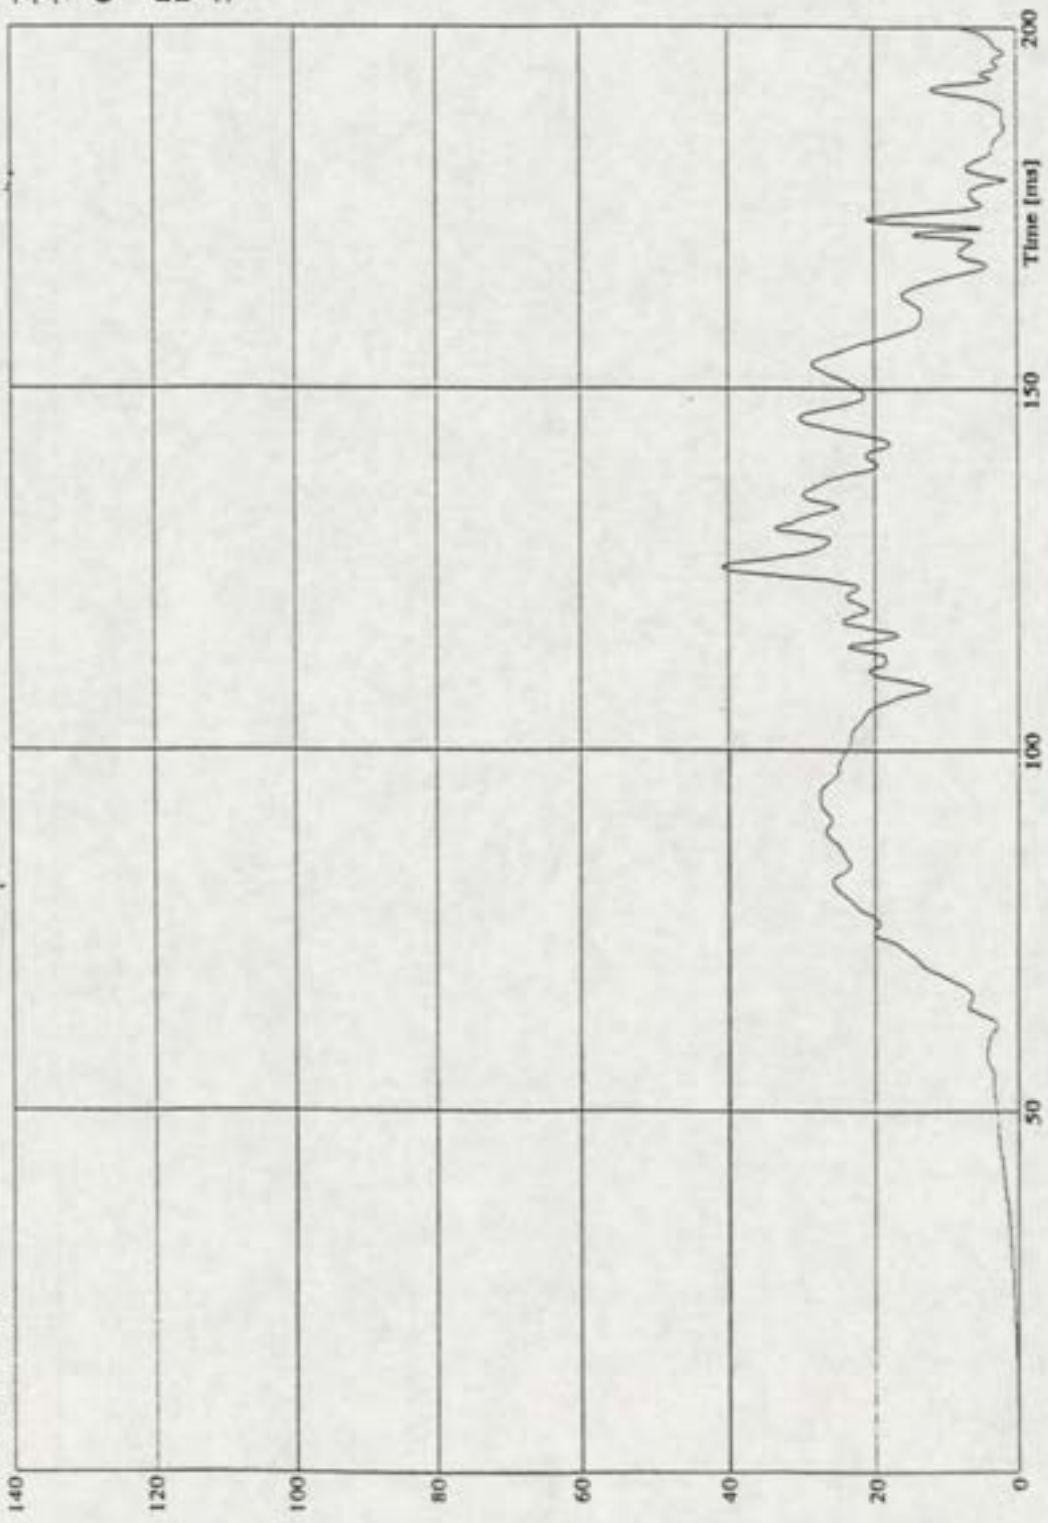
Figure 17f

# P3 LH CHEST ACCELERATION RESULTANT

Test Number : S2840  
Test Date : 30-04-92  
Test Engineer : P. Glyn-Davis  
(29-05-92)

Max. 41g [ 125.0ms ]  
Min. 0g [ 0.0ms ]  
3 ms max. 33g

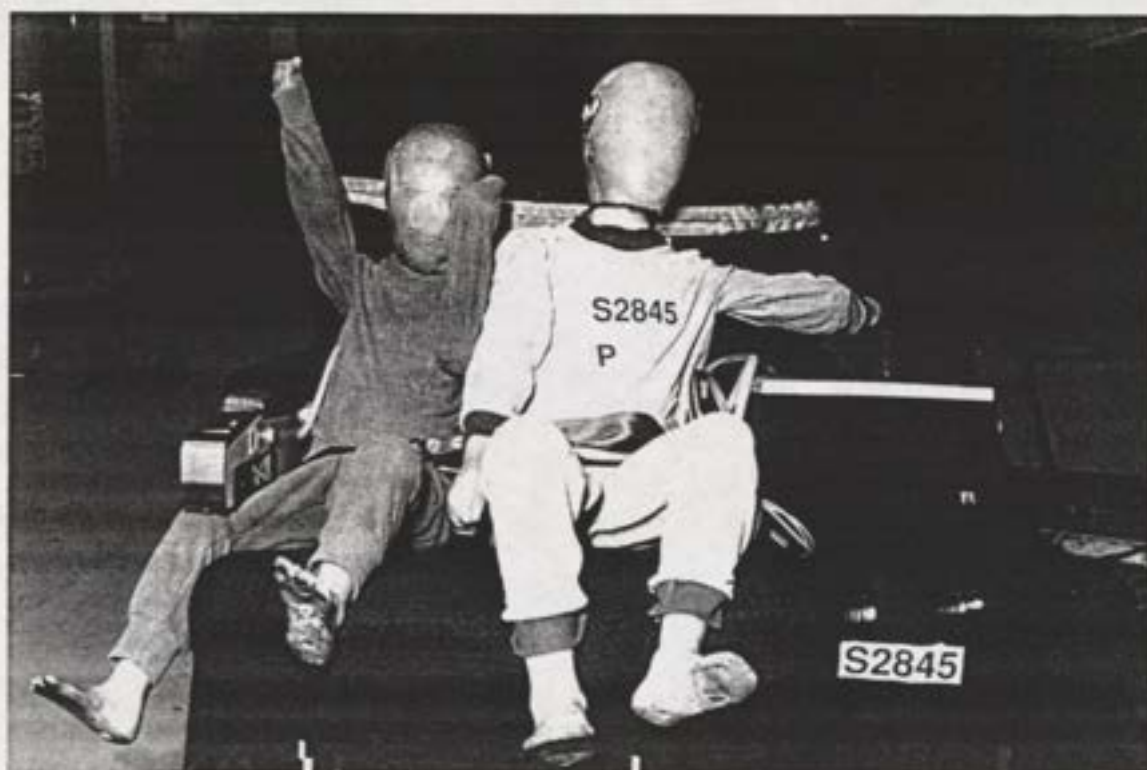
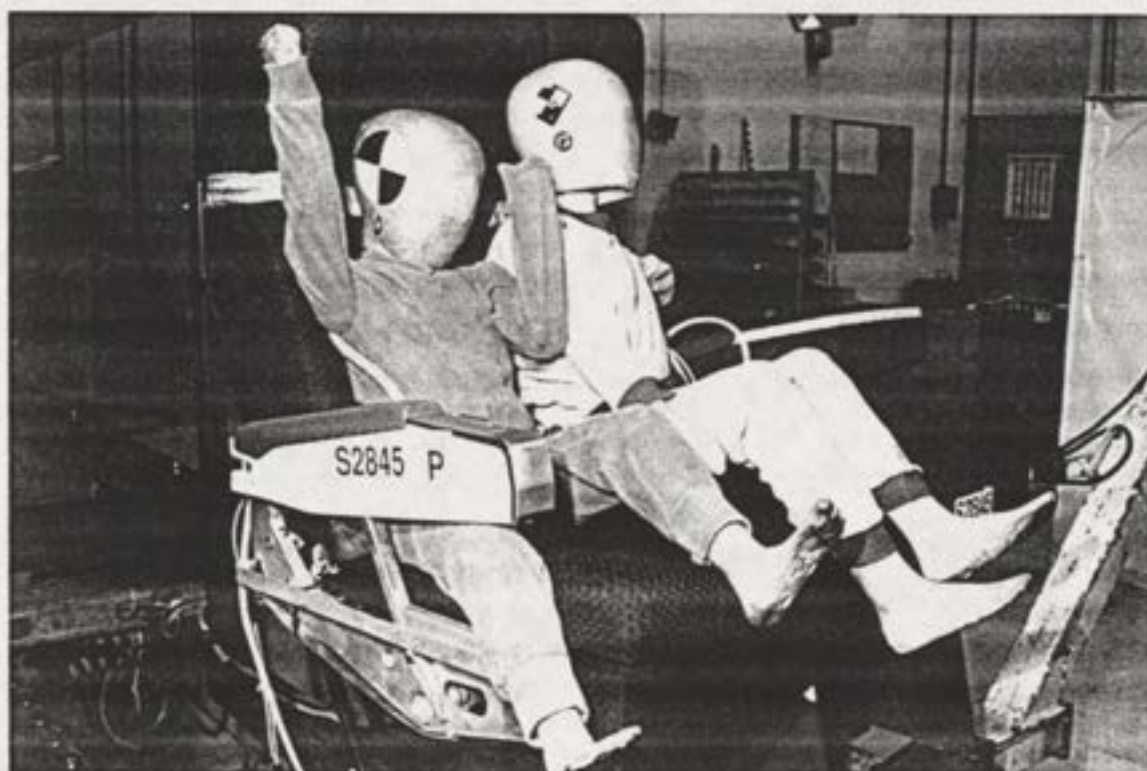
Figure 18a Positions of the 3 year and 6 year dummies after test

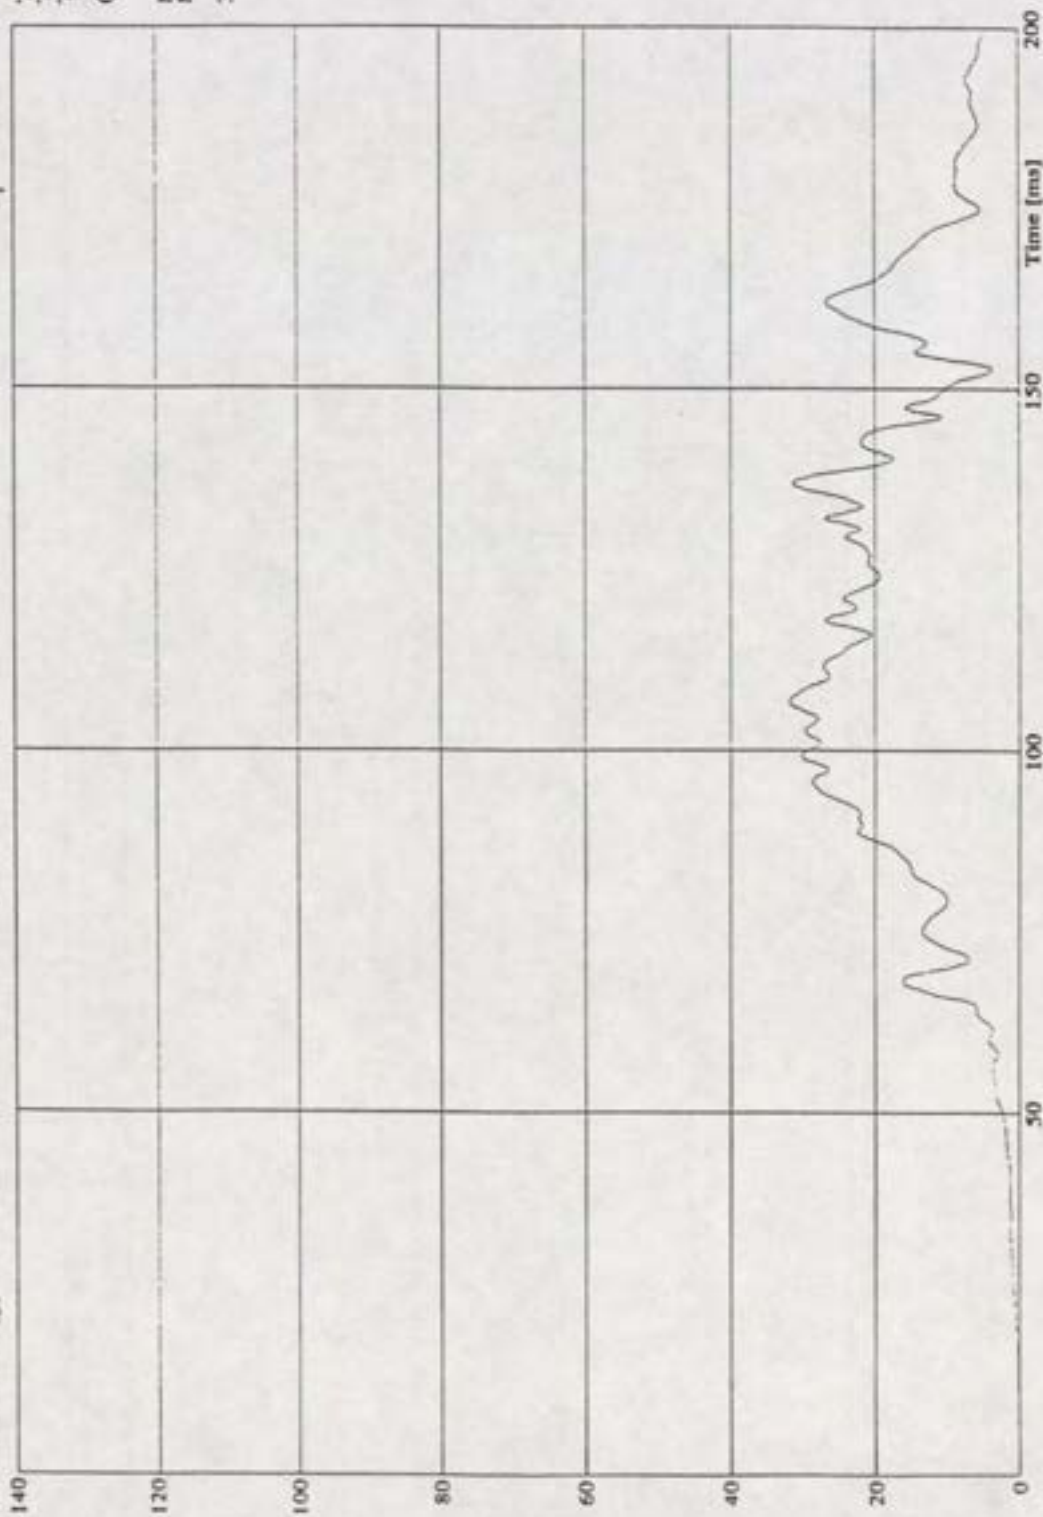
# P3 CHEST ACCELERATION RESULTANT

Resultant  
Acceleration [g]

Test Number : S2845  
Test Date : 12-05-92  
Test Engineer : P. Glyn-Davies  
(12-05-92)

Max. 32g [ 106.0ms ]  
Min. 0g [ 0.0ms ]  
3 ms max. 31g

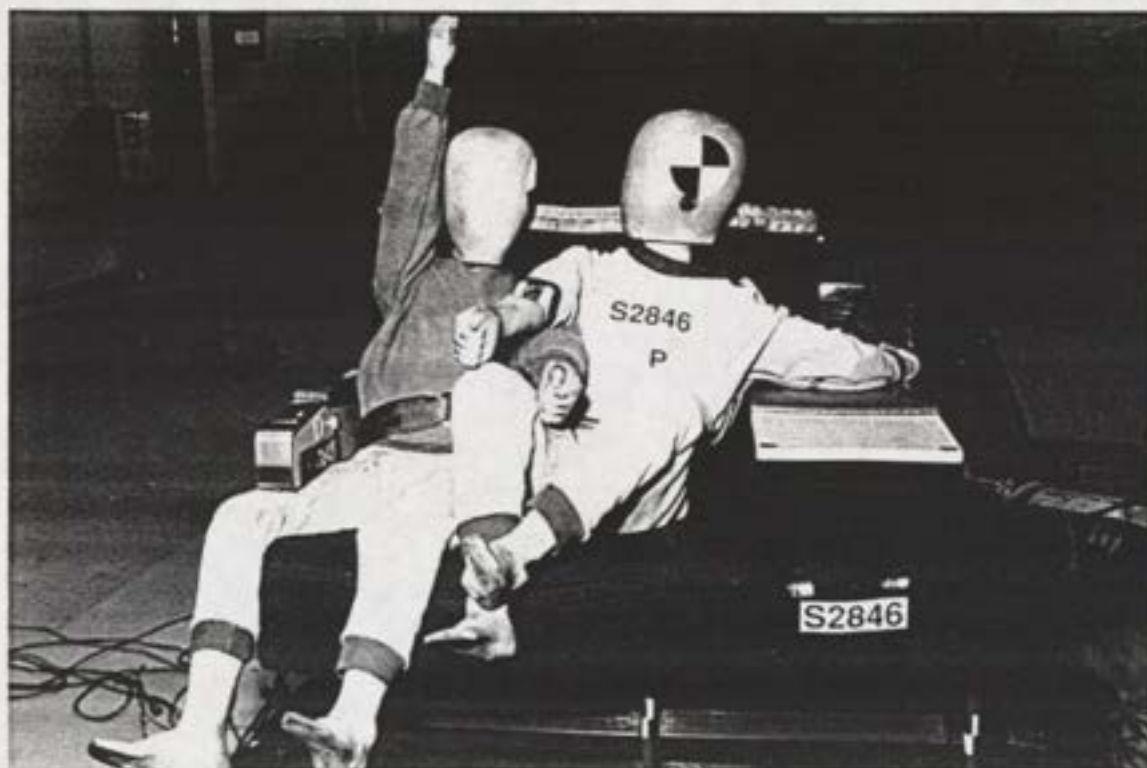
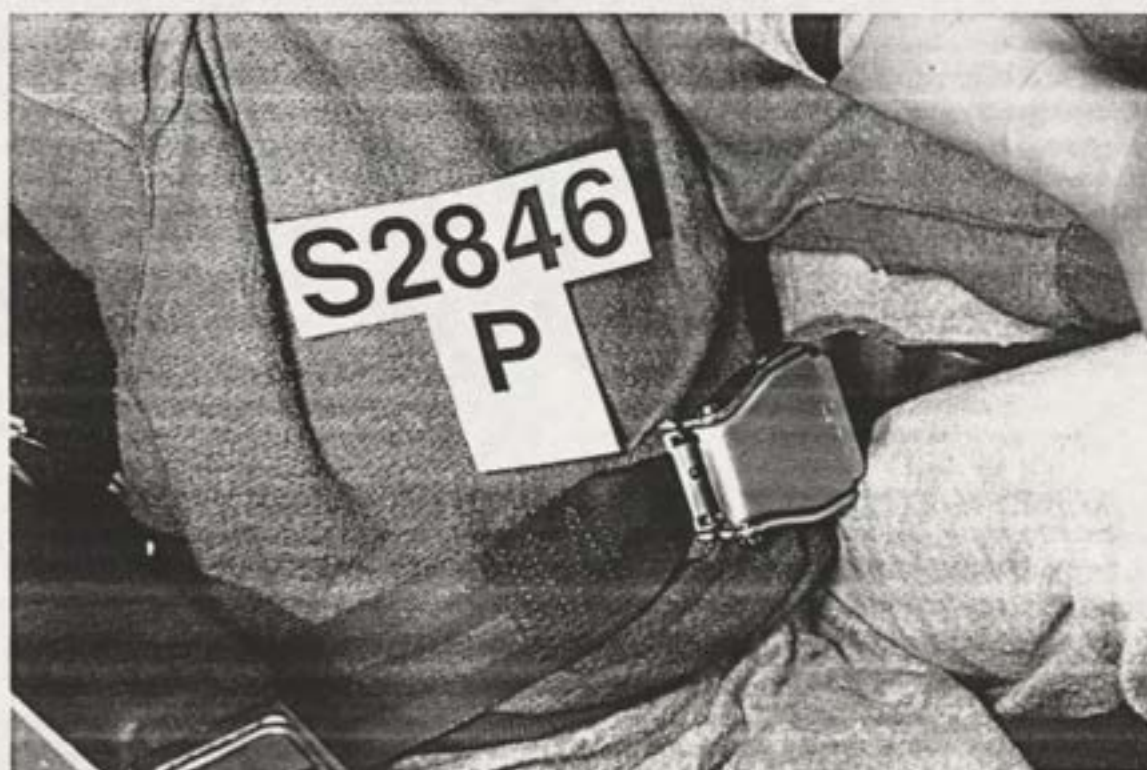
Figure 20a Positions of the 6 year dummies after test

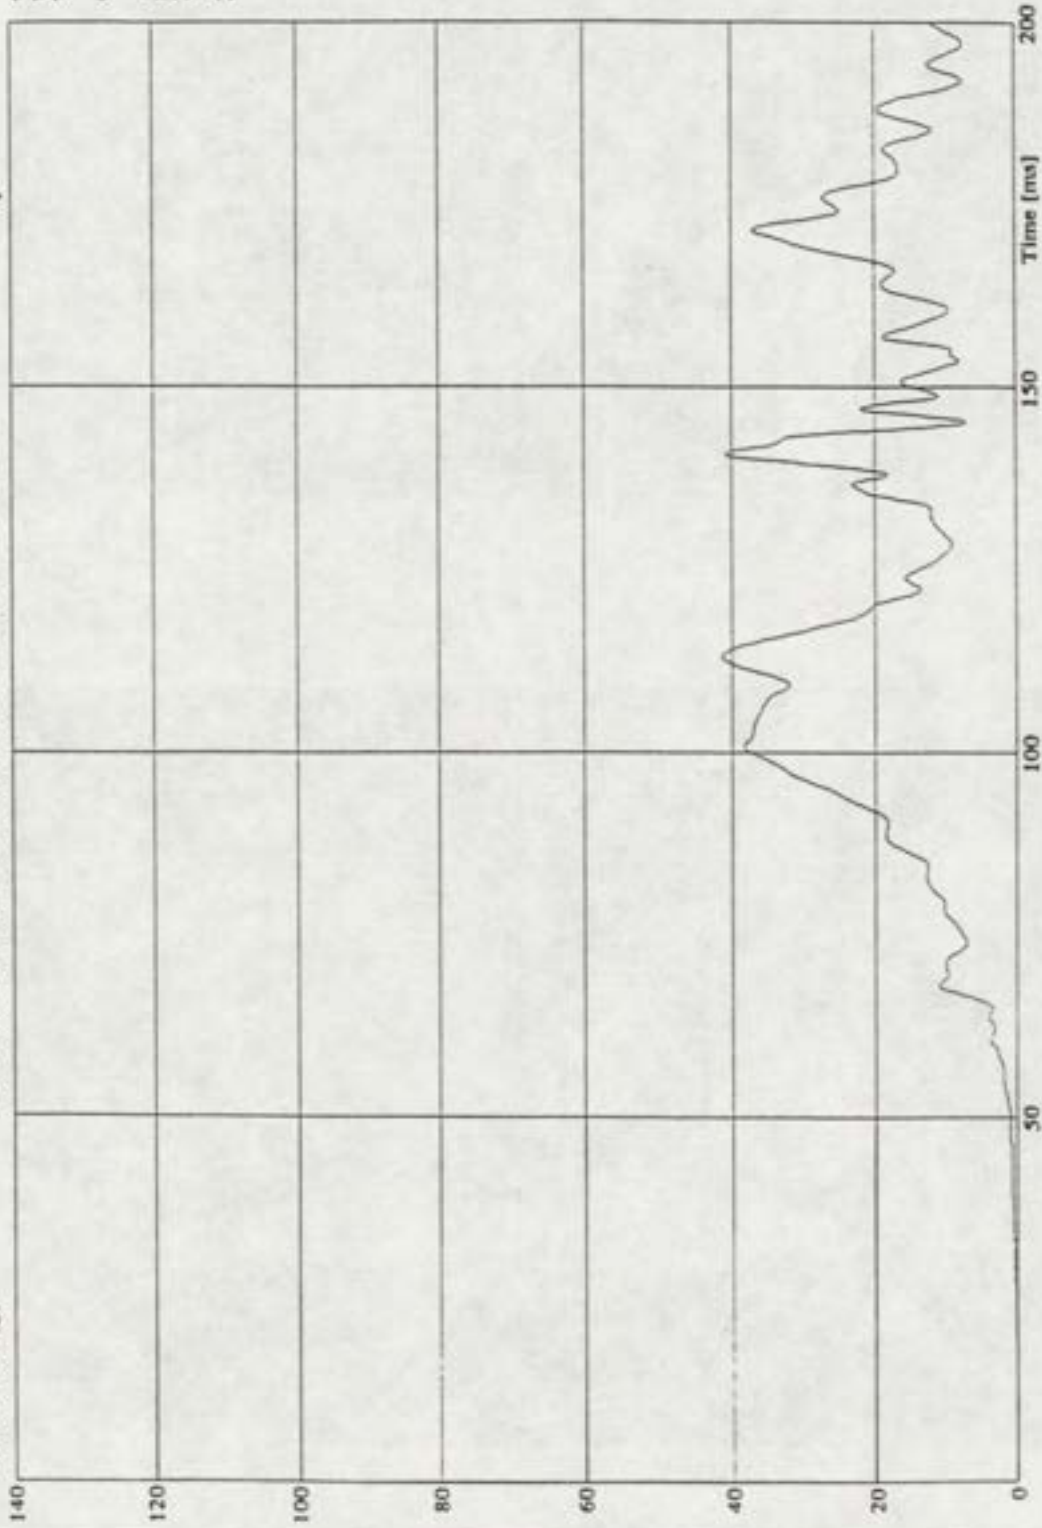
# P6 LH CHEST ACCELERATION RESULTANT

Resultant  
Acceleration [g]

Test Number : S2846  
Test Date : 12-05-92  
Test Engineer : P. Glyn-Davis  
(12-05-92)

Max. 41g [ 113.0ms ]  
Min. 0g [ 0.0ms ]  
3 ms max. 40g

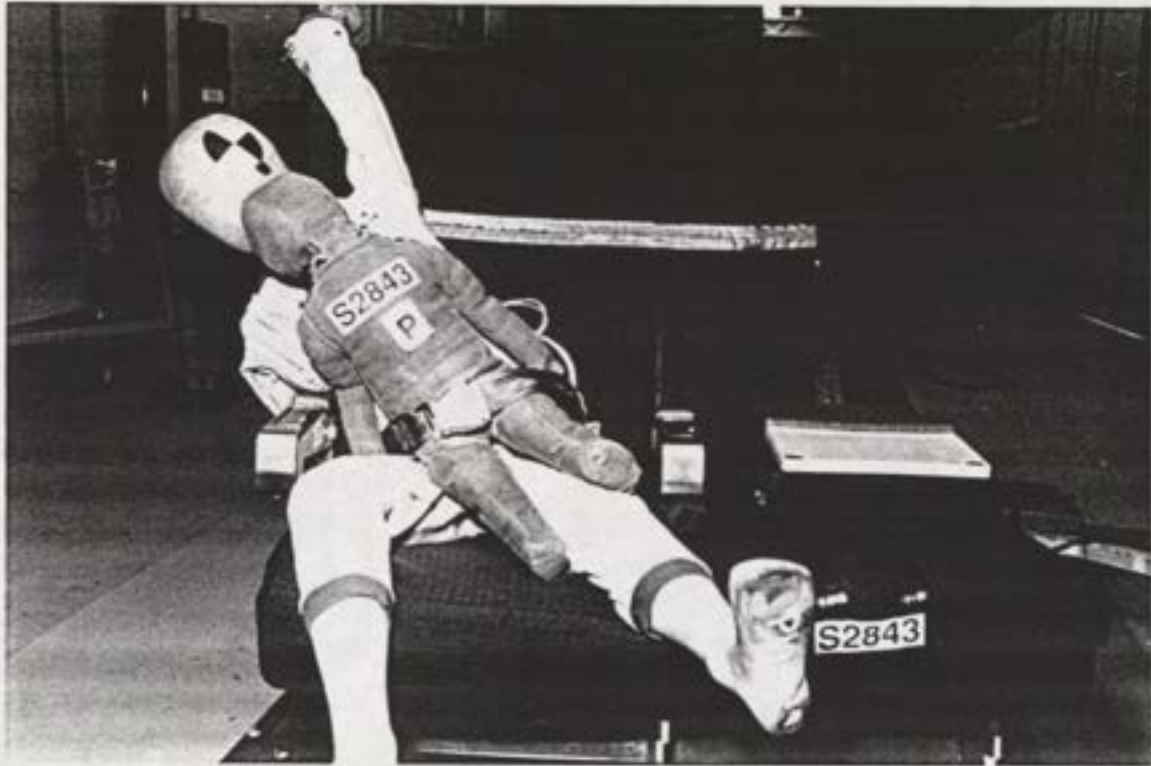
Figure 21a Positions of the 9 month and 10 year dummies after test

passed through the 9 month dummy to the abdomen of the larger dummy – thereby loading it more heavily than during the test with a single 10 year dummy. If the 9 month dummy could have been instrumented it would probably have registered forces and accelerations that were extremely high and likely to cause debilitating or fatal injuries to an infant.
